Asbestos Management Plan – Birrigai Outdoor School.

### Hazardous Material Survey & Management Plan

**Birrigai Outdoor School**  
**Tidbinbilla Rd**  
**Tharwa ACT 2620**

**10 June 2010**

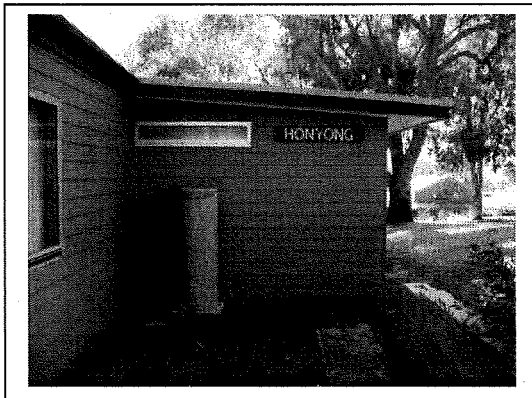
**Photograph 1:**  
Honyong dormitory exterior wall panel  
*Refer Sample: 5816 – A3*

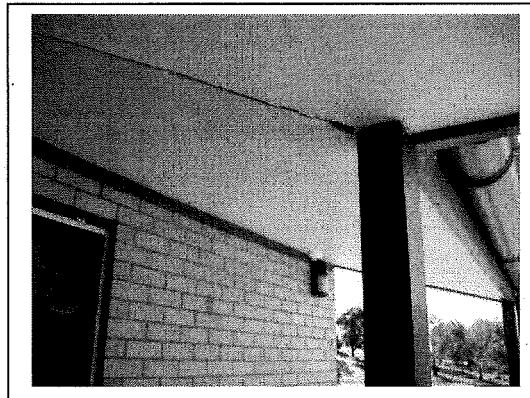
**Photograph 2:**  
Green Dormitory perimeter eave sheet  
*Refer Sample: 5816 – A6*

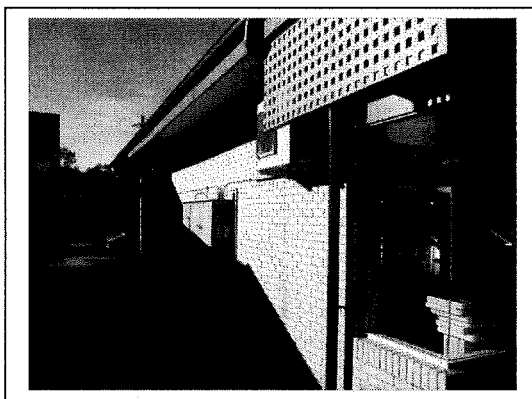
**Photograph 3:**  
Dining room building southern eave sheet  
*Refer Sample: 5816 – A13*

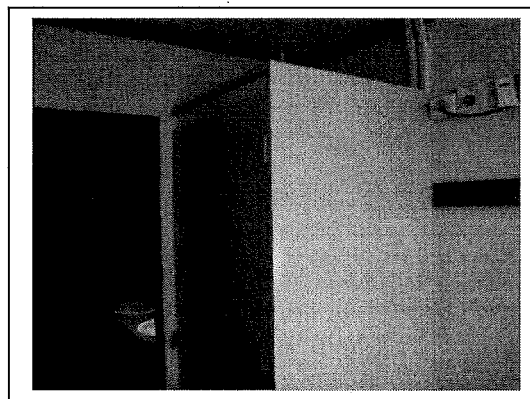
**Photograph 4:**  
Green Dormitory wet area wall sheet  
*Refer Sample: 5816 – A9*

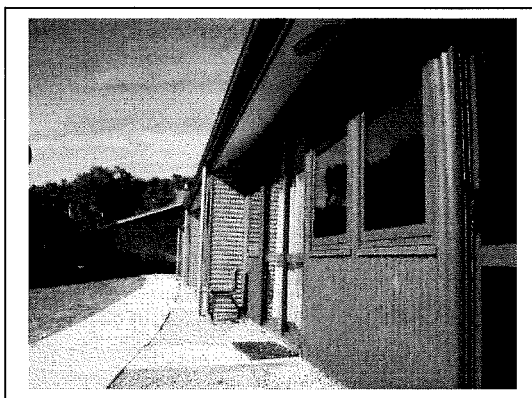
**Photograph 5:**  
Cabins – perimeter eave sheet  
*Refer Sample: 5816 – A5*

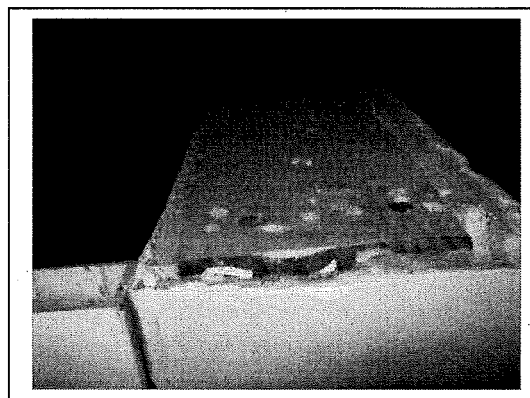
**Photograph 6:**  
Blewitt Hall male wc cubicle partition wall sheet. *Refer Sample: 5816 – A16*

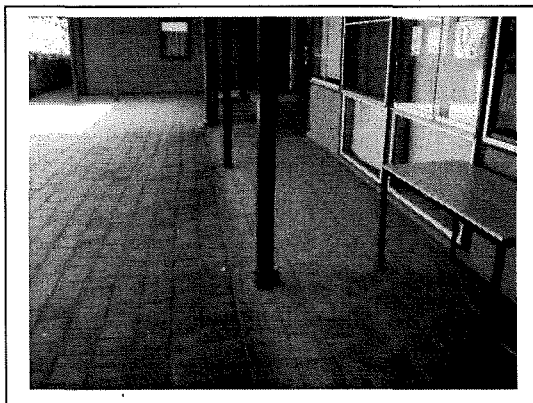
**Photograph 7:**  
Honyong courtyard verandah posts.  
1<sup>st</sup> Schedule Paint – 0.16 to 0.31% Lead  
Refer Sample: 5816 – P3(a,b,c)

- The first schedule paint is in reasonable condition and may remain in-situ. It should be assumed that all similar paint applications throughout the Birrigai Outdoor School site would contain similar percentages of lead.

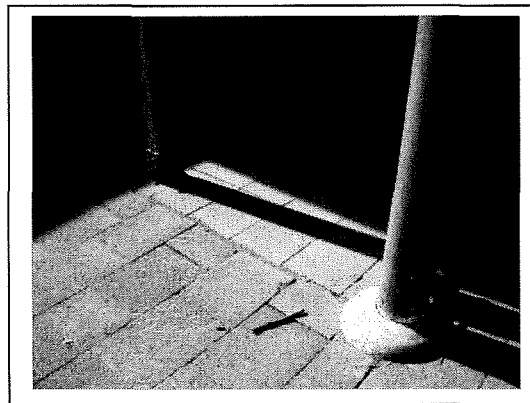
**Photograph 8:**  
Honyong courtyard verandah posts.  
1<sup>st</sup> Schedule Paint – 0.16 to 0.31% Lead  
Refer Sample: 5816 – P3(a,b,c)

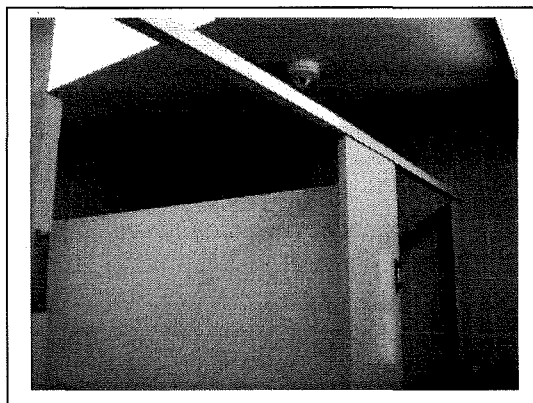
**Photograph 9:**  
Green Dormitory wet area partition frame  
1<sup>st</sup> Schedule Paint – 0.65 to 0.80% Lead  
Refer Sample: 5816 – P9(a,b,c)

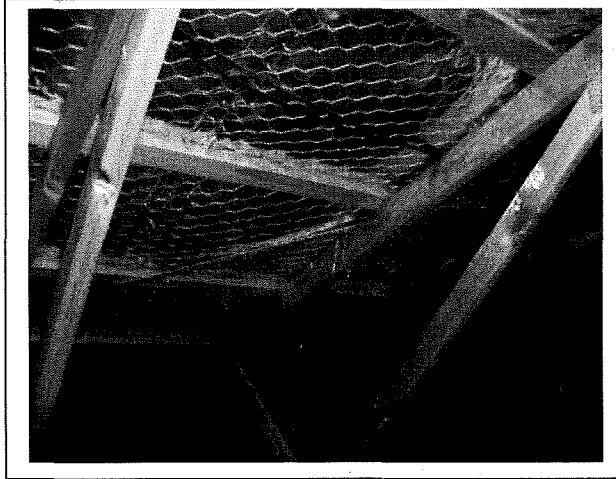
**Photograph 10:**  
Honyong dormitory ceiling space – foil  
backed yellow fibreglass insulation

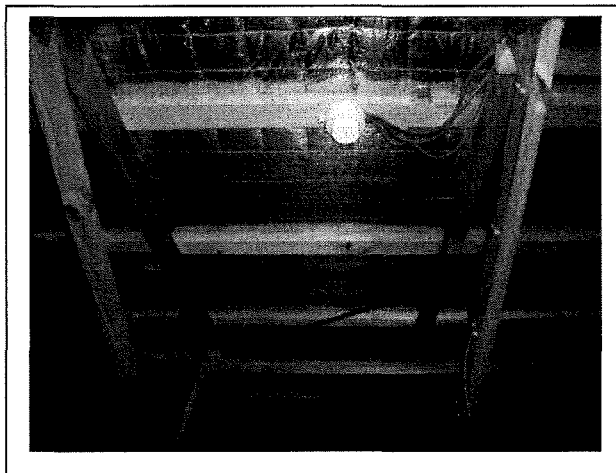
**Photograph 11:**  
Green dormitory ceiling space – foil  
backed yellow fibreglass insulation

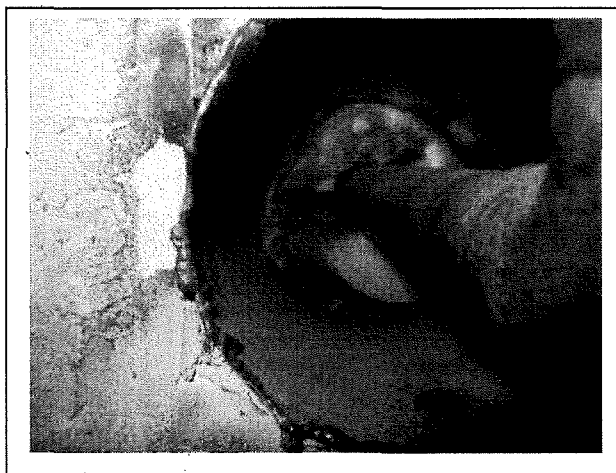
**Photograph 12:**  
Administration Building – yellow  
fibreglass insulation to copper  
heating pipe

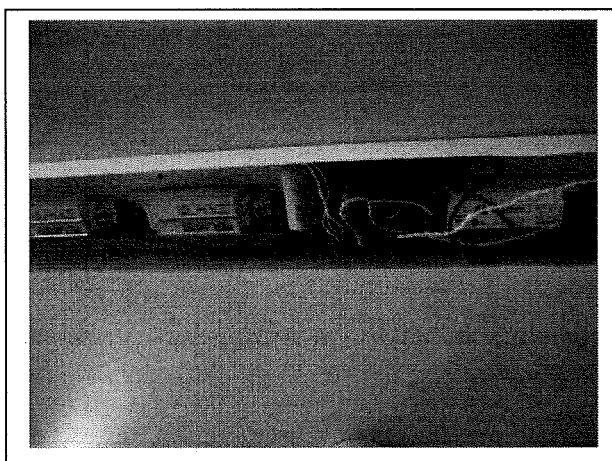
**Photograph 13:**  
Honyong dormitory - throughout  
Elco, plastic cylindrical – non PCB

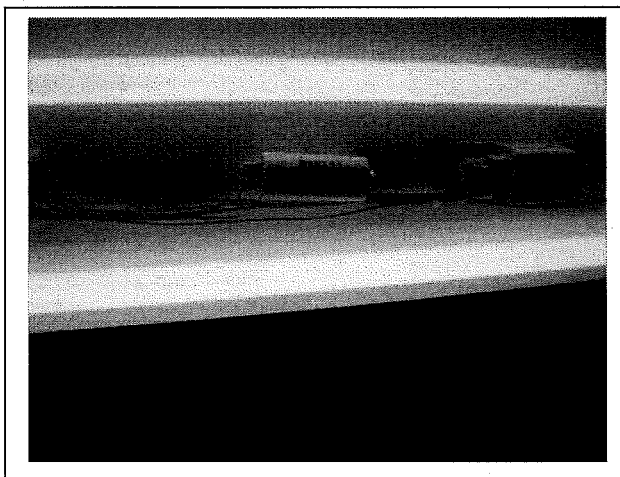
**Photograph 14:**  
Dining Hall kitchen – throughout,  
Vossloh Schwabe,  
plastic cylindrical – non PCB

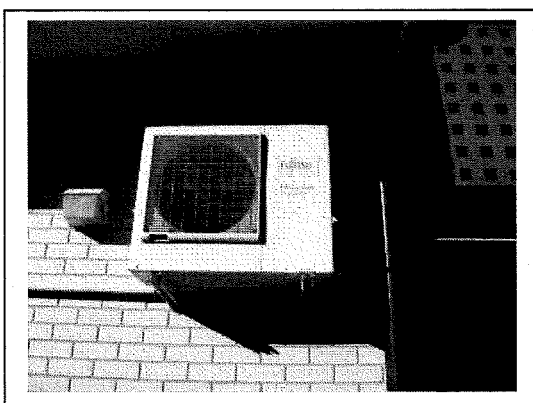
**Photograph 15:**  
Dining Hall  
Fujitsu Split System Airconditioning unit –  
Refrigerant R410A

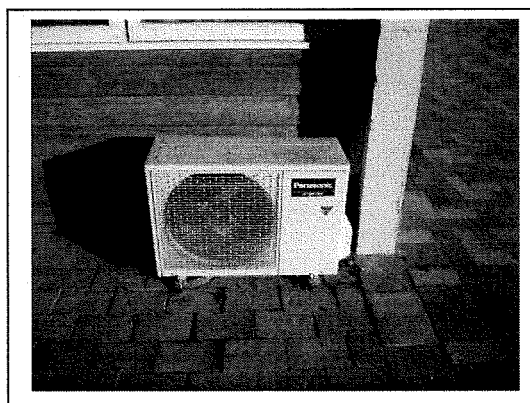
**Photograph 16:**  
Blewitt Hall  
Panasonic Split System Airconditioning  
unit – Refrigerant R410A

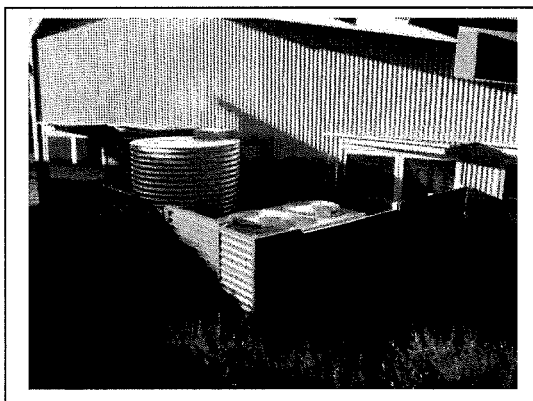
**Photograph 17:**  
Administrative Building  
McQuay Airconditioning unit –  
Refrigerant R407C

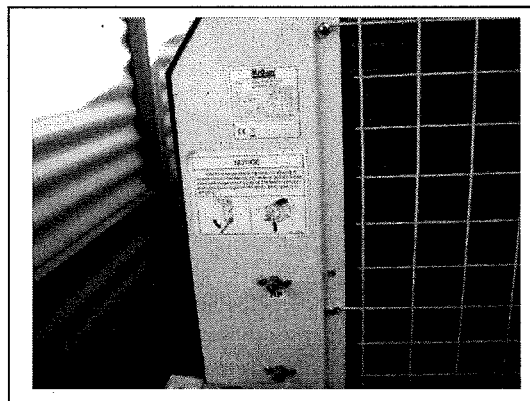
**Photograph 18:**  
Administrative Building (photo 17)  
McQuay Airconditioning unit –  
Refrigerant R407C

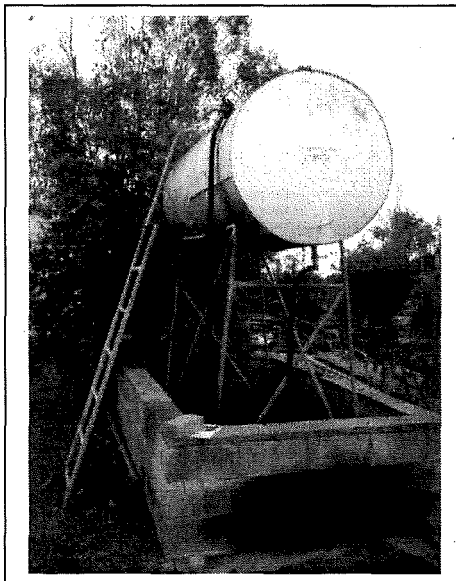
One Above Ground Storage Tank(s) (AST) was identified during the survey. The AST is satisfactorily bunded and no significant spillage was noted.

**Photograph 19:**  
Bunded Above Ground Storage Tank  
Diesel Fuel

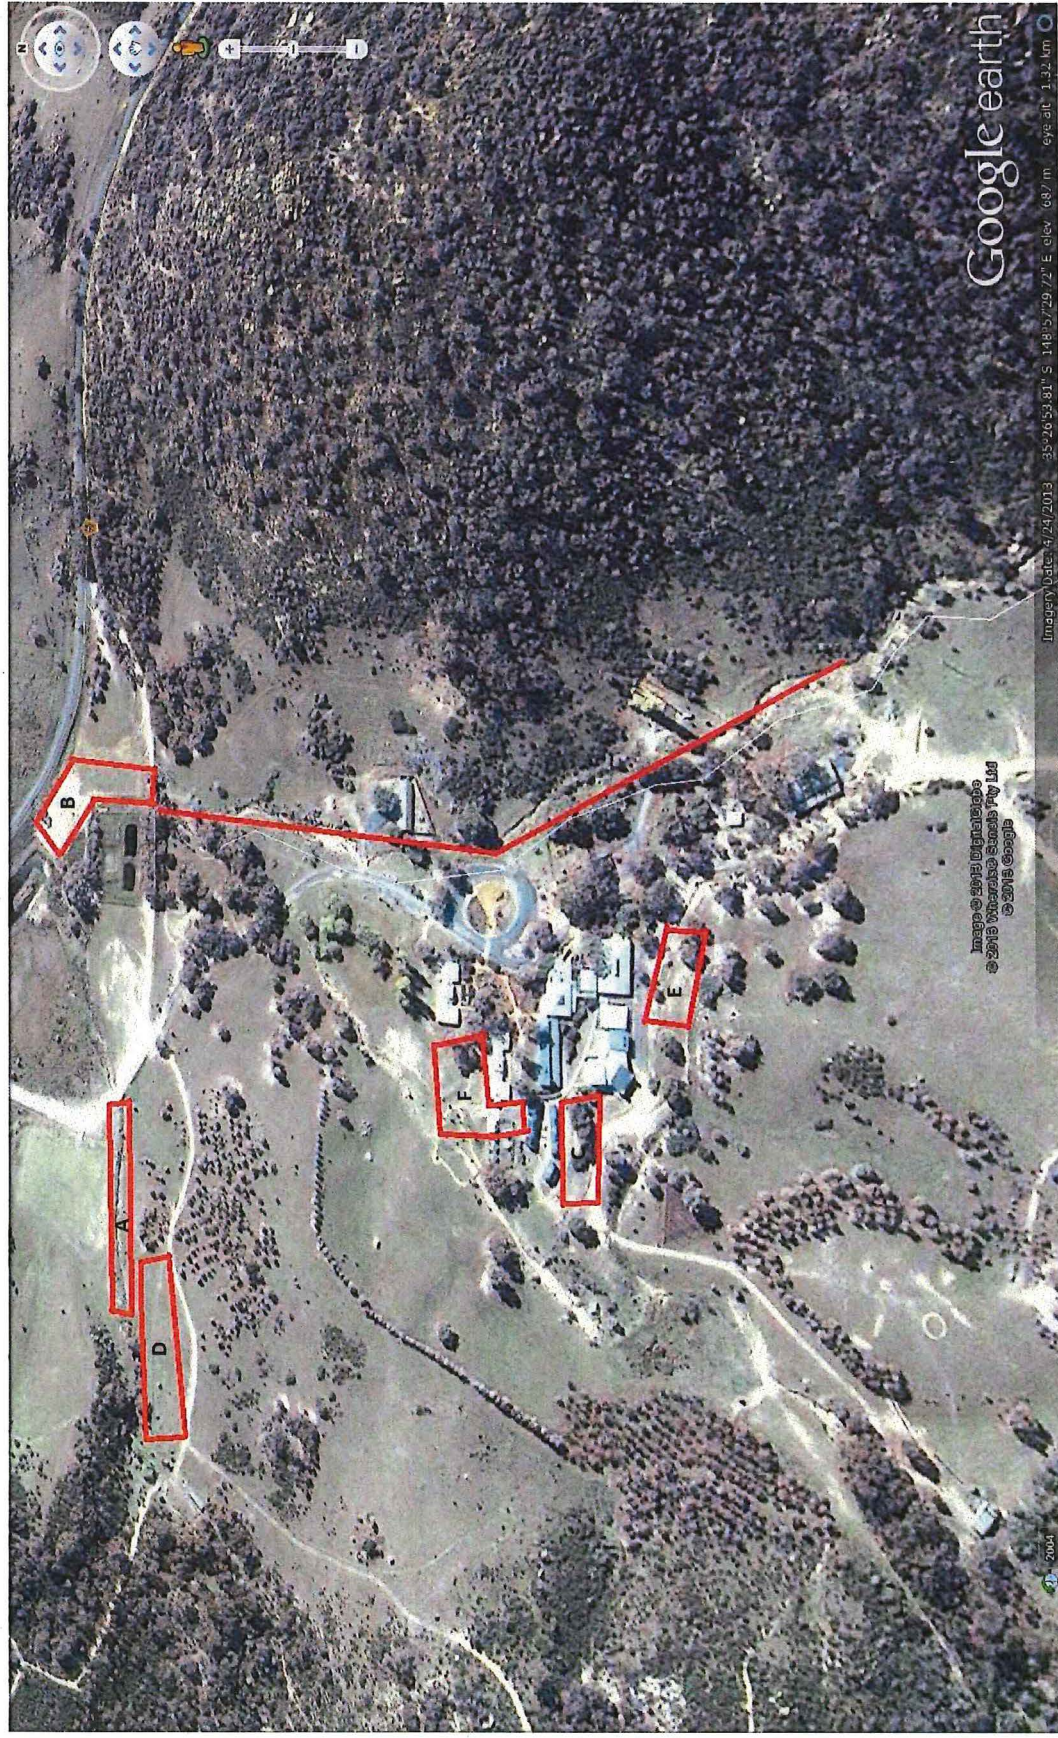
Areas that need Visual Inspection & Removal
