Inquiry into referred 2017–18 Annual and Financial Reports
ANSWER TO QUESTION ON NOTICE

Glenburn Homestead

Scope of Conservation Work

27 June 2018

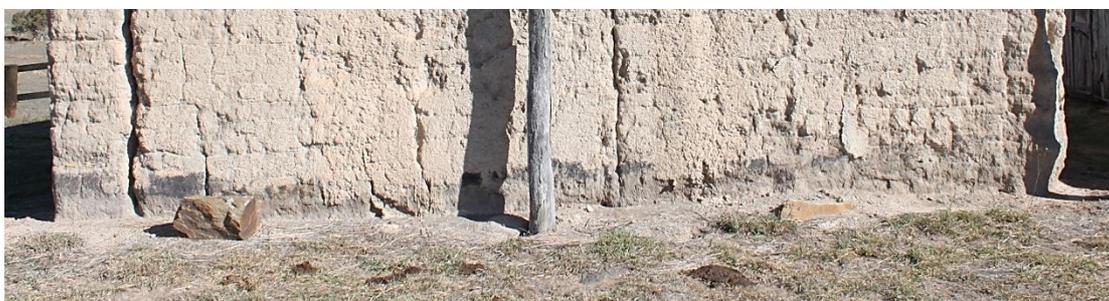
Base of north wall 2018

There is no evidence of a damp proof course and in most parts of the external wall there has been some loss of earth most probably due to rising damp. The most problematic area had been on the south west corner of the building and this was repaired in 2013. The cause elsewhere is not entirely clear and could be a result of rising damp, excess surface water, wind abrasion, rain splash and/or animals. The walls are not actively monitored and so it is not clear if most of the erosion occurred when the roof was off, or if it is more gradual.

Black material on the earth wall above ground has not been analysed but may have been an earlier attempt to arrest decay using sump oil.

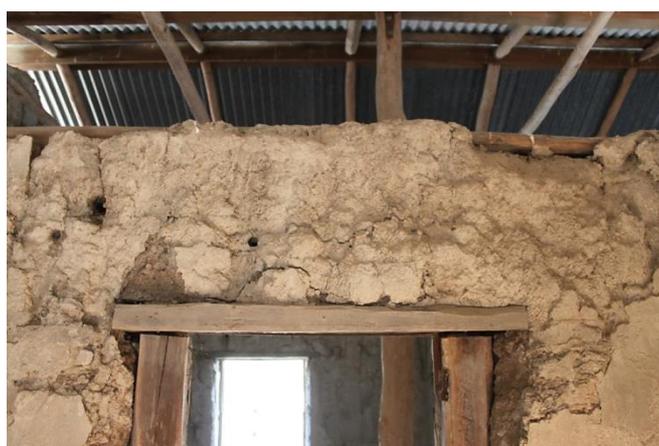
It is not known if an analysis of the sand/clay content has been undertaken however it seems the mix is very susceptible to water erosion, which is particularly obvious on some of the internal walls.

Water damage that would have occurred prior to re-roofing.

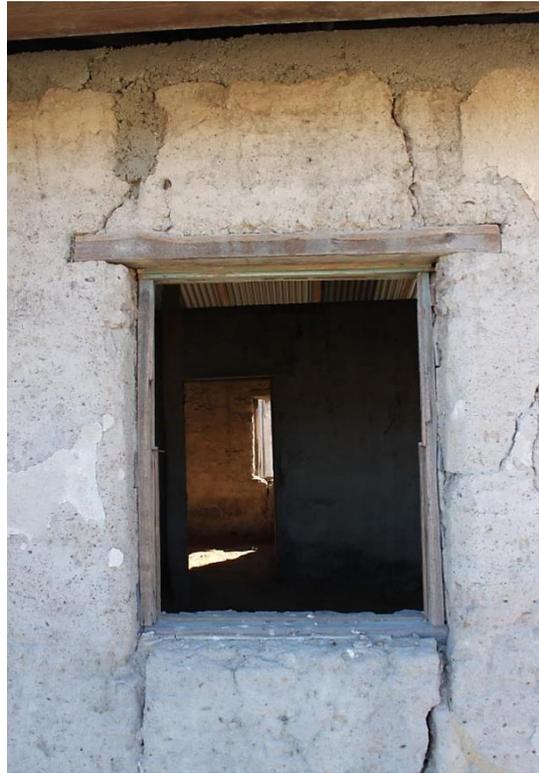
North west window 2018

Like the doors, the earth above windows is supported by two parallel rough-hewn timber lintels laid side by side and embedded into the pise` wall by approximately 100- 150 mm. The window frame is of machined hardwood and sits midway in the thickness of the wall. The frame is secured to timber lugs embedded in the wall and appears to provide conditional support to the timber lintels above.

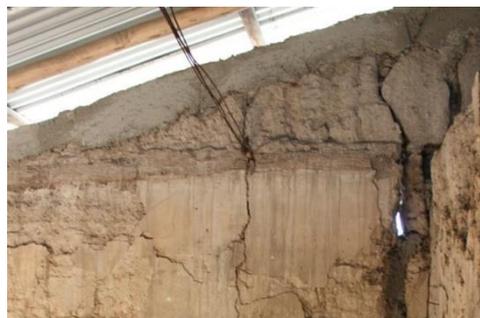
Two sets of wall ties run through the building from the north gable to the south. They comprise four or so strands of fencing wire that are now rusty and presumed to date from the occupation phase, although they may have been added after the roof blew off - in an attempt to hold the walls together?. They are located just above the former ceiling level and are no longer tight. The south end wraps around the chimney and the north is fixed to a short external timber plate. The wires should not be tightened as there is a risk they will break.

Wire 'tie' above former ceiling level

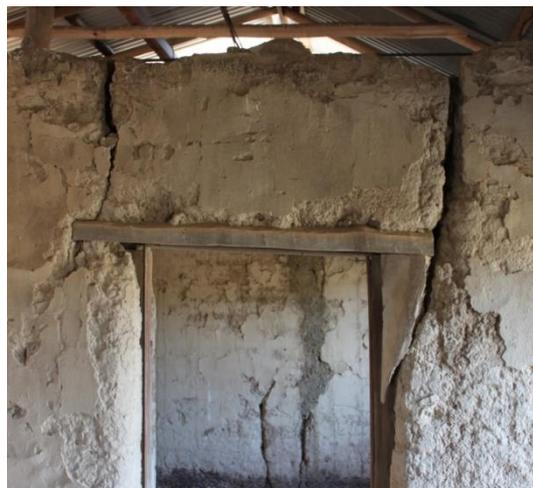
From subsidence and some evidence of former termite activity it is assumed that the bases of the door jambs /posts have been eaten by termites. As the post has subsided the weight of the earth-bearing lintel above has placed pressure on the adjacent earth wall causing it to shear away in several instances.

Subsidence of door jamb leading to shear of adjacent earth

It is assumed that decay or termite attack at the base of jambs has caused subsidence which will continue if strength at the base of jambs is not re-established.

Gently, and only where necessary, prop the lintel. If possible apply upward pressure to slightly lift the lintel and prise back to level position and relieve weight off the jamb.

Expose the base of the jamb and if decayed carefully remove it for repair.

Excavate around the base of the jamb by about 250 x 250mm and pour a 125mm thick concrete footing to finish approximately 50mm below the original internal floor level. Monitor the excavation for artefacts, traditional construction techniques etc. If there is a timber threshold it should be reinstated.

Cut back the jamb to sound material and splice on a new base of termite-resistant Australian hardwood. The splice should be half-lapped, glued and bolted.

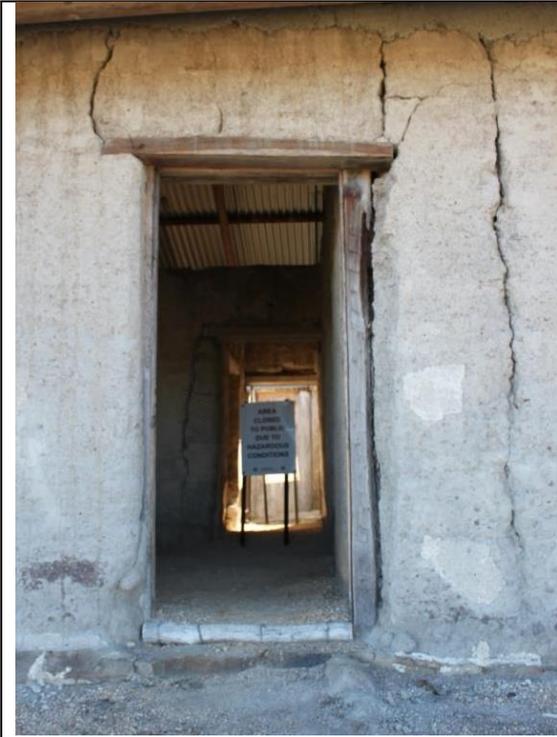
Door 1 East entry door

Left hand (south) door jamb

Appears to be stable and should be left undisturbed unless problems are noted on closer examination.

- Inspect base of jamb
- Remove and splice on new base if required
- Add steel angle under lintel
- Reinstate jamb on sound footing
- Reinstate pise` on front (east) corner.

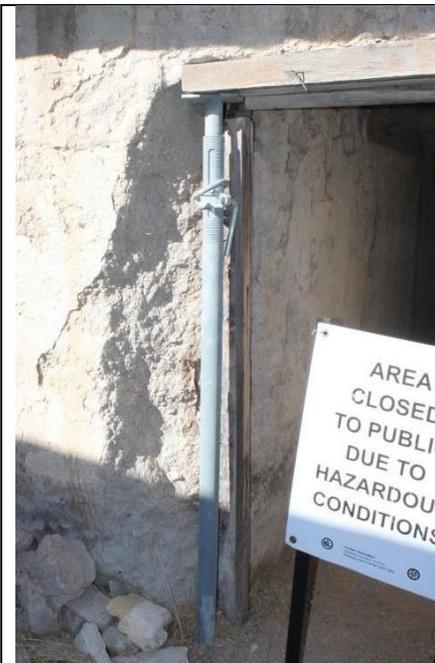
Door 2 Rear entry door

Left hand (north) jamb

- Remove and repair base of jamb
- Install steel angle to underside of lintel
- Reinstate jamb on sound footing
- Reconstruct collapsed pise`.

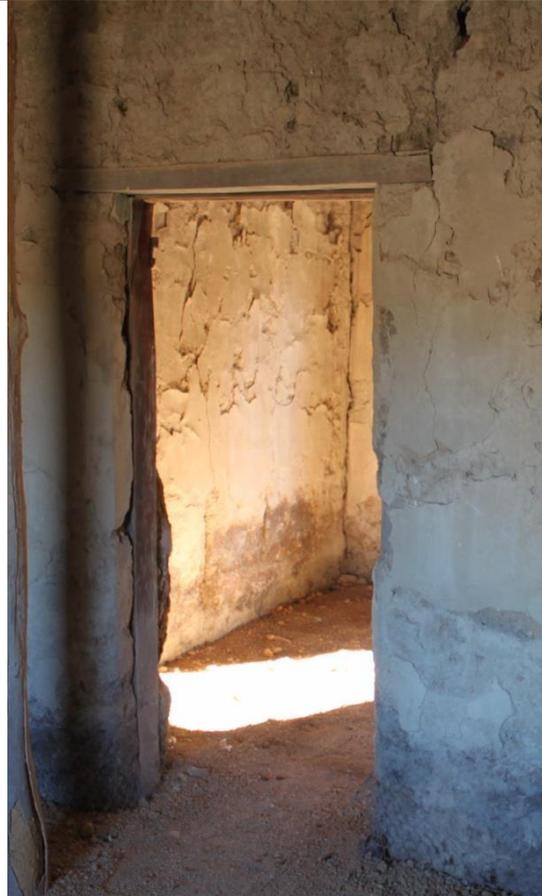
View from east

Although there is no obvious cracking in the pise` above the lintel, both jambs are loose and not providing support:

- Remove jamb,
- repair base,
- install steel angle under lintel and
- reinstate jamb on a sound footing.

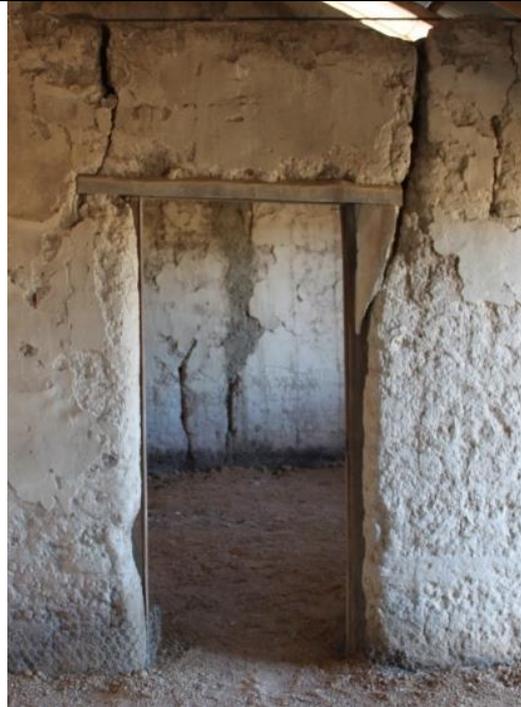
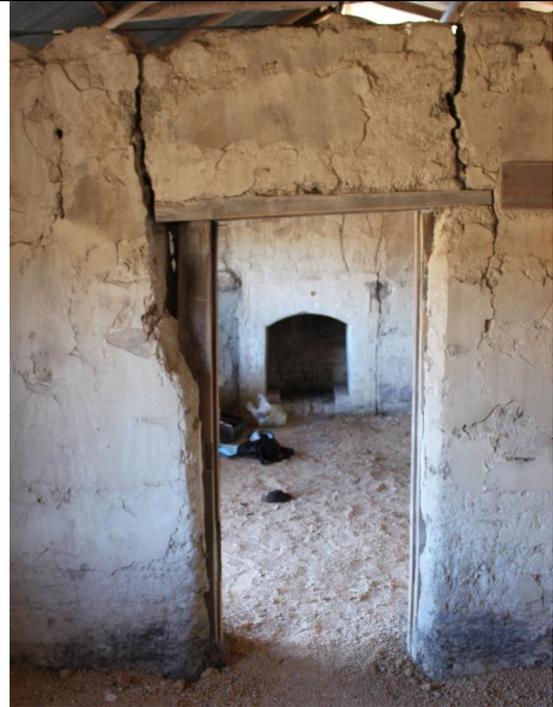
Door 4 Between Rooms 2 and 3

The pise` above the lintel is in a precarious position but should be retained if safe and feasible. Ensure the pise is restrained from lateral collapse before undertaking work.

- If safe and feasible jack up (or suspend from a temporary structure) the lintel and pise` block and reposition to a more level state.
 - If necessary remove debris from the cracks so that adjacent walls are not damaged or distorted.
 - Repair jambs and reinstate with steel angles under the lintels as per other doorways.
 - Fully re-grout cracks above the lintel with firm new pise` to anchor edges of pise to the adjacent wall.
 - Add additional restraint if necessary to prevent rotation of the lintel and earth above.
- Reinstate lost pise` to both sides of both door jambs.
 - If the pise` above the lintel cannot be saved, it should be dismantled, reconstituted with new material and re-compacted as per the traditional manner.

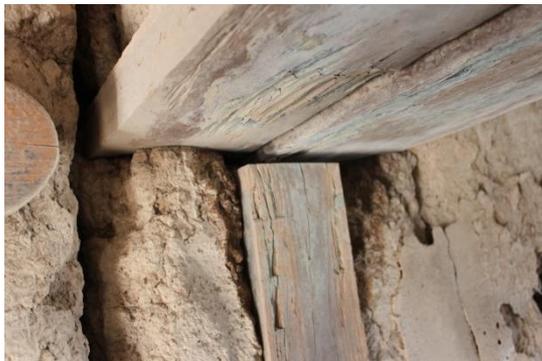
North jamb

The face of the left hand (north) jamb is flush with the wall but has subsided relative to the timber lintel.

- Inspect the base and repair the jambs as per elsewhere.
- Locate steel angle under lintels as shown below:

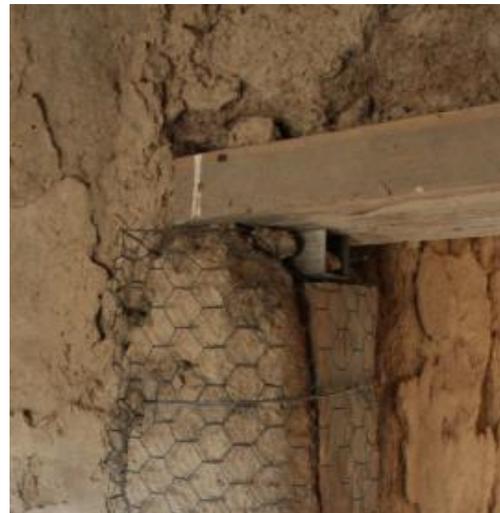
South jamb detail.

The jamb has subsided by about 50mm and a large section of corner pise`is breaking away.

- Stabilise the lintel.
- Remove existing steel hollow section and chicken wire.
- Repair the jamb as per elsewhere including steel angle to underside of lintels.
- Remove corner pise` and reconstitute with new material. Ram back into corner position using lugs and mesh to hold in place.

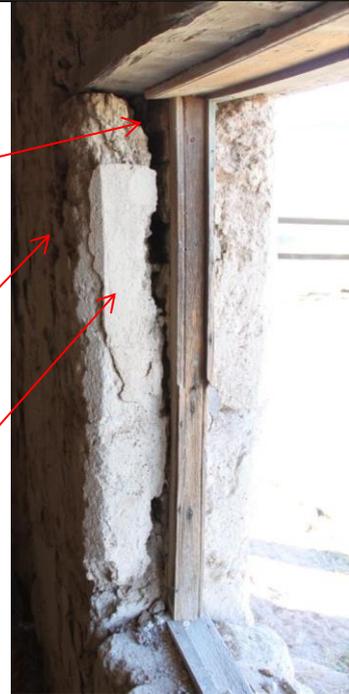
The pise under the internal lintel on the north side of window is showing preliminary signs of weakness

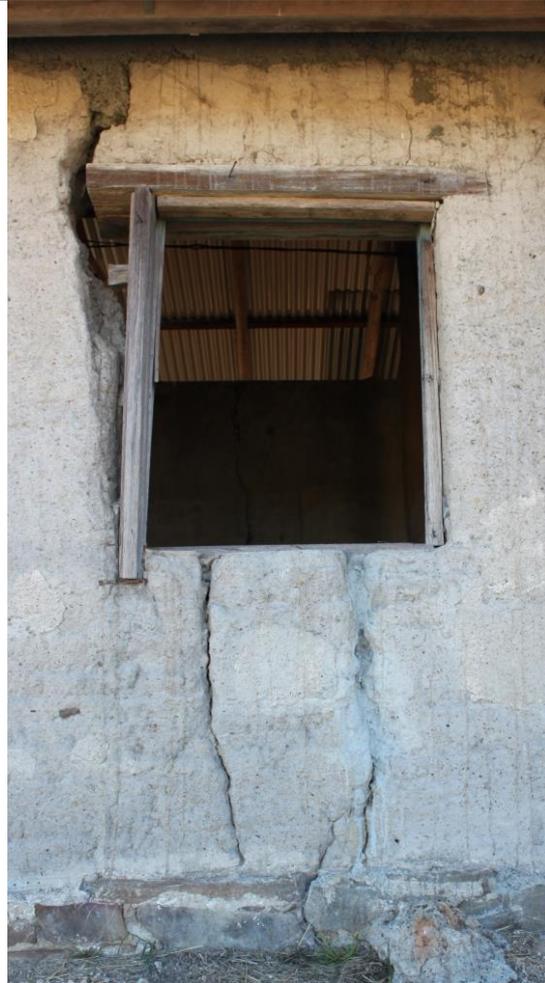
W2

Extensive decay has occurred around the south jamb and an additional piece of timber has been inserted to help carry loads. It is embed well into the matrix and should not be moved.

- Infill the space between the jamb and wall with new pise` after preparation by ledging and addition of mesh.

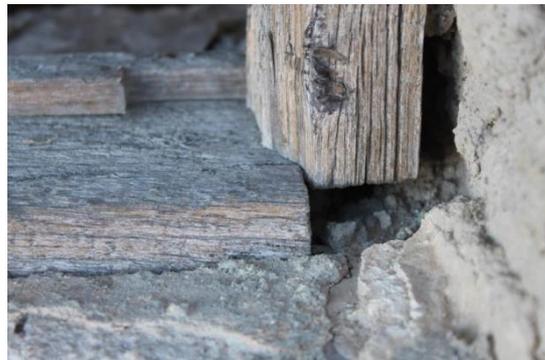
The north jamb has dislodged but cannot be safely returned to its former position.

- Clean the space beneath the jam and grout with a firm mix of 1 cement:1lime:6 sharp sand

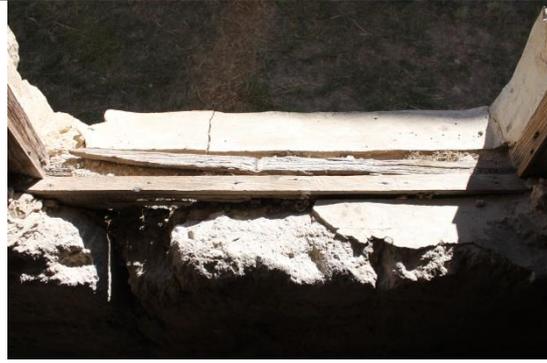
W4 – North West window

The timber sill has decayed although some of the original external render is still intact.

- Remove the damaged sill and replace with seasoned hardwood. Undercut the side window frames if necessary so that they are supported firmly by the new sill.
- Retain original render in place if possible.
