## **Asbestos Survey & Management Plan**

**Brumbies Rugby Club  
Griffith  
Canberra ACT**

**October 2009**

**Title:** Hazardous materials survey  
Brumbies Rugby Club  
Griffith Canberra ACT

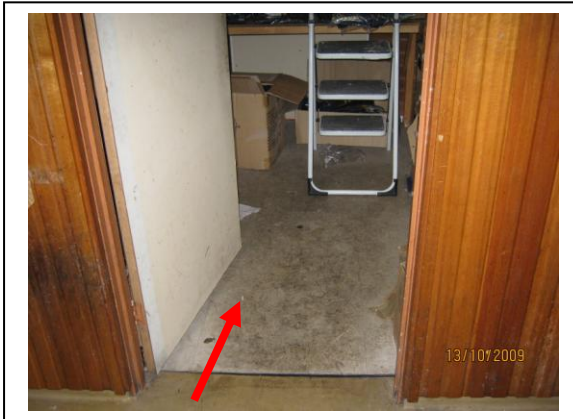
| TYPE | ACM | Locations | Action to be taken |
|---|---|---|---|
| Bonded asbestos | VFT | Storeroom and internal stairwell | Leave Label and Maintain |

**Photograph 1:** Storeroom adjacent to bar – Vinyl floor tiles (refer sample 5038 – A3)

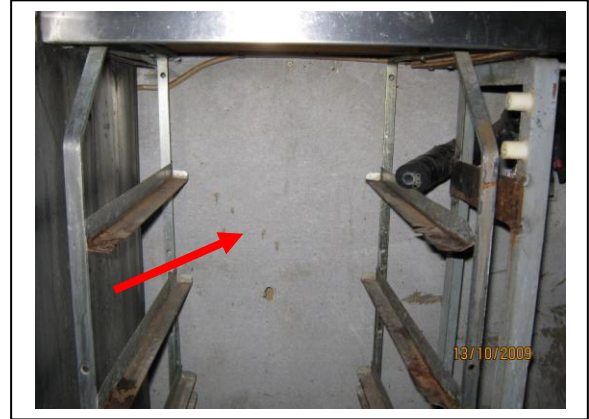
| TYPE | ACM | Locations | Action to be taken |
|---|---|---|---|
| | Sheet | To inside of bar | |

**Photograph 2:** Bar area – Wall sheet to bar in serving area (refer sample 5038 – A4)

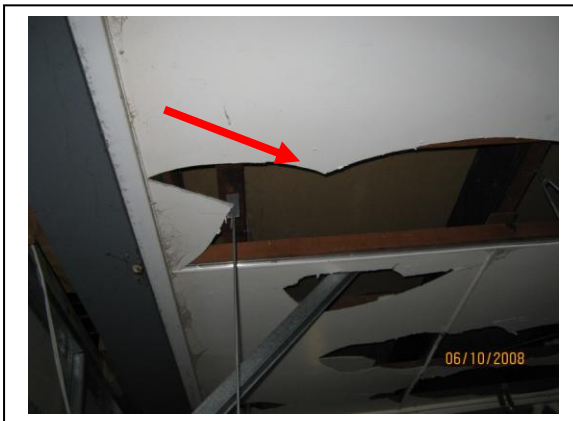
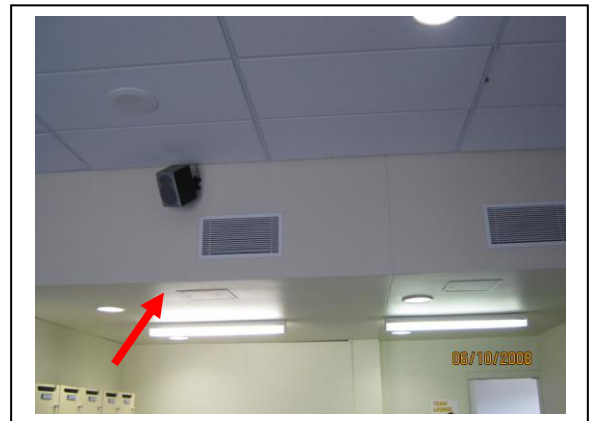
| Sample Reference | Sample location | Sample type | Composition/ Assessment |
|---|---|---|---|
| 5038 – A5 | Team locker area – Ceiling sheet in bulk head (Damaged) | Sheet | <b>Chrysotile Crocidolite Amosite Asbestos</b> |

| Bonded Asbestos | | | | | | |
|---|---|---|---|---|---|---|
| 5038 – A5 | 3,4 | Sheet | Team locker area – Ceiling sheet in bulk head (Damaged) | 2 | B | Remove prior to any building works |

**Photograph 3:** Team locker area – Ceiling sheet in bulk head (Damaged) (refer sample 5038 – A5)

**Photograph 4:** Team locker area – Ceiling sheet in bulk head (Damaged) (refer sample 5038 – A5)

| TYPE | ACM | Locations | Action to be taken |
|---|---|---|---|
| | Ceiling sheet | Team locker area inside bulkhead | Remove |

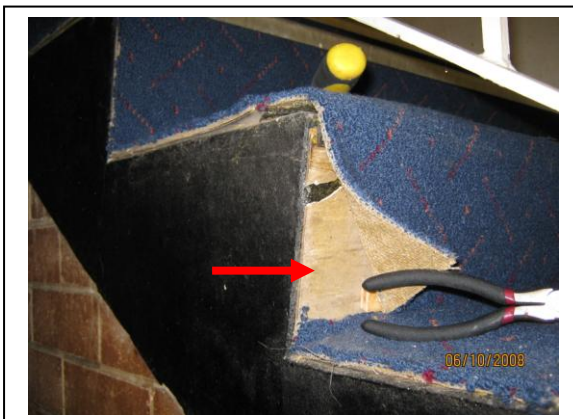
**Photograph 5:** Internal stairwell – Vinyl floor tiles beneath carpet to stairs (refer sample 5038 – A8)

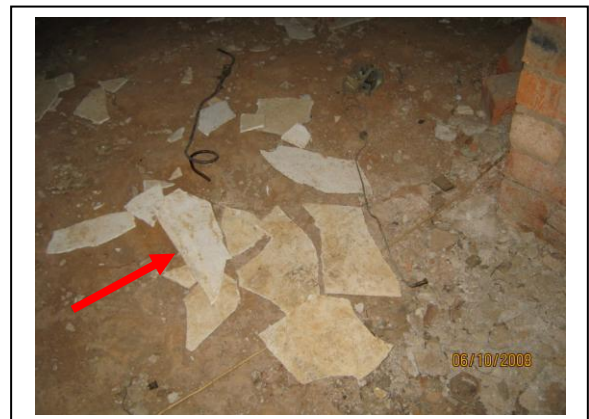
| TYPE | ACM | Locations | Action to be taken |
|---|---|---|---|
| | Debris | Throughout sub floor | Remove |

**Photograph 6:** Sub floor – Sheeting debris throughout (refer sample 5038 – A10)

**Description of Work** Clean-up of asbestos cement sheet debris to sub floor area

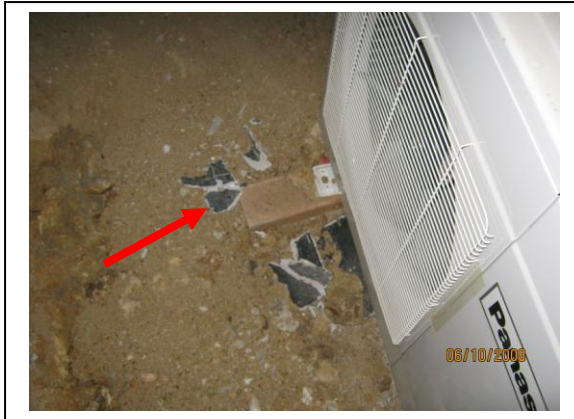
**Photograph 7:** Sub floor – Sheeting debris adjacent to A/C Unit (refer sample 5038 – A11)

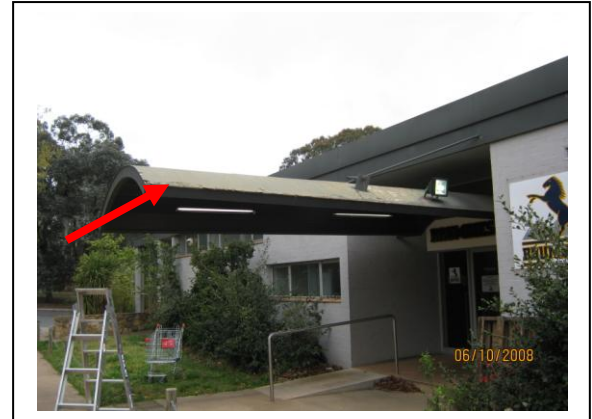
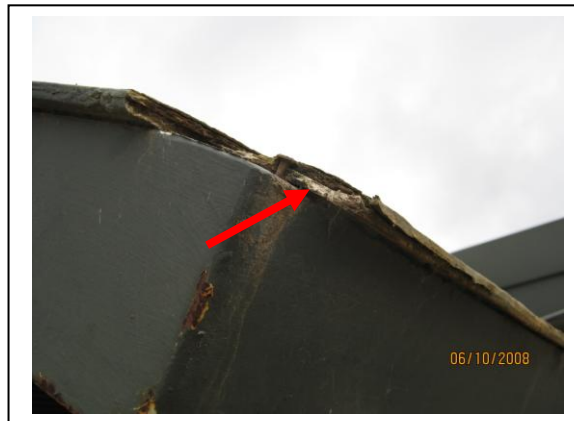
- The ACM awning above the main entry doors is in poor condition and must be removed or remediated by an ACT licensed Asbestos Removalist as per the Code of *Practice for the Safe Removal of Asbestos, 2<sup>nd</sup> Edition* [NOHSC: 2002 (2002)] as soon as practicable.

| 5038 – A14 | 8,9 | Sheet | Ground floor external – Sheet to awning above entry doors(Damaged) | 3 | C | leave label and maintain |

**Photograph 8:** Ground floor external – Sheet to awning above entry doors (refer sample 5038 – A14)

**Photograph 9:** Ground floor external – Sheet to awning above entry doors (refer sample 5038 – A14)

| TYPE | ACM | Locations | Action to be taken |
|---|---|---|---|
| | Sheet | Sheets to awning above main entry | Remove |

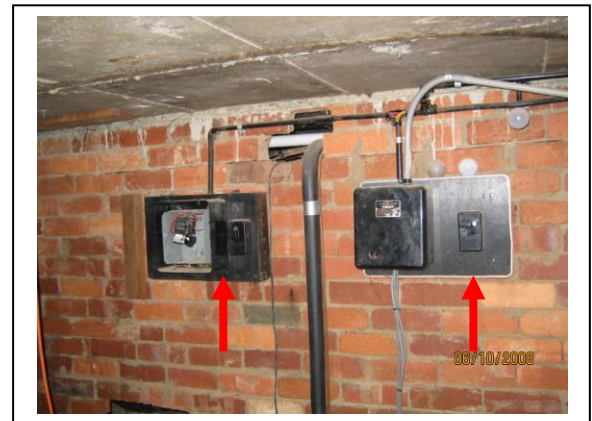
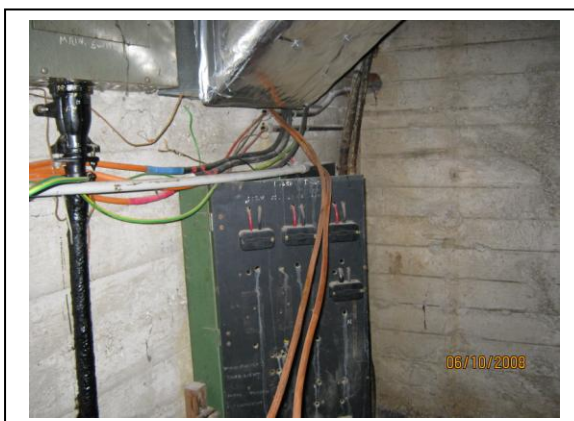
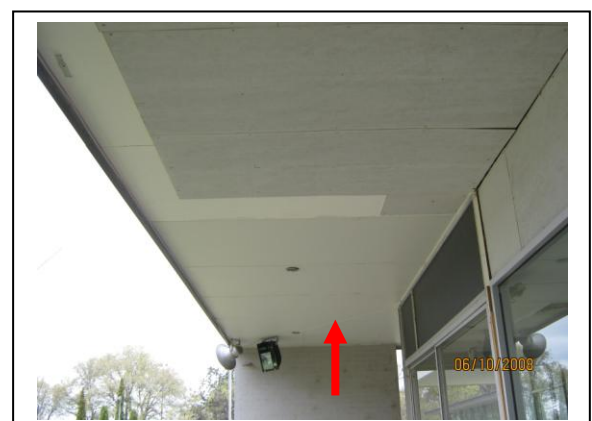
| TYPE | ACM | Locations | Action to be taken |
|---|---|---|---|
| | Electrical switch board backing sheet | Plant room 2 and sub floor area | Leave Label and Maintain |

**Photograph 10:** Electrical switch board backing sheet – Sub floor area x4 (refer sample 5038 – VA2)

**Photograph 11:** Electrical switch board backing sheet – Sub floor area x4 (refer sample 5038 – VA2)

**Photograph 12:** Electrical switch board backing sheet – Sub floor area x4 (refer sample 5038 – VA2)
