Appropriation (Loose Fill Asbestos Insulation Eradication) Bill 2014/15

The report prepared by/for Roads ACT in relation to the extension of Nudurr Drive – can the Committee be provided with a copy of the report.

Re: 816701 – Response to Auditor Comments Regarding Review of the Robson Phase 1 Environmental Site Assessment Report, Nudurr Drive Extension, Gungahlin, ACT

To	Stuart McElroy	Robson Environmental	stuartmcelroy@robsonenviro.com.au
cc	Gilbert Ortiz	Brown Consulting	Gilbert.Ortiz@brownconsulting.com.au
From	Mike Nash		Date 13 November 2012
Subject	Statutory Site Audit ACT 004 Contamination Assessment Nudurr Drive Extension, Gungahlin, ACT		Project No. 72812

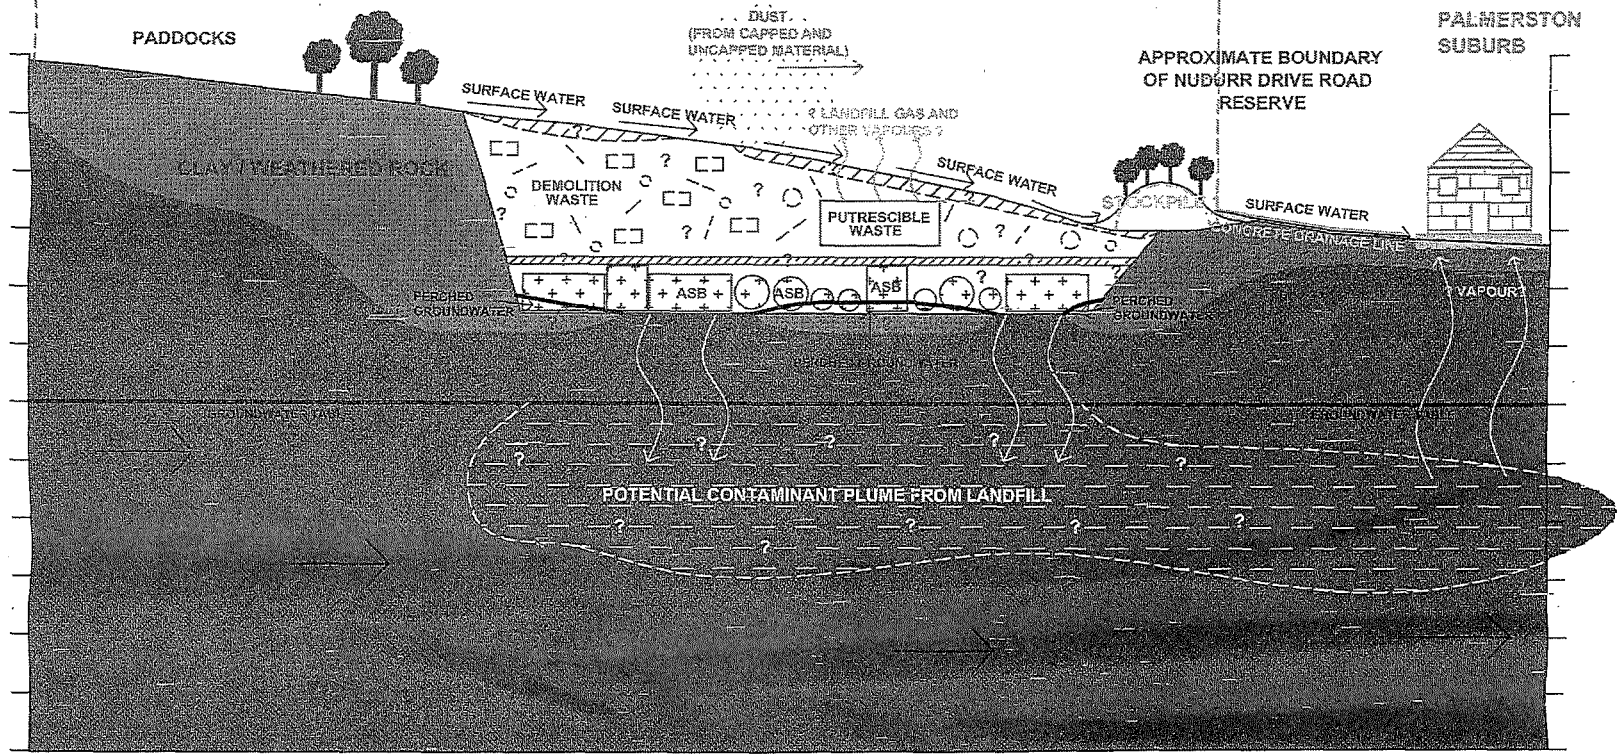
Figure 8: CSM Cross-Section

Auditor Comment: *'A CSM – would be useful and could take the form an annotated cross section showing potential contaminant sources, pathways and receptors.'*

Robson Response: An indicative cross section of the conceptual site model for the system is provided in the attached Figure 8. Note that Figures 1 to 7 are in the Phase 1 ESA report.
