Inquiry into Building Quality in the ACT

Submission Number: 57

Submission to the Inquiry into building quality in the ACT

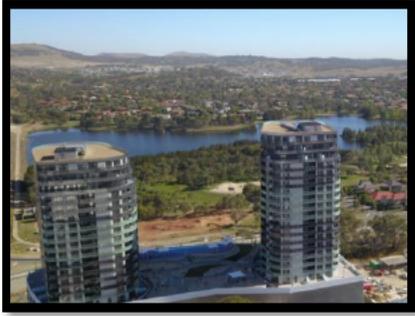
In relation to the safety of the balustrade our concerns set out below are also reflected by a number of many other property owners in the complex. We have provided a number of photographs to assist, with Photo 1 of the two building towers of the [REDACTED] completed in early 2018.

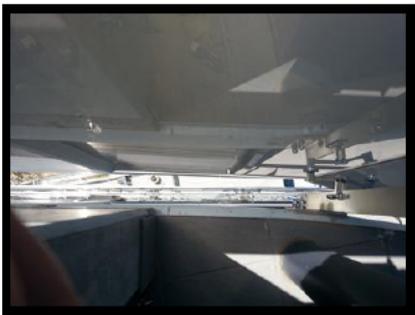
Photo 2

The balcony glass balustrades installed on each floor of both buildings is typically set out away from the building facia, see Photos 2, 3 & 4. The gap between the balcony edge/facia and the glass balustrade is very excessive and is the primary issue of concern (see Photos 5 & 6), although missing or loose balustrade stanchion mounting bolts were also an issue, (see Photo 7). We (the owners [REDACTED] have made requests to the builder [REDACTED] for detail of the balustrade design and approval process, but have only received verbal assurances that the balustrades and design are 'approved'.

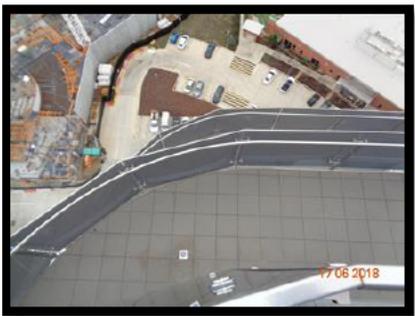
Photo 3

- a. a glass wine bottle (diameter of say, less than 100mm) could be easily and accidentally knocked over, roll and drop through the balustrade openings, falling around 70 metres with catastrophic effect onto someone in the busy public thoroughfare below (see Photo 6 for comparison), which incidentally provides the only access/egress to the adjacent [REDACTED] child care centre (top right in Photo 3) as well as the main pedestrian access and egress to both [REDACTED];

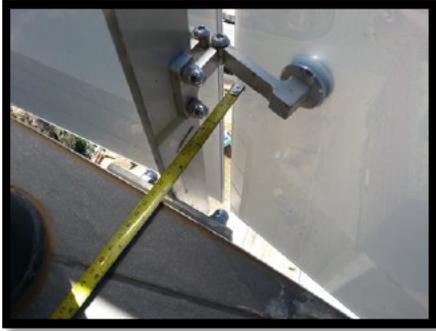
Specifically, the balustrade safety and design issues relate to an unusually excessive and consistent gap between the facia and the glass balustrade panel. From our understanding the balustrade should comply with the performance requirements of the National Construction Code (NCC), Part 3. We have searched for alternate guidance relating to maximum distances between a surface/floor level and the

In application it would appear that Part 3.9.2.3 (c), is focused at horizontal distances and not the setback distances (outwards from the building line) as with the Infinity's balustrades, however in the absence of any other standard or guidance we have used this section as a performance measurement. We have taken a number of measurements along the balcony and found gaps between the glass balustrade and the building facia ling that regularly exceed the prescribed 125mm; see Photo 5 and 6 as examples. As we understand the ACT construction legislation, a builder (in addition to legislative compliance requirements) should also consider undertaking a risk assessment of a proposed design or system of work as an integral part of the construction process. This appears to be absent in relation the design and safety of our apartments balustrade.

2. ACT Government; the ACT through its representative (Director-General Environment, Planning and Sustainable Development Directorate) make representations to the Australian Building Codes Board to expand Part 3.9.2.3 (c) of the National Construction Code to investigate and make specific recommendations on the maximum safe distances a balustrade can be set out and way from a floor or balcony, specifically taking into consideration balustrades in high rise developments.
