Shane Rattenbury MLA - Arrangements brief

FUNCTION:	Launch of the 2022 Waterwatch Catchment Health Indicator Program (CHIP) report A copy of the report is at Attachment D .
VENUE:	Dickson Wetland, Dickson. See map at Attachment A .
HOST:	Name: Woo O'Reilly Mobile: Personal Information
DAY:	Wednesday
DATE:	22 March 2023
TIME:	8:30am
TIME COMMITMENT:	30 minutes
CATERING:	Yes – coffee and pastries will be provided
DRESS CODE:	Casual
YOUR ROLE:	A short speech to launch the CHIP report. Speaking notes in Attachment B .
WHERE TO PARK:	Off Hawdon St, Dickson
WHO WILL MEET YOU:	<ul style="list-style-type: none"> Bren Burkevics (Executive Group Manager, Environment, Heritage and Water Division, EPSDD) Woo O'Reilly (Regional Waterwatch Facilitator, EPSDD)
ADVISOR ATTENDING:	Lachlan Roberts/ Anna McGuire (TBC with your office).
AUDIENCE:	Waterwatch volunteers as well as the broader Waterwatch network. This includes members of the three community-based Catchment Groups (Molonglo, Ginninderra and Southern ACT) who partner with the ACT Government to implement the program plus water scientist from UC and members of the UMCN committee. Icon Water representatives are also invited.

Launch of the W

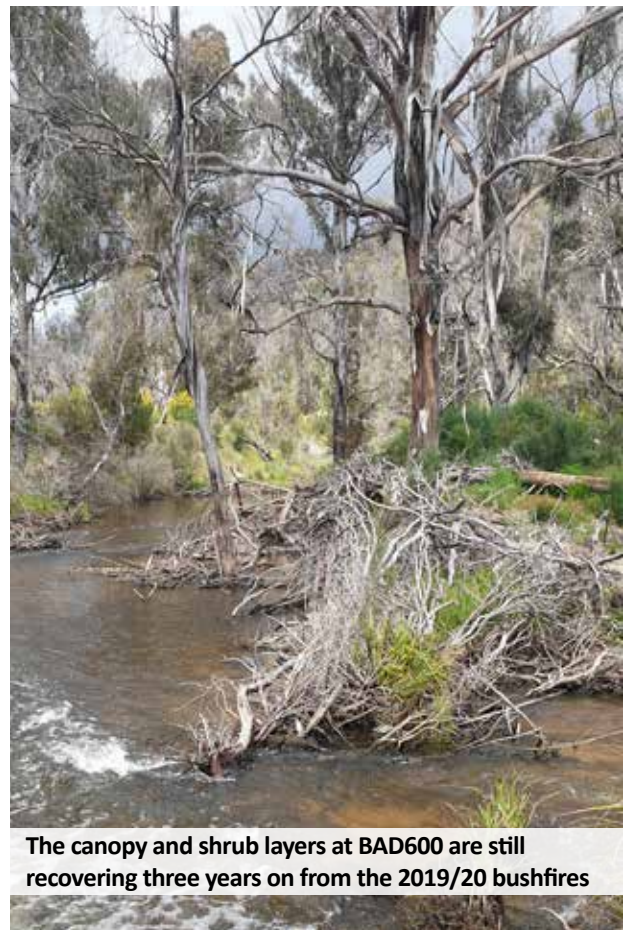
The 2019/20 bushfires greatly impacted this reach with fire burning out most of the catchment. Three years on, much of the riparian shrub and canopy layer vegetation has yet to recover properly. The higher than average rainfall over the last three years has been very favourable, resulting in replenished groundwater and good groundcover being established in this part of the catchment. Several larger flow events have flushed the heavy ash and sediment from in-stream habitats, which was washed into the river after the bushfires. This has contributed to improved waterbug survey results, which have been *excellent* for the last couple of years.

The canopy and shrub layers at BAD600 are still recovering three years on from the 2019/20 bushfires

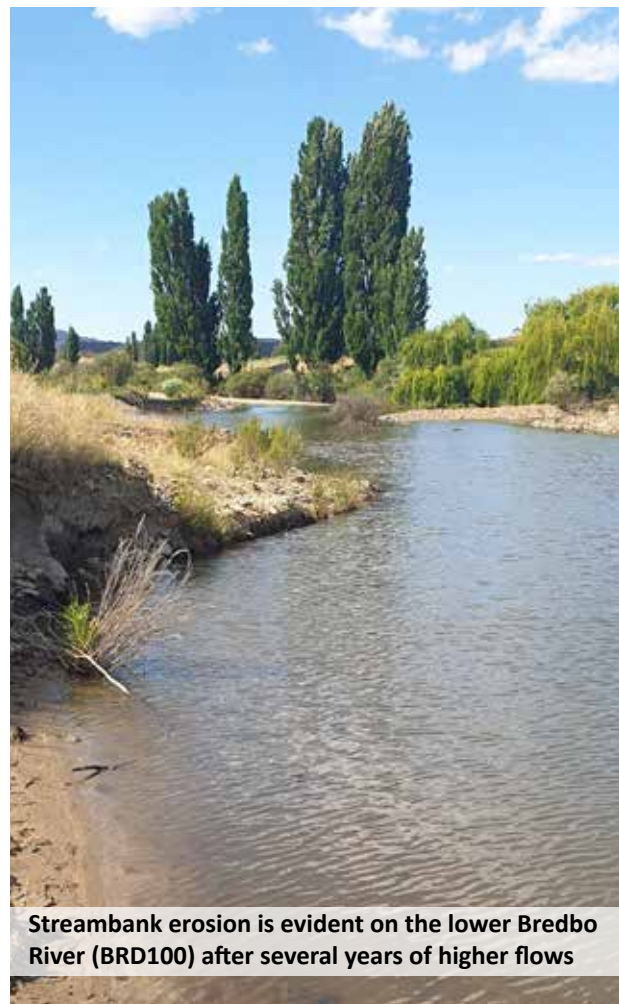
High flows continued throughout 2022 which saw ongoing streambank erosion along this reach, especially in areas where deep rooted native vegetation is limited. Successive flood events saw new deposits of sand and ash at the confluence, indicating the ongoing mobility of both fine and gross sediment in the system. This year's waterbug survey results reflected this with the majority of bugs found belonging to the Orders of Hemiptera (true bugs) and Diptera (fly larvae) which are tolerant of both poor habitat and water quality.

Streambank erosion is evident on the lower Bredbo River (BRD100) after several years of higher flows

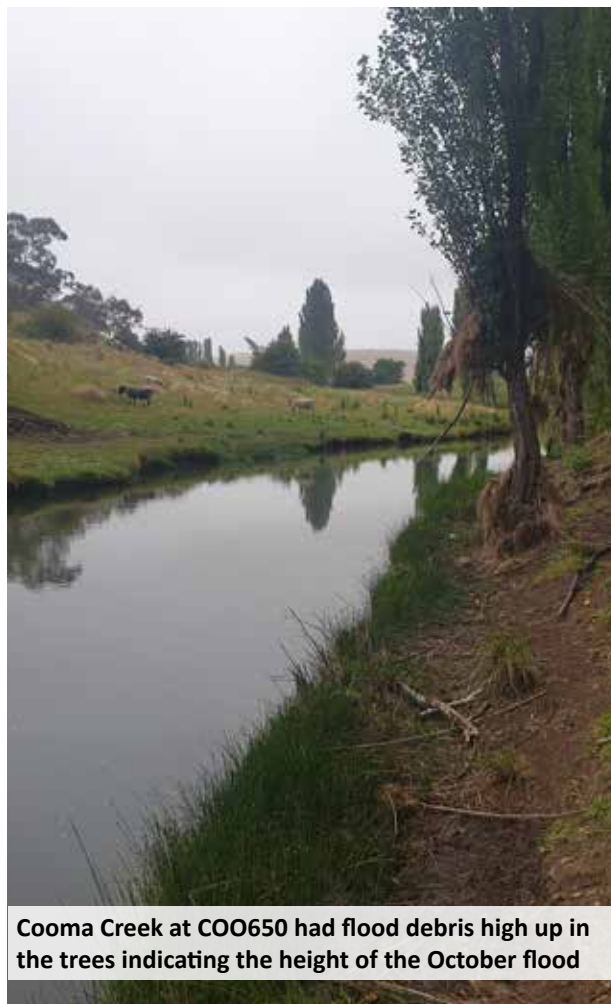
Cooma Creek at COO650 had flood debris high up in the trees indicating the height of the October flood

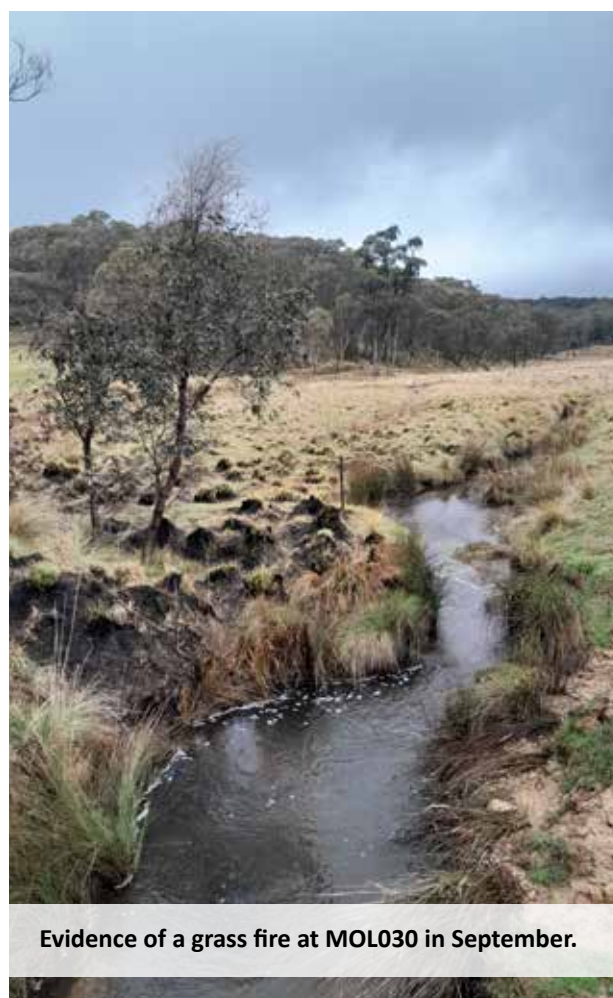
Evidence of a grass fire at MOL030 in September.

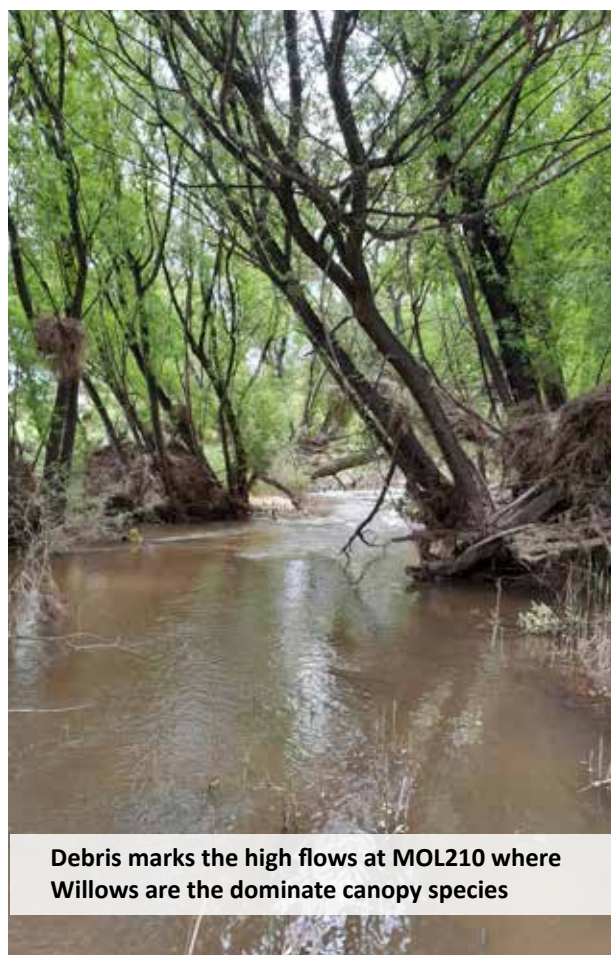
Debris marks the high flows at MOL210 where Willows are the dominate canopy species

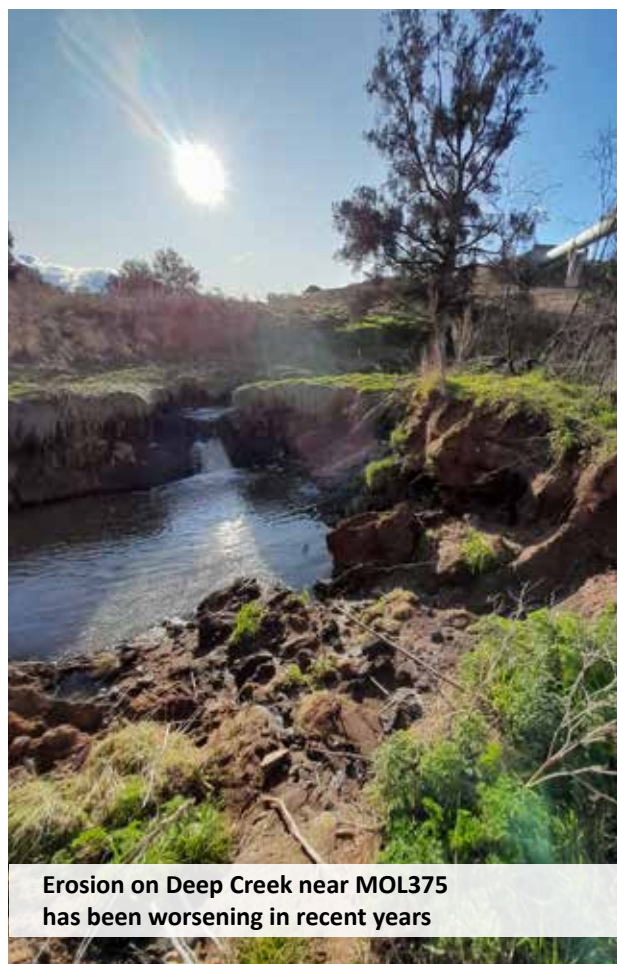
Erosion on Deep Creek near MOL375 has been worsening in recent years

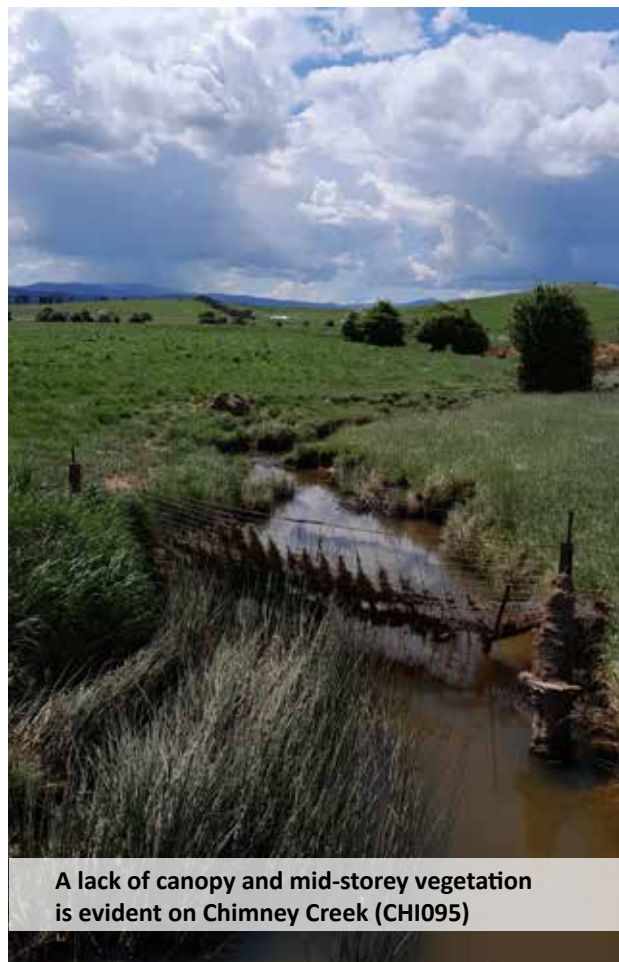
A lack of canopy and mid-storey vegetation is evident on Chimney Creek (CHI095)

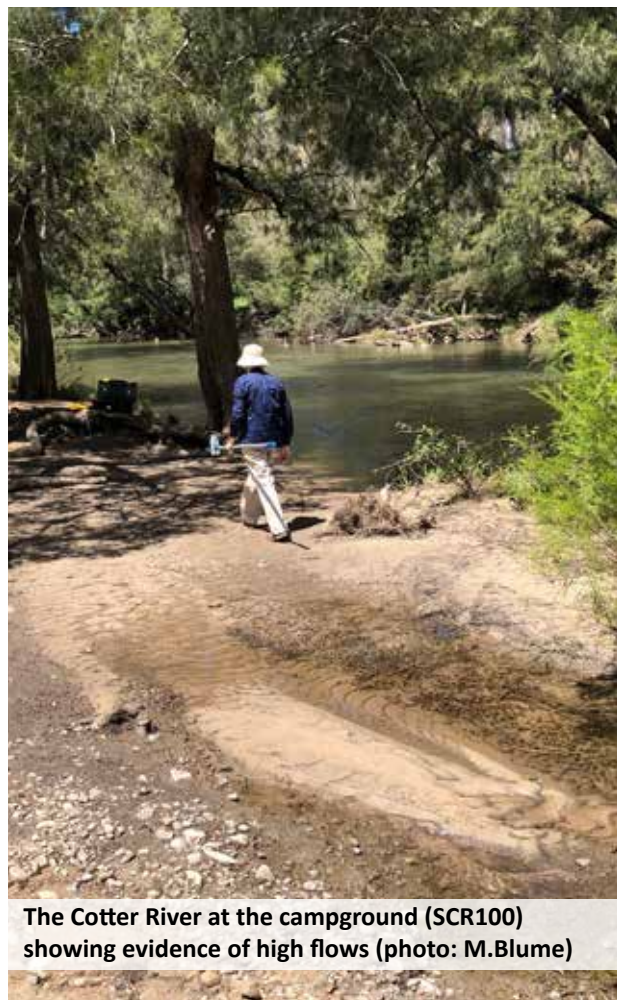
The Cotter River at the campground (SCR100) showing evidence of high flows (photo: M.Blume)

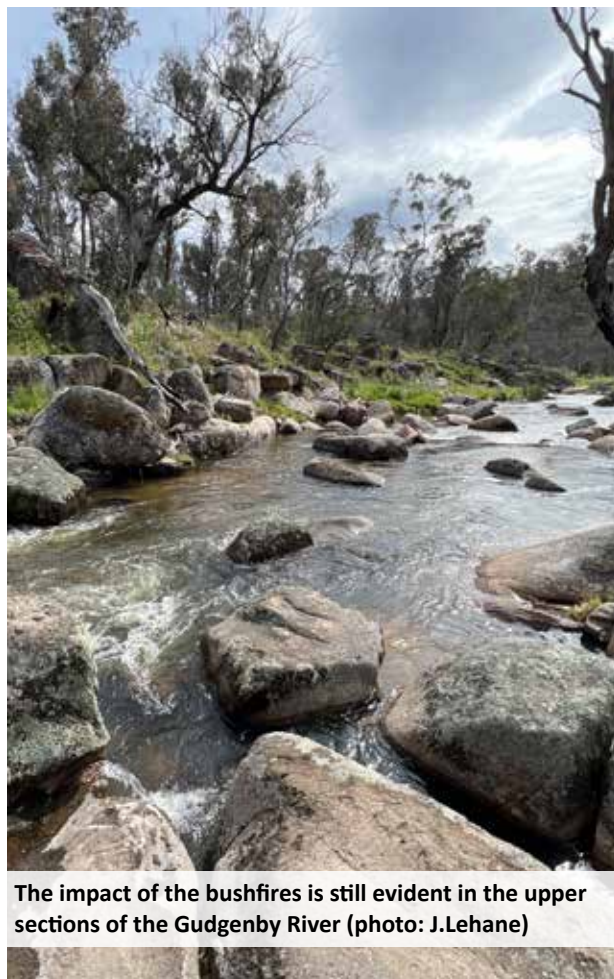
The impact of the bushfires is still evident in the upper sections of the Gudgenby River (photo: J.Lehane)

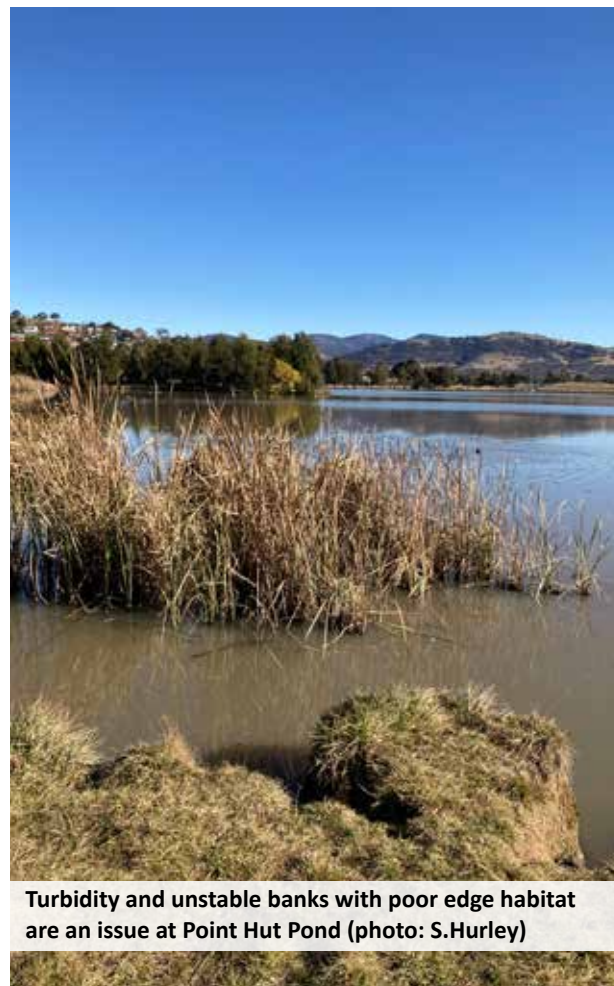
Turbidity and unstable banks with poor edge habitat are an issue at Point Hut Pond (photo: S.Hurley)

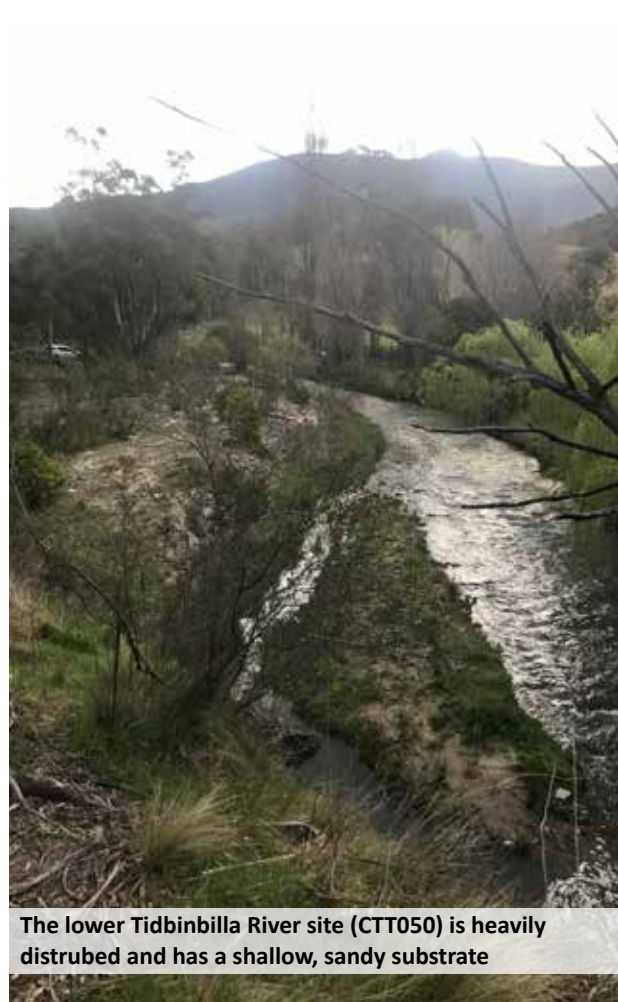
The lower Tidbinbilla River site (CTT050) is heavily disturbed and has a shallow, sandy substrate

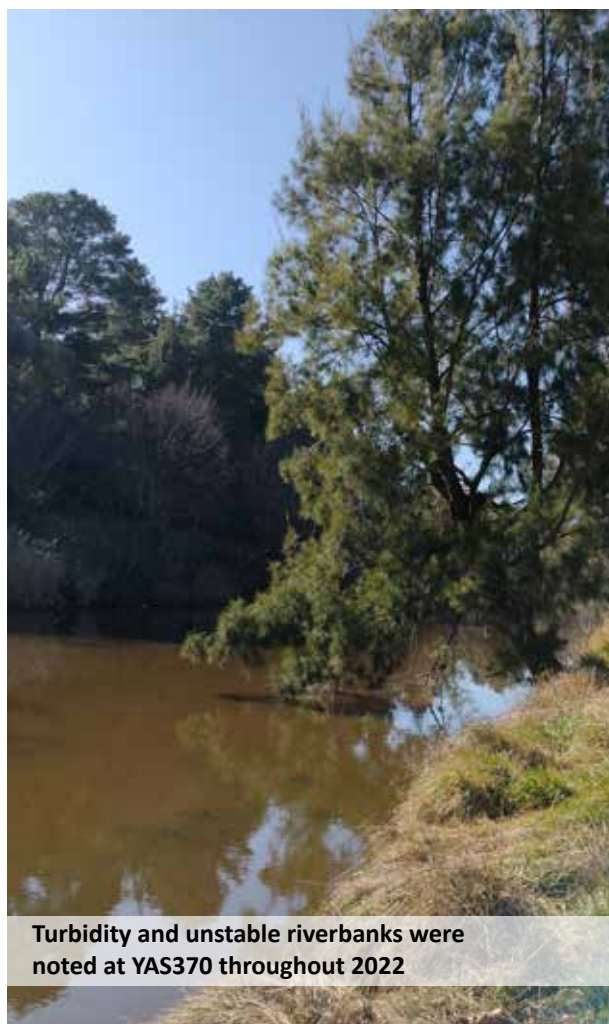
Turbidity and unstable riverbanks were noted at YAS370 throughout 2022

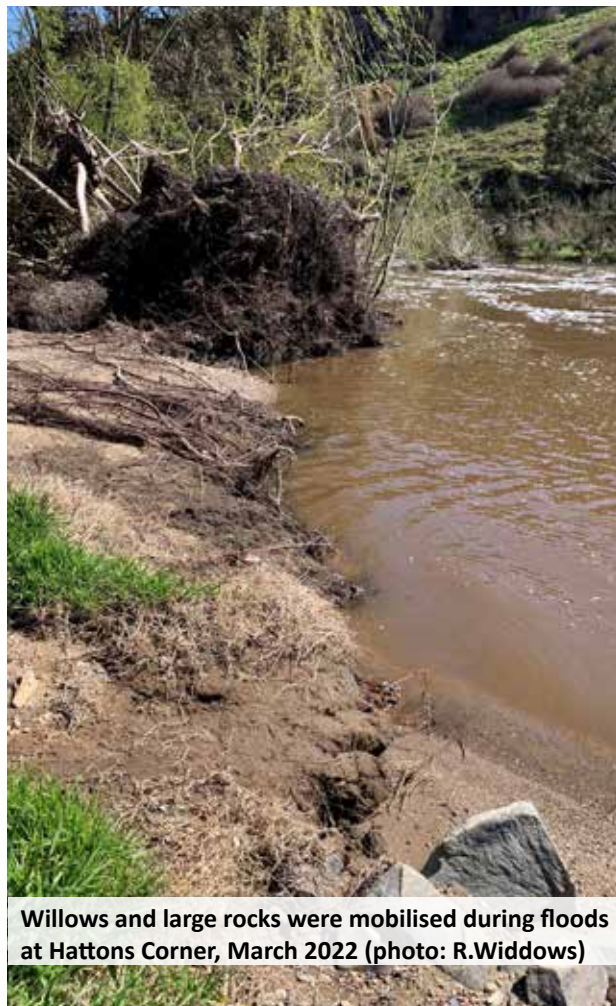
Willows and large rocks were mobilised during floods at Hattons Corner, March 2022 (photo: R.Widdows)
