Territory and Municipal Services

Tabled 24 September 2015

## **Cycle Separation Trial Report 2015**

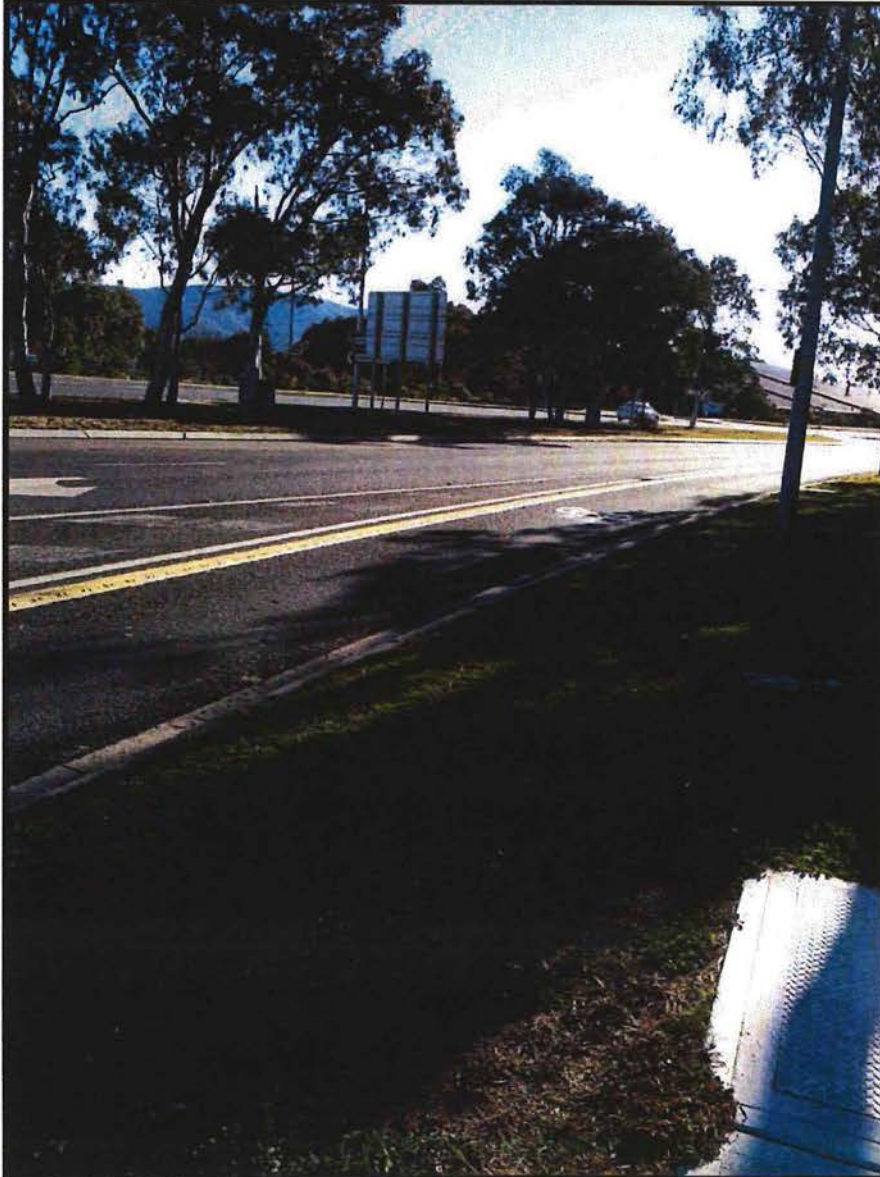
Figure 1. Tram Separator

The Tram Separator is a continual profile rubber kerb. The purpose of the 'Tram Separator' is to physically delineate the on-road cycle lane. As the name suggests, this device is more commonly seen in cities where trams are commonplace such as Melbourne, Australia.

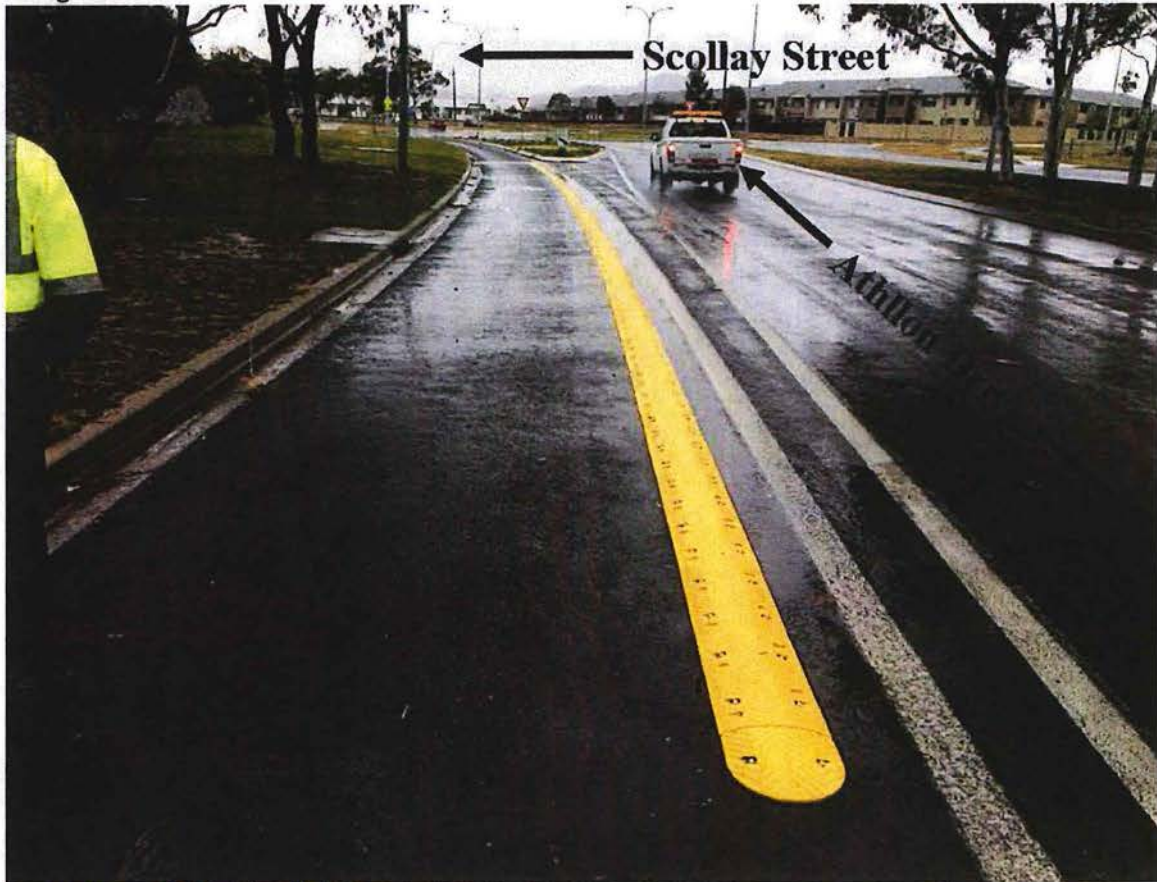
Figure 2. 12 months after installation

In addition to physically delineating the cycle lane, a tram separator was trialed at this location to deter motorists from using the on road cycle lane as a slip lane to turn onto Scollay Street.

During the 12 month period in which the devices were monitored, there were not any apparent damages to the device. This could be due to the low number of vehicles hitting the device in comparison to other trial locations, as the primary intention of this device was to minimise the number of vehicles using the cycle lane as a slip lane to turn onto Scollay Street.

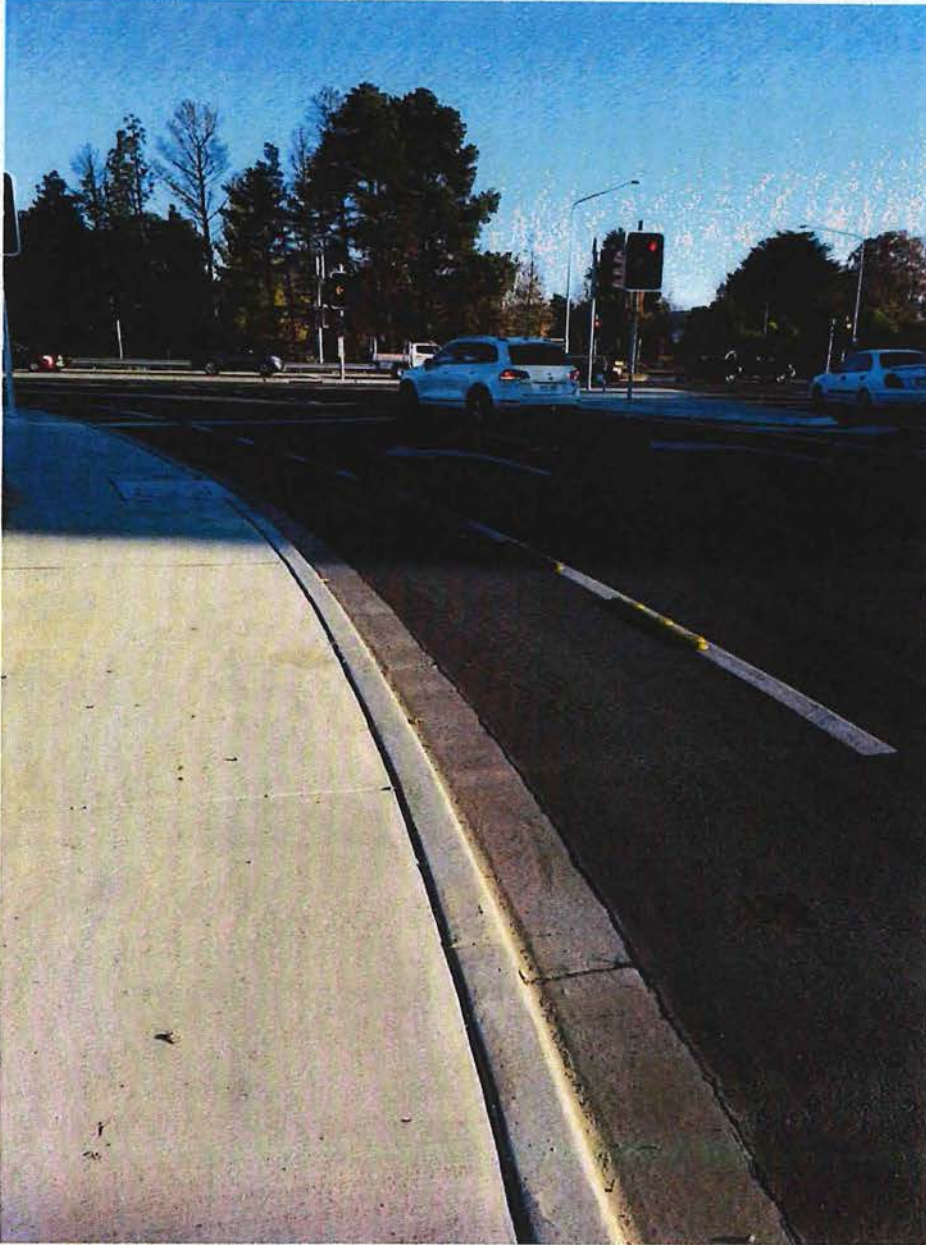
Figure 3. Riley Kerb

The Riley Kerb is a profile rubber kerb. The purpose of the 'Riley kerb' is to physically delineate the on-road cycle lane. Some strengths of the Riley Kerb device are that it can be placed intermittently to allow cyclists to enter and exit the cycle lane, and it allows water to pass through, addressing any drainage requirements.

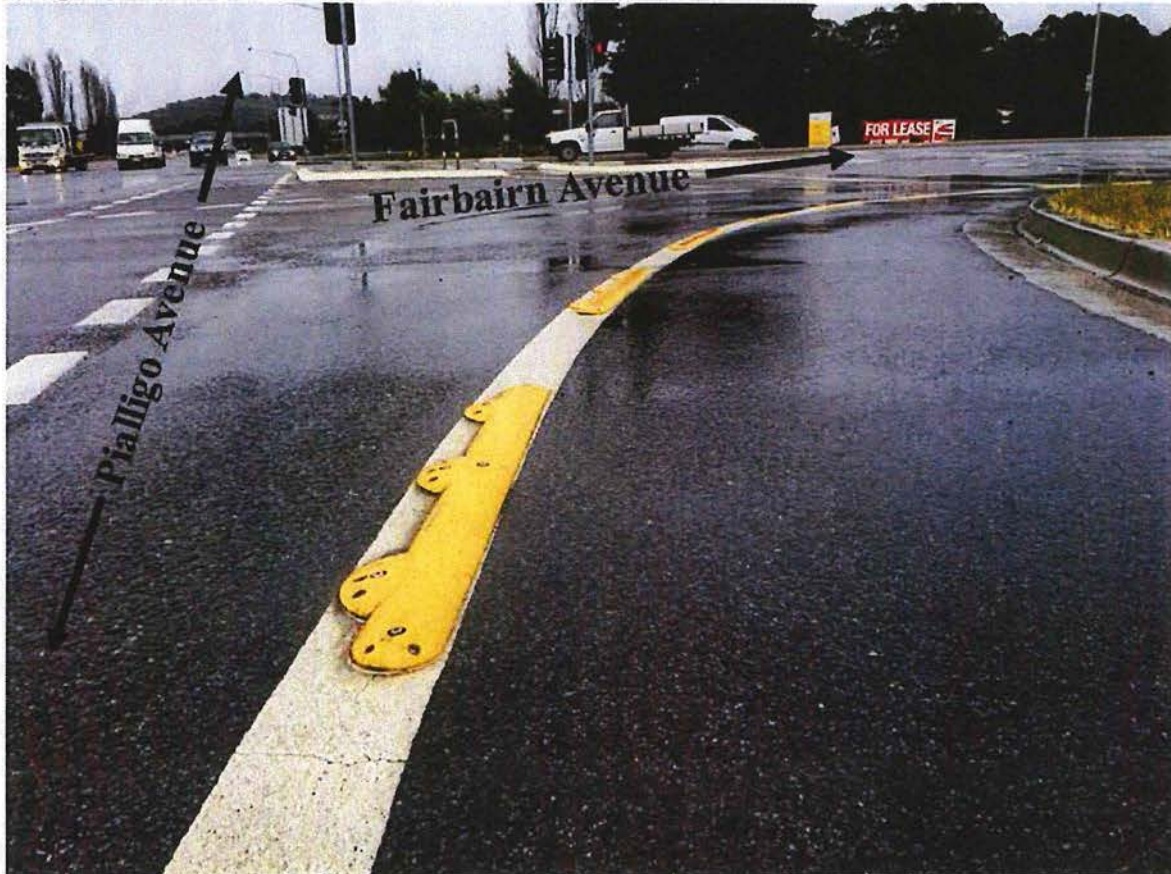
Figure 4. 12 months after installation

Riley kerb was trialed at this location due to the high proportion of motorists encroaching onto the cycle lane as they make a left turn from Fairbairn Avenue to Pialligo Avenue, and due to a large proportion of these vehicles being heavy vehicles.

During the 12 months that the devices were monitored, noticeable discolouration due to rubber markings from vehicle tyres was apparent.

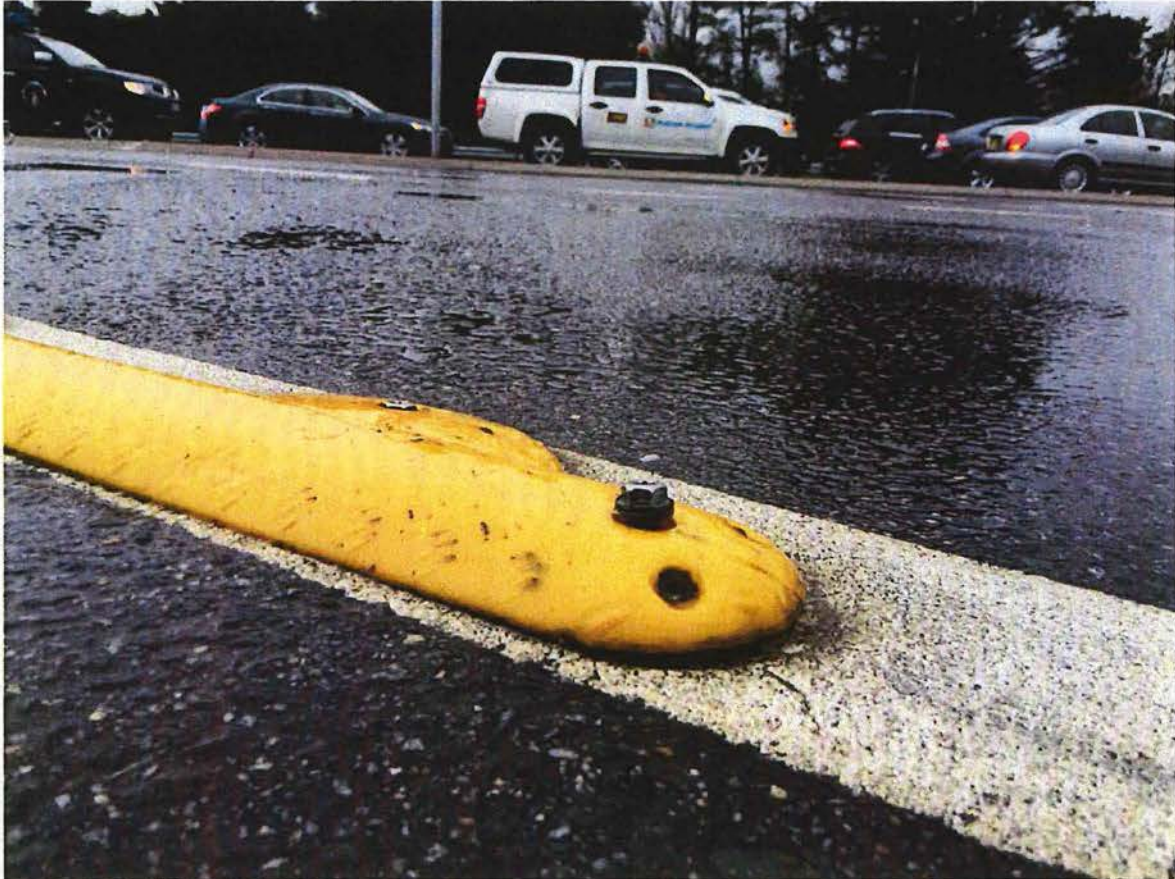
Figure 5. 12 months after installation

There were not any significant damages to the device, apart from some experiencing loose bolts. This could be due to the high proportion of heavy vehicles encroaching onto the cycle lane when making a left turn onto Pialligo Avenue, driving over the devices.

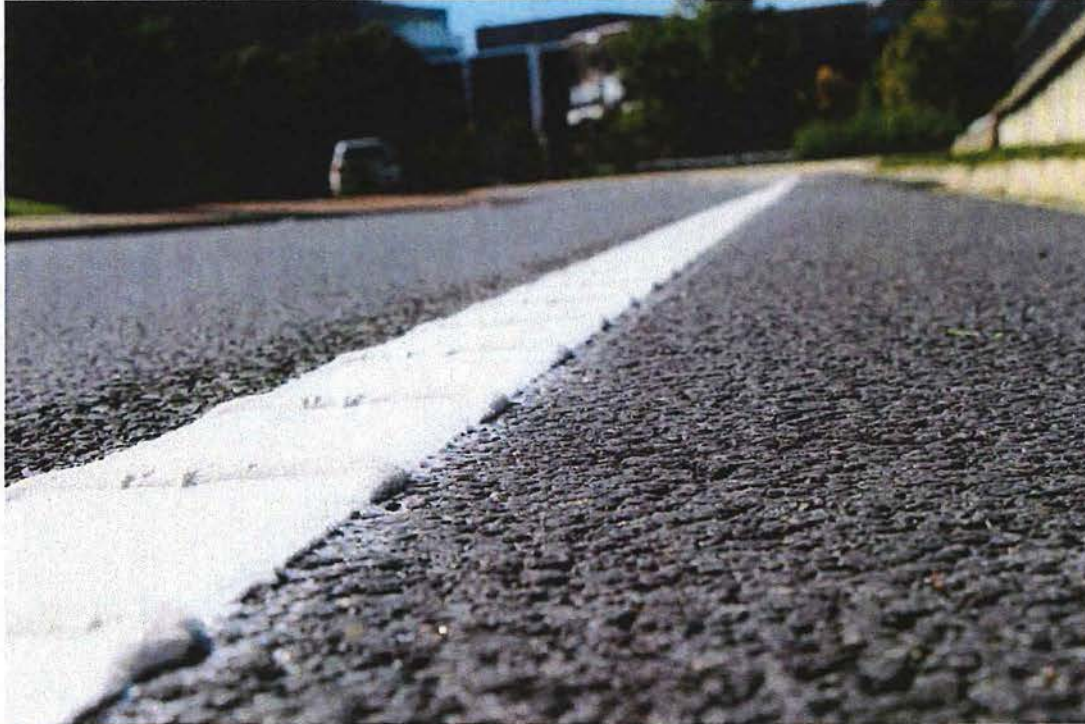
Figure 6. ATLM

Screed applied audio tactile thermo plastic line marking commonly referred to as “rumble strips” - is used to provide an audible and vibratory alert to motorists. Similar to rumble strips used on highways to target driver fatigue, these devices alert the driver if they encroach onto the adjacent cycle lane. The line marking consists of a 2mm thick continual base and an intermittent 8-10mm raised profile. Unlike other devices, rumble strips do not use any additional road space, as it is applied over the existing line marking. This profile allows cyclists to enter and exit the lane as they please, whilst allowing water to flow over as designed. Rumble strips contain glass beads in the thermoplastic for added reflectivity across the line marking for delineation at night.

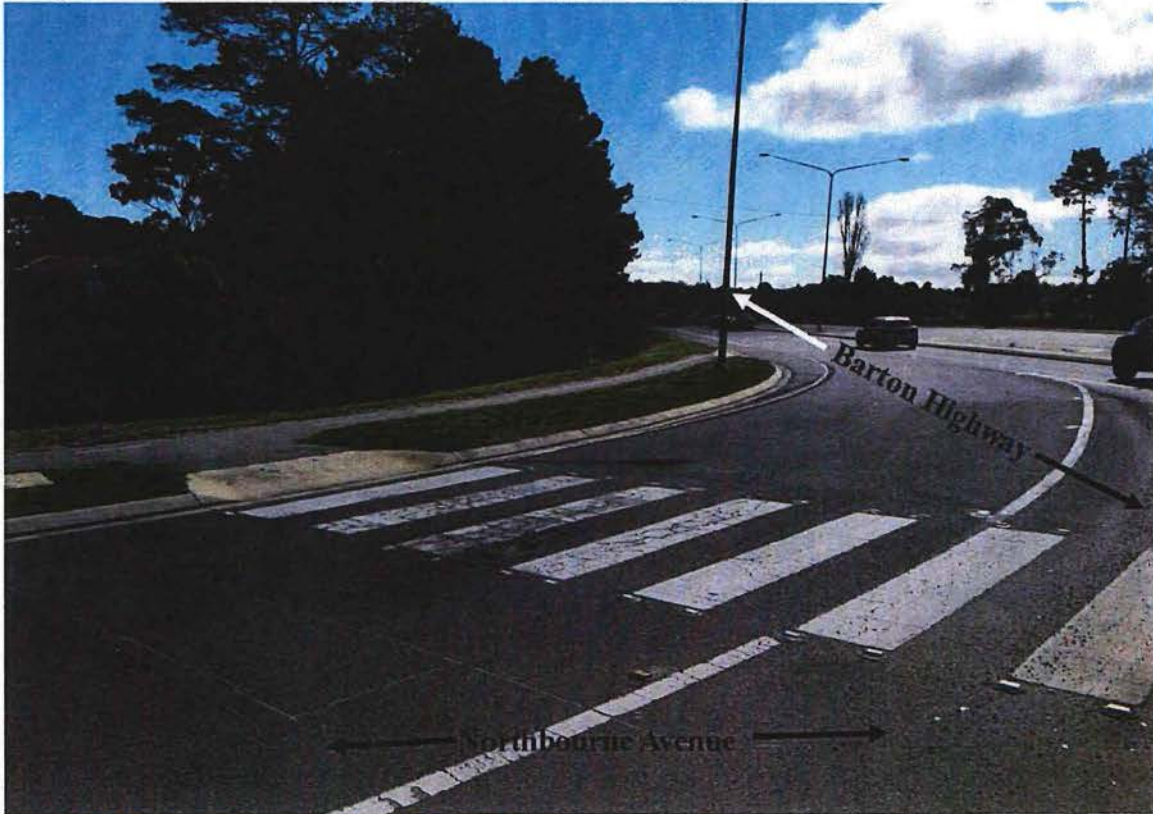
Figure 7. ATLM along Northbourne Avenue/Barton Highway

On road cyclists travelling northbound on Northbourne Avenue towards Barton Highway are directed off the on road cycle path, as there is no on road cycle lane along the slip lane.

ATLM was applied with the reintroduction of the on road cycle lane (Figure 7) to alert any distracted drivers of the cycle lane.

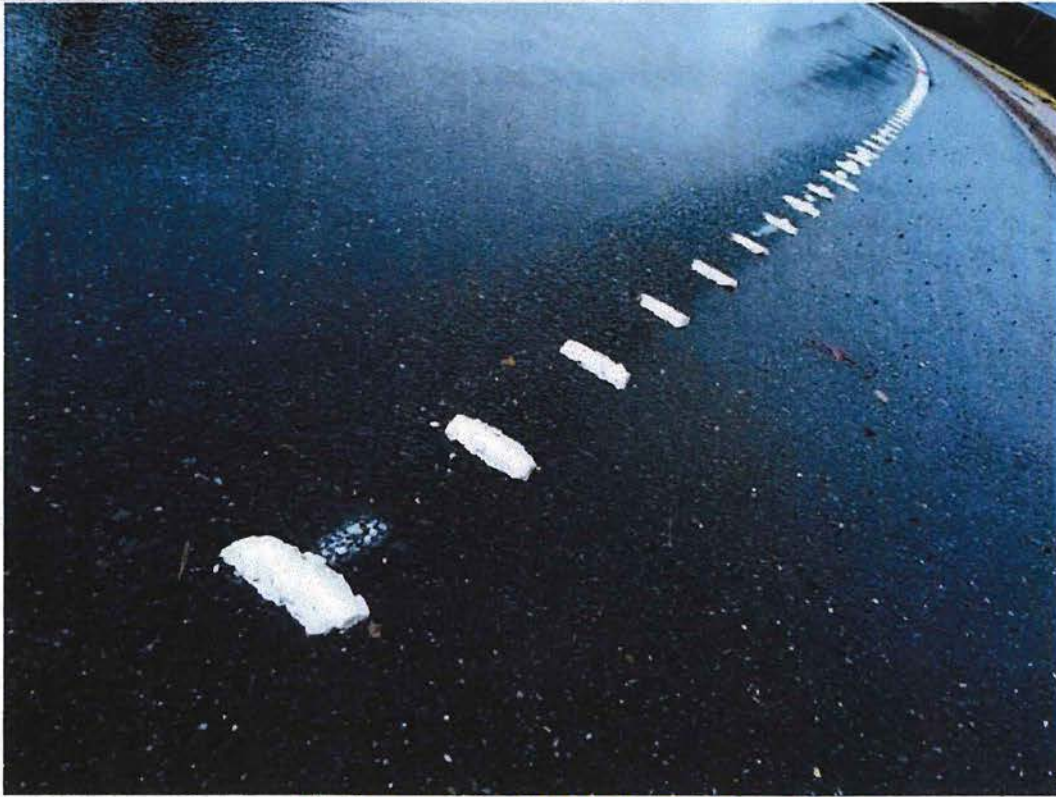
Figure 8. Screed applied ATLM – 12 months after installation

As shown in Figure 8, durability of ATLM decreased at screed applied thermoplastic areas compared to preformed thermoplastic. However, the costs associated with preformed were significantly greater than screed applied.

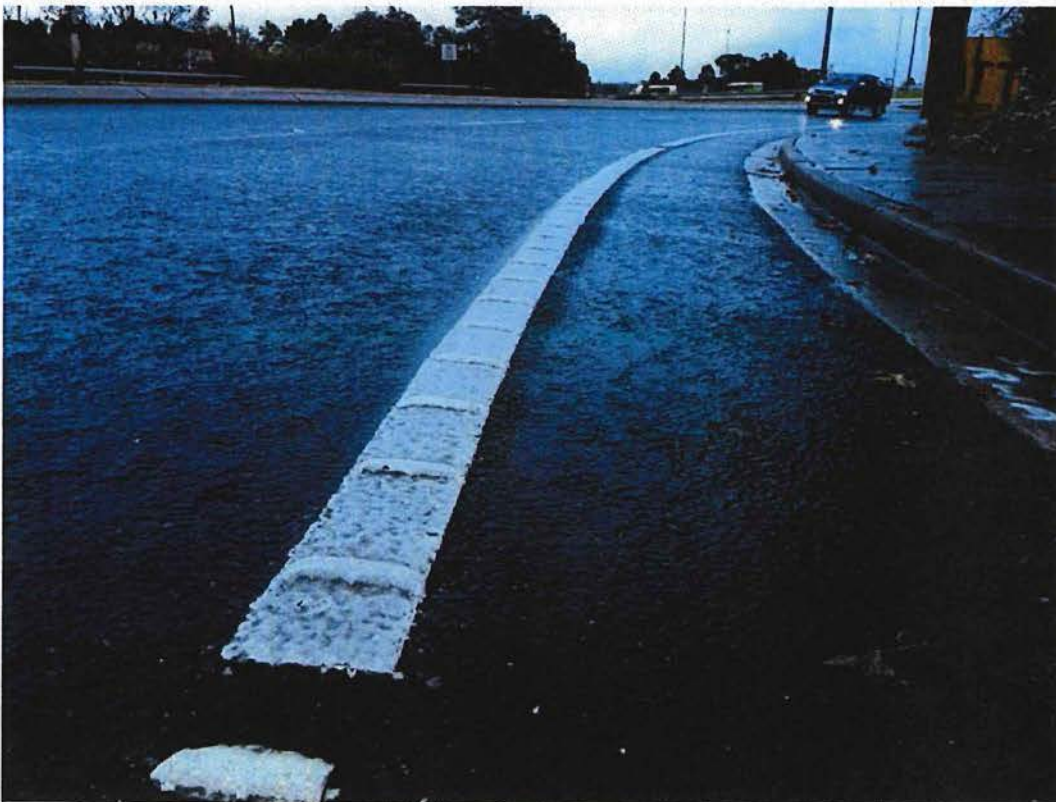
Figure 9. Preformed ATLM – 12 months after installation

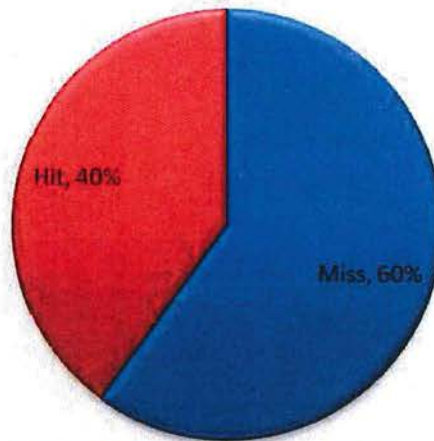
Figure 10. Total vehicles - upon installation

Total vehicles – upon installation									
	Total	Avoided	% avoided	Encroached	% encroached	Not reacted	% not reacted	Reacted	% reacted
Small vehicles	820	507	62%	313	38%	186	59%	127	41%
Heavy vehicles	61	22	36%	39	64%	33	85%	6	15%
Total vehicles	881	529	60%	352	40%	219	62%	133	38%

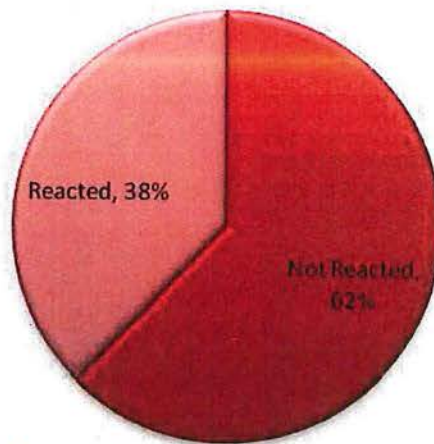
Figure 11. Whether motorists reacted after encroaching onto the cycle lane

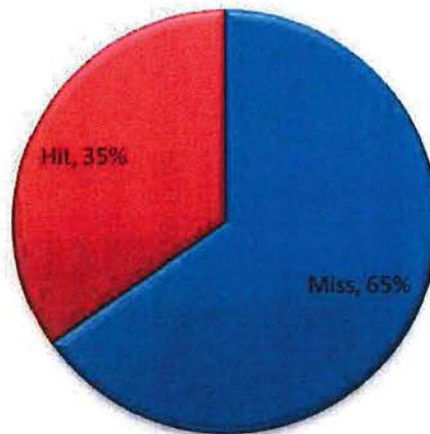
Figure 12. Total vehicles - 6 months after installation

<b>Total vehicles - 6 Months After Installation</b>									
	Total	Avoided	% avoided	Encroached	% encroached	Not reacted	% not reacted	Reacted	% reacted
Small vehicles	869	588	68%	281	32%	158	56%	123	44%
Heavy vehicles	53	14	26%	39	74%	33	85%	6	15%
Total vehicles	922	602	65%	320	35%	191	60%	129	40%

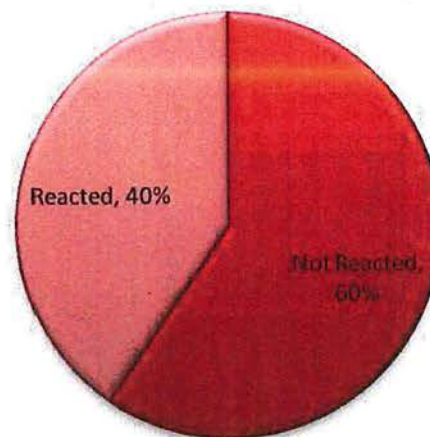
Figure 13. Whether motorists reacted after encroaching onto the cycle lane

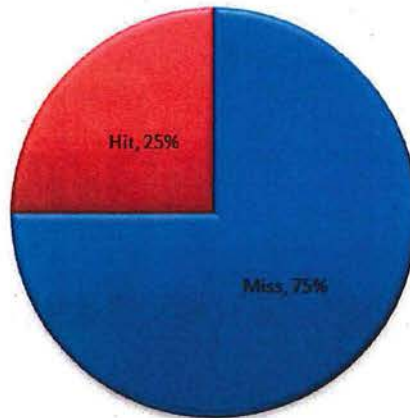
Figure 5. Total vehicles - 12 months after installation

Total vehicles - 12 Months After Installation									
	Total	Avoided	% avoided	Encroached	% encroached	Not reacted	% not reacted	Reacted	% reacted
Small vehicles	860	661	77%	199	33%	92	46%	107	54%
Heavy vehicles	43	16	37%	27	63%	23	85%	4	15%
Total vehicles	903	677	75%	226	25%	115	51%	111	49%

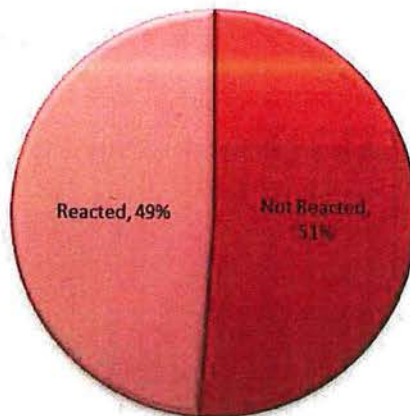
Figure 6. Whether motorists reacted after encroaching onto the cycle lane

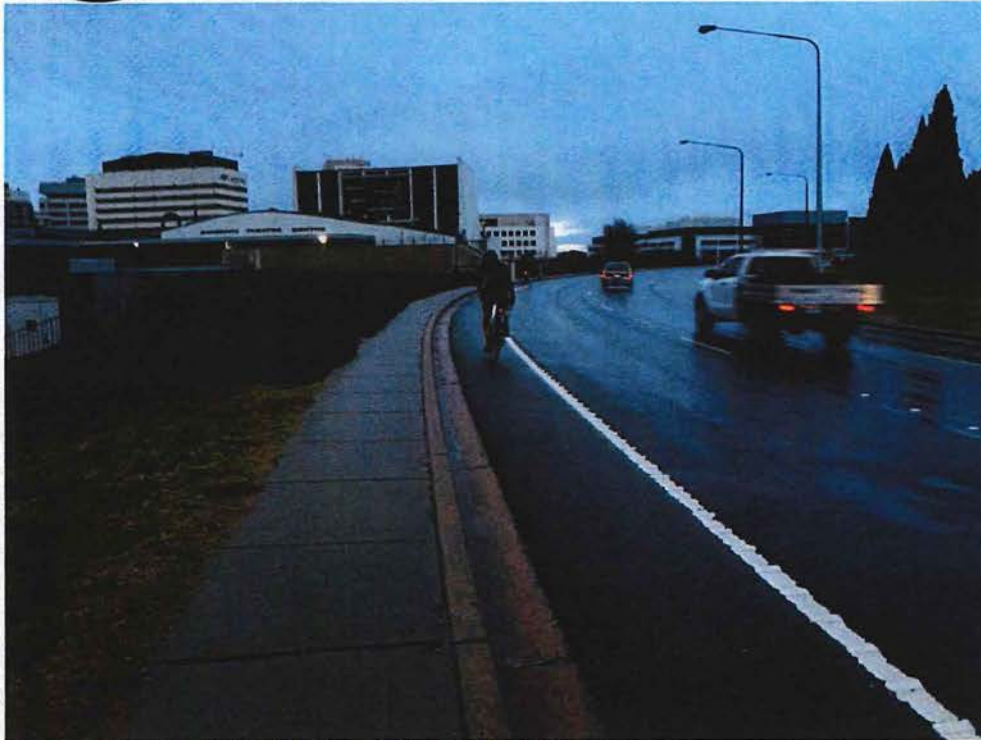
Audio Tactile Line Marking separation devices do not require additional road space, as it is typically applied over the existing edge line marking. If ATLM is to be screed applied, particular attention must be given to the installation (i.e. road surface conditions/temperature, application of line marking, etc) of the product. Not all screed applied sections experienced deterioration to the same extent as shown in Figure 8. However the durability of these varied, depending on the quality of the installation process.

Figure 14. Scribed applied ATLM – 12 months after installation

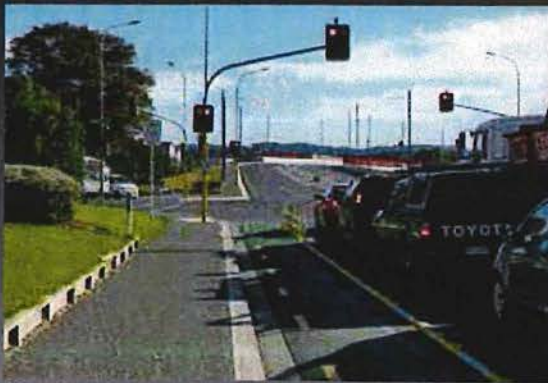
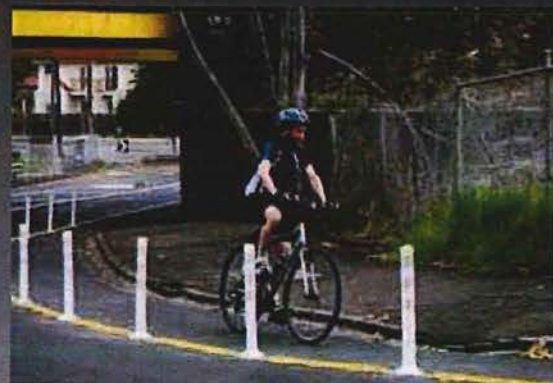
# RILEY KERB

- >> 1200mm or 2000mm long with transition at each end
- >> Rumble device in the vehicle lane to alert drivers that they are crossing into a cycle lane
- >> Yellow recycled rubber with built in reflectors
- >> Can be placed with 100mm gaps to allow for water to flow through
- >> A typical installation could be 1200mm or 2000mm of Riley Kerb with a 1m gap to allow cyclist to enter and exit the cycle lane
- >> Offers protection for cyclists; contours to road surface and curves
- >> Can be removed and relocated if required

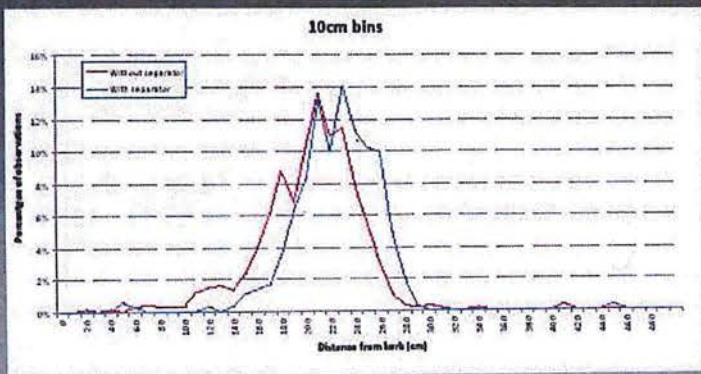
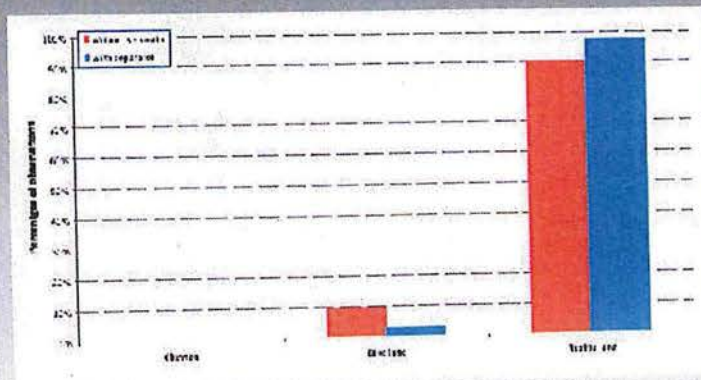
The volume of traffic and multiple merging movements resulted in significant numbers of motor vehicles intruding into the bicycle lane. During the testing, it was found up to 24% of vehicles travelling with their left hand side wheels in the cycle lane. This is despite the clear road markings to identify the lane. The separation was installed and there was a clear shift away from the kerb by the vehicles

## A report by SINCLAIR KNIGHT MERZ has found several benefits from the installation of separation kerbs

- ✓ Increase in the average position of motor vehicles away from the kerb (and hence the bicycle lane), leading to greater separation between cyclists and motor vehicles;
- ✓ Fewer vehicles intruding into the bicycle lane;
- ✓ Cyclists felt safer and more relaxed riding along separation kerbs.
