Asbestos Management Plan – Birrigai Outdoor School.

### Hazardous Material Survey & Management Plan

**Birrigai Outdoor School**  
**Tidbinbilla Rd**  
**Tharwa ACT 2620**

**10 June 2010**

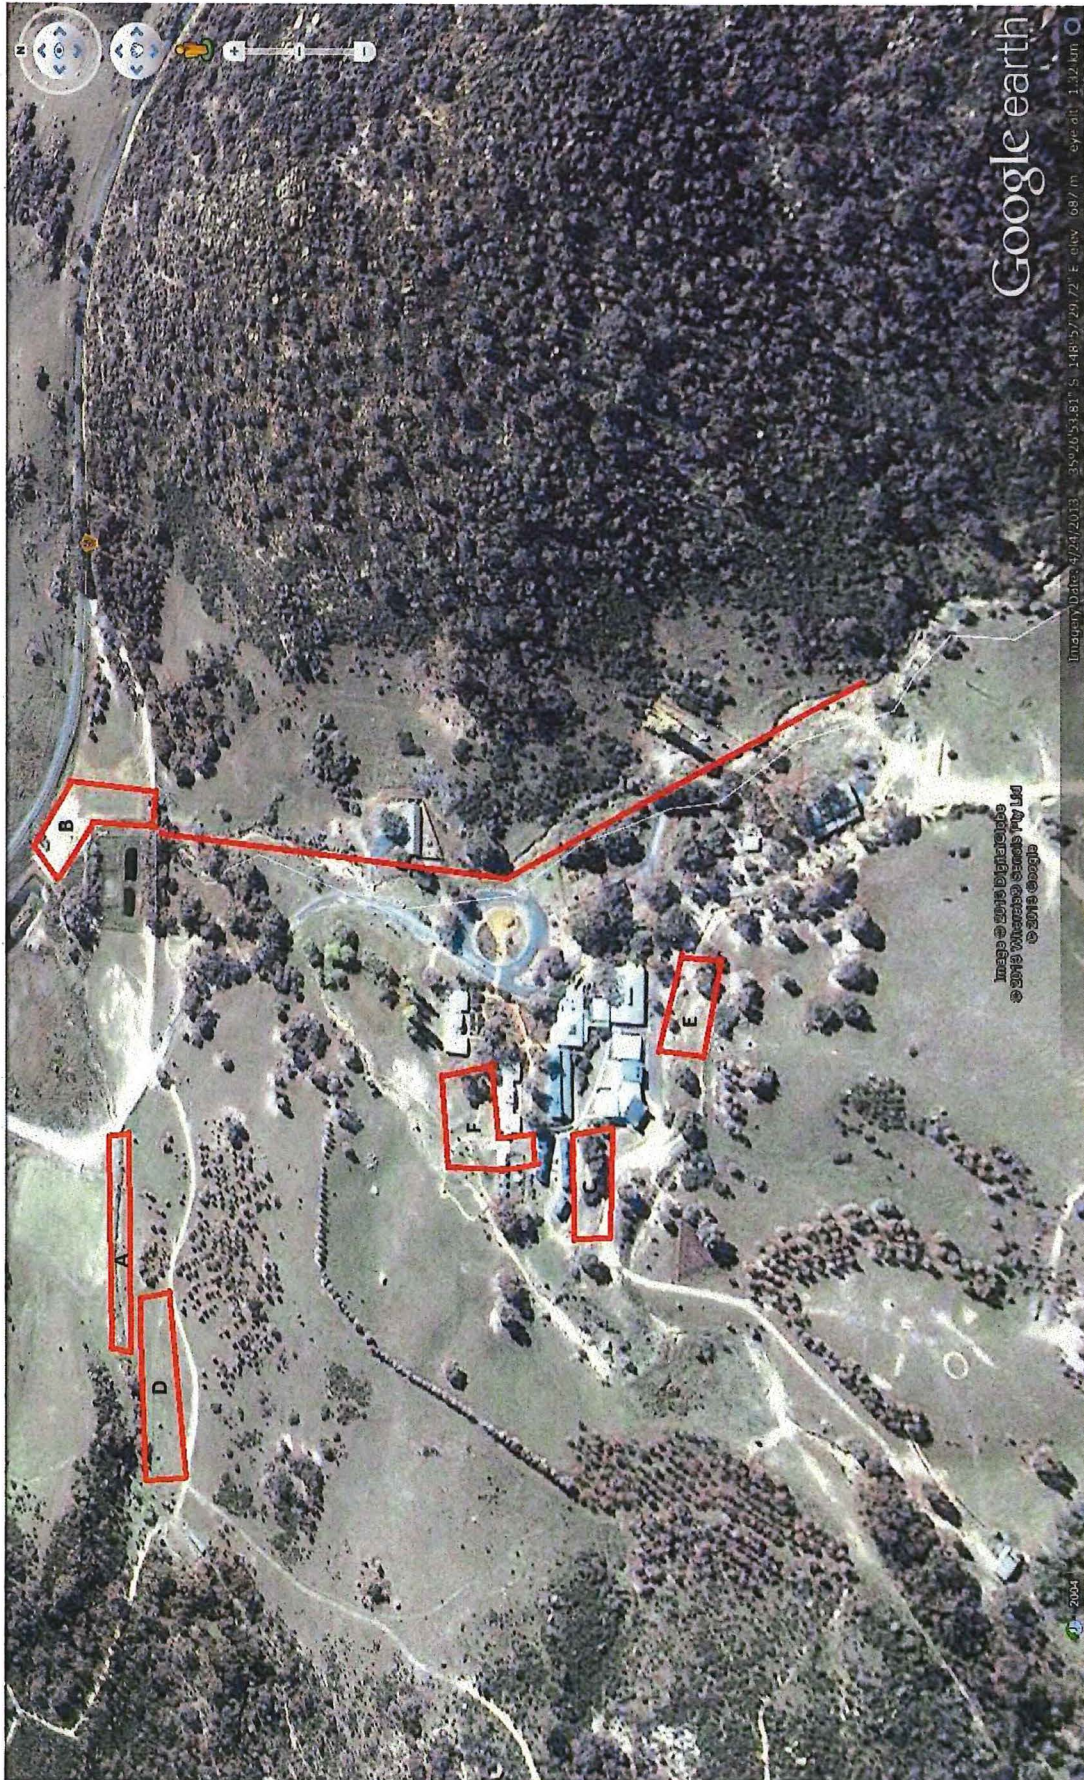
Site plan:

A copy of the school site plan showing the asbestos contaminated soil sites at the Birrigai Outdoor School is at Attachment C.
