Inquiry into referred 2017–18 Annual and Financial Reports
ANSWER TO QUESTION ON NOTICE

Glenburn Homestead

Scope of Conservation Work

27 June 2018

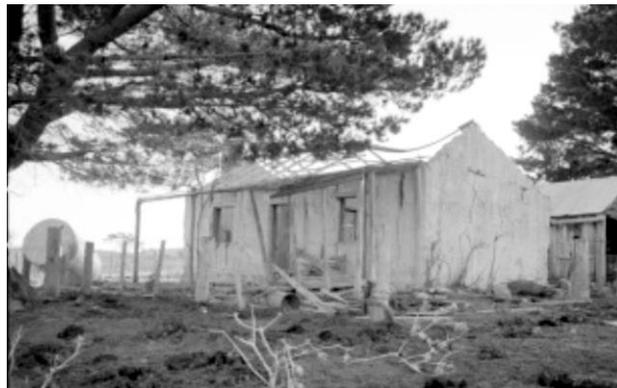
Glenburn Homestead 1971 showing collapsed roof
-photo by David Read in collection of NLA sourced from McAlister.

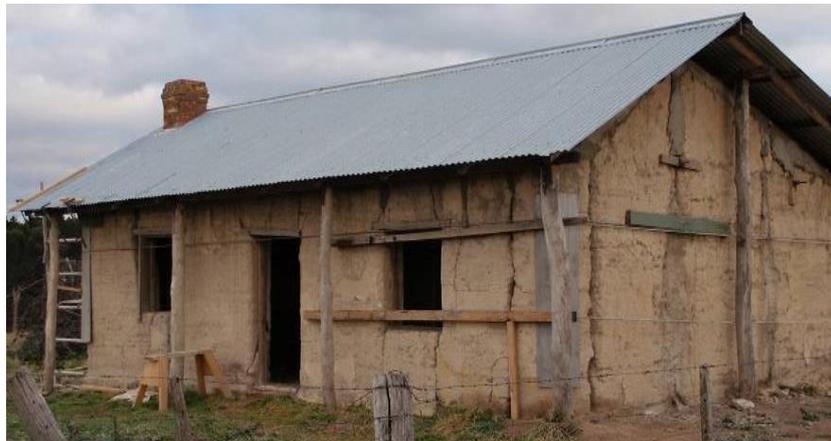
Steel cable at door head height with vertical timber shutters on corners, 2010.
Source: *Pise` Photo comparison* -courtesy Louisa Roberts, Act Gov

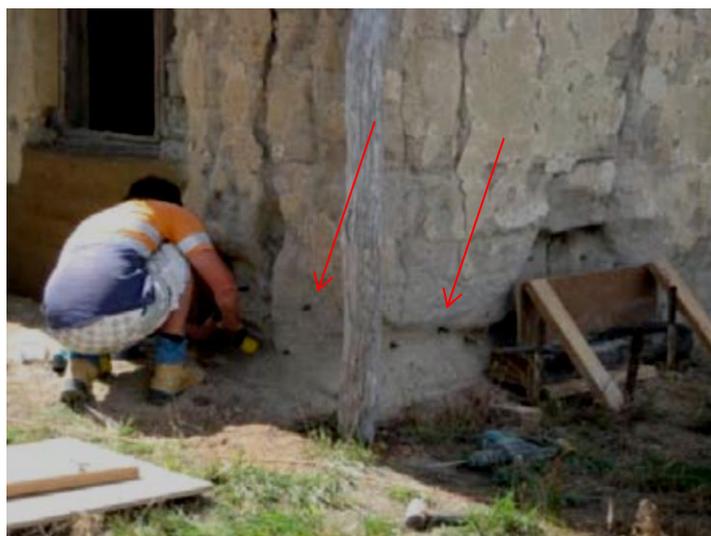
2013 restoration of pise` (A Work in Progress Colin McAlister 2013).
Note the use of metal rods or starter bars (arrowed) protruding from the old wall.

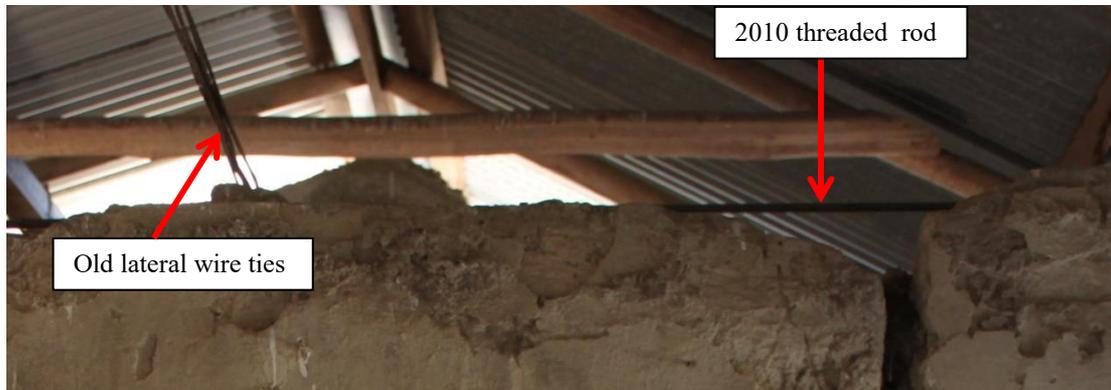
Modern cross tie

A steel cross-tie runs on top of the east west internal wall and is presumed to have its ends embedded into the 2010 concrete topping beam. The old lateral wire ties can also be seen in the image below

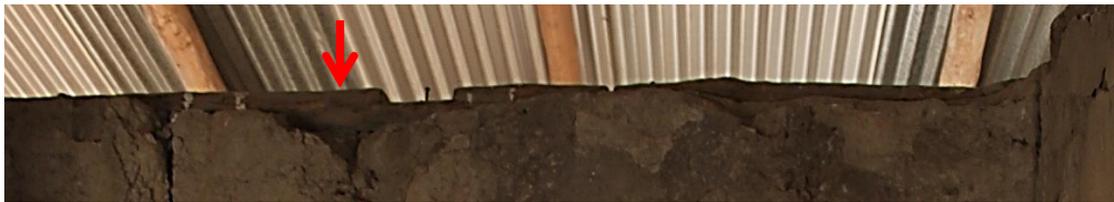
Timber wall plate

A timber wall plate is located on top of the internal north/south wall and includes a rebate for a former ceiling rafter. The plate is most likely to have supported ceiling rafters and would have had minimal impact on the building's overall structural system.

Bush round wall plate between lounge room and western bedroom.

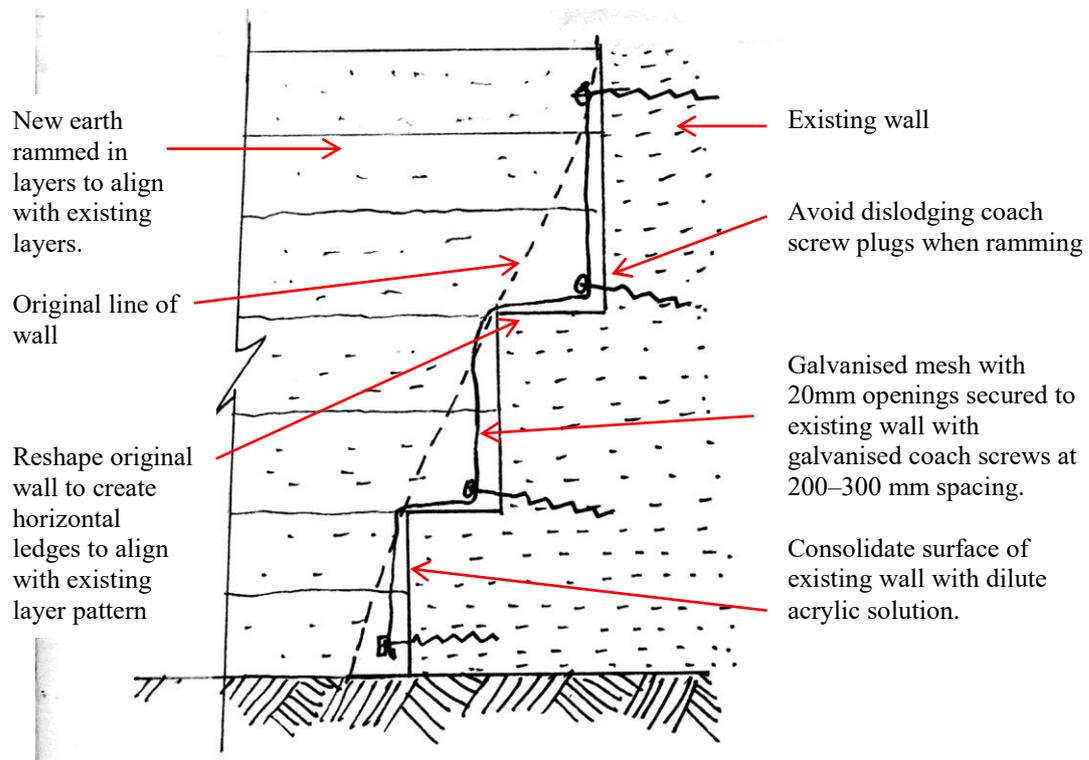
Indicative section showing repair methodology

- Form 20 mm by 20 mm galvanised mesh to fit the surface to be repaired, ensuring none of the mesh will protrude beyond the repair. Anchor the mesh loosely to the pise` surface with galvanised coach bolts, starter bars or similar. Screw fix or gently hammer in place to obtain a firm fit. Epoxy resin should not be necessary. The mesh can be tacked to door jambs where relevant. Add additional lugs or pins if warranted to ensure new material will lock onto the existing matrix.

- Form up shutter boards to closely follow the original surface and ram the new earth firmly into layers of approximately 75 mm high. Work well into the mesh and the original surface. Lightly re-moisten the original surface if appropriate to improve the bond.

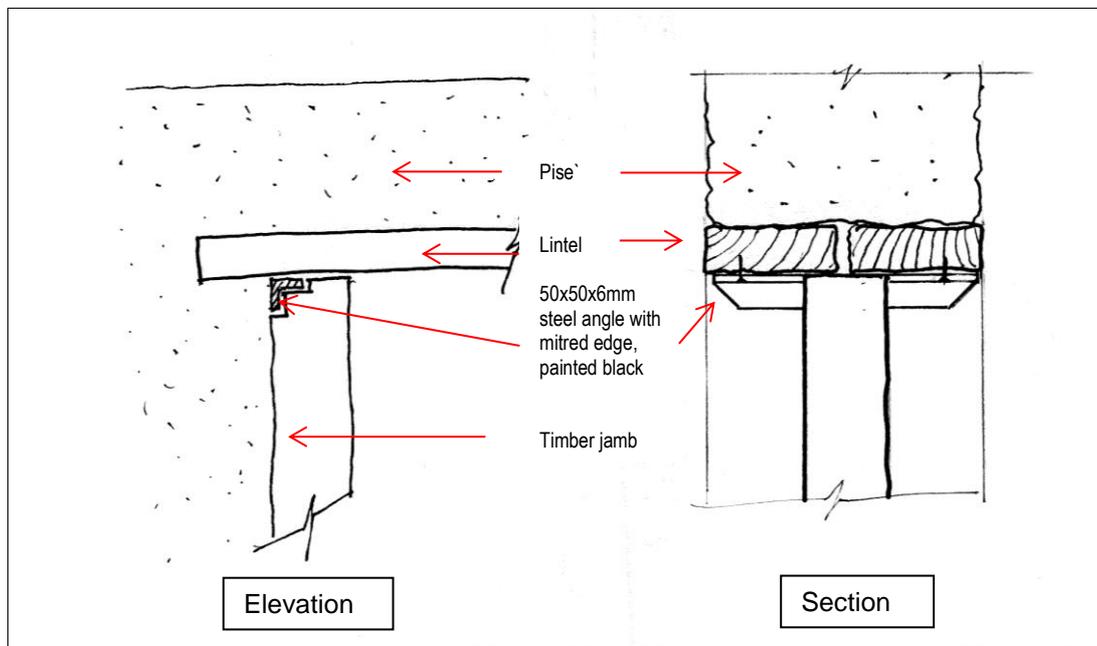
Detail showing steel angle to be introduced between top of jamb and underside of timber lintel

Where there is inadequate bearing between the top of jamb and underside of timber lintel, a 50 x 50 x 6mm right angled steel channel should be inserted as shown in the diagram below.

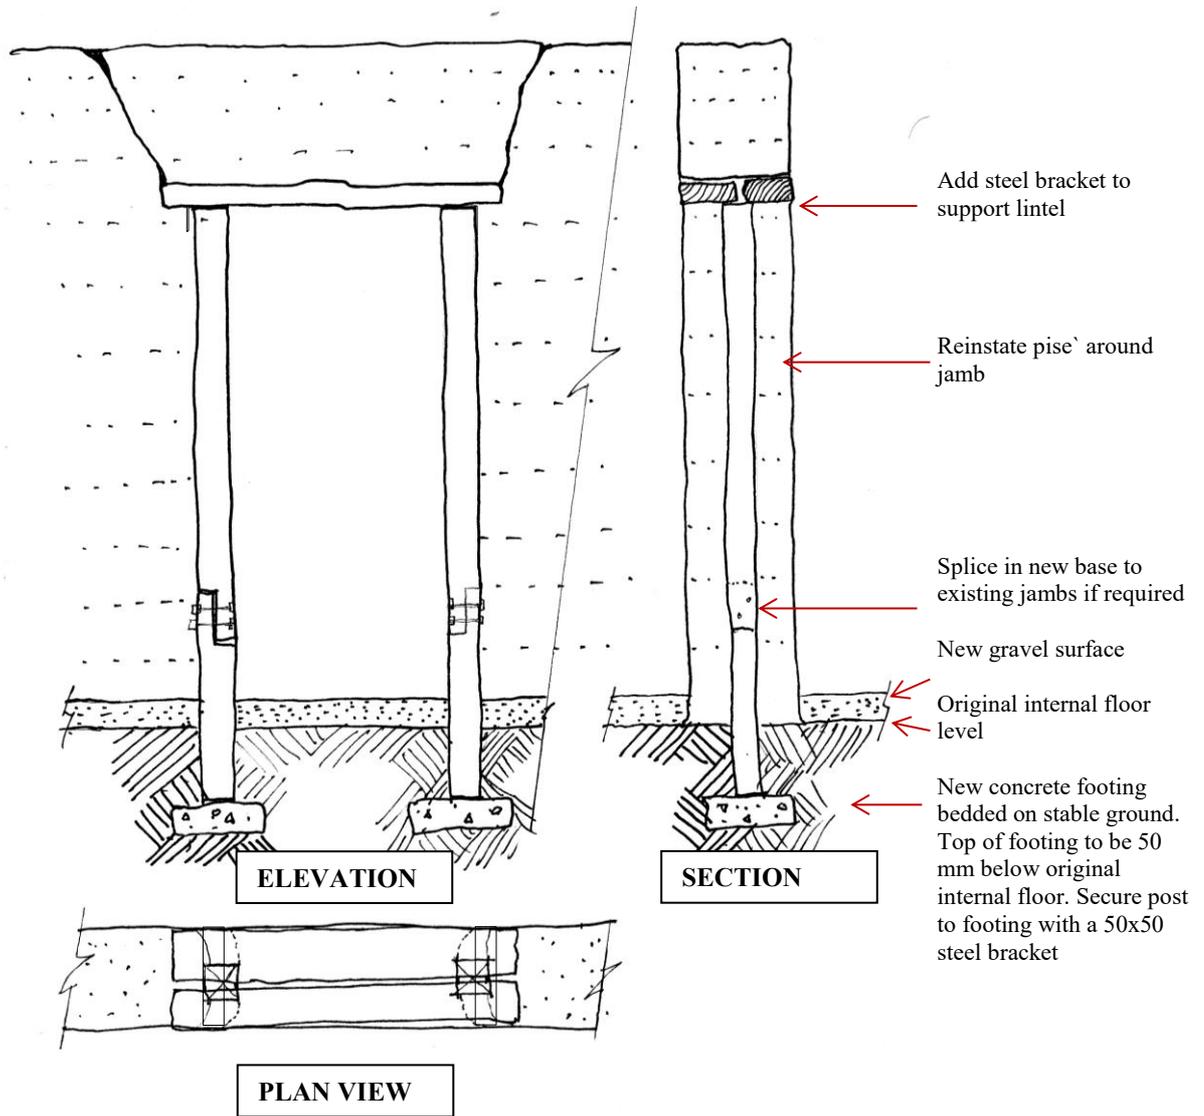
Indicative repair to door jambs

Cut back the jamb to sound material and splice on a new base of termite-resistant Australian hardwood. The splice should be half-lapped, glued and bolted.

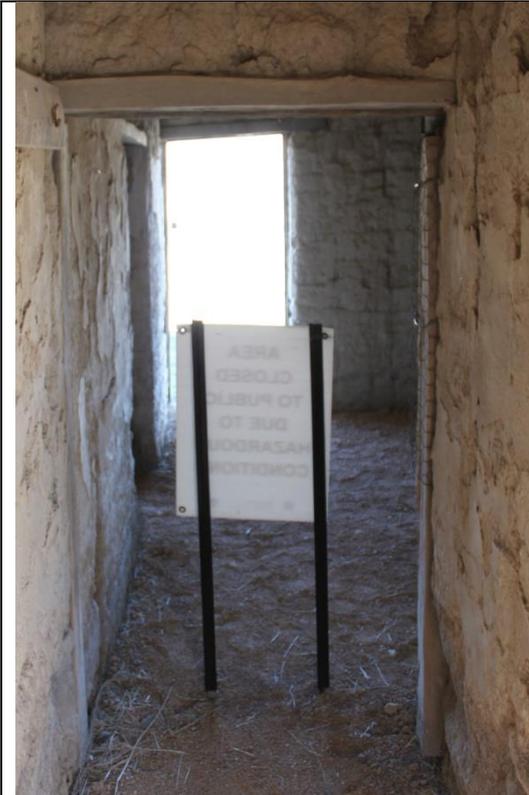
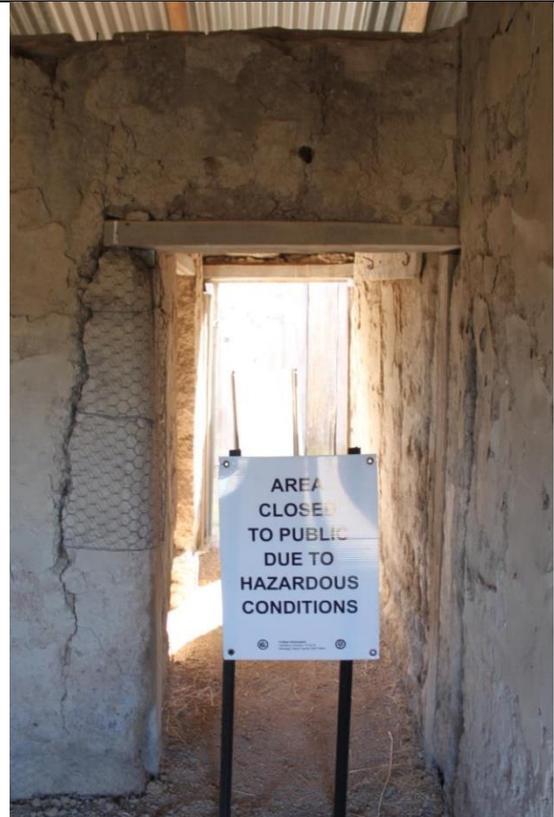
D6 Between Room 3 and Hall

The face of the left hand (north) jamb is flush with the wall but has subsided relative to the timber lintel.

- Inspect the base and repair the jambs as per elsewhere.
- Locate steel angle under lintels as shown below:

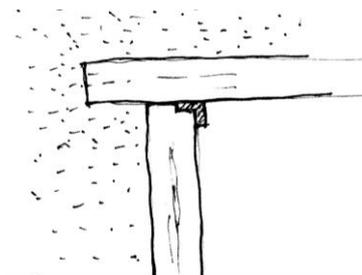
South jamb detail.

The jamb has subsided by about 50mm and a large section of corner pise`is breaking away.

- Stabilise the lintel.
- Remove existing steel hollow section and chicken wire.
- Repair the jamb as per elsewhere including steel angle to underside of lintels.
- Remove corner pise` and reconstitute with new material. Ram back into corner position using lugs and mesh to hold in place.

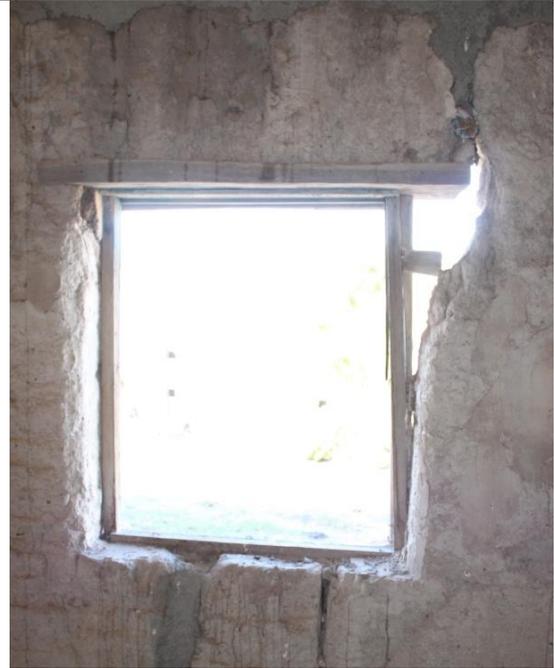
The north jamb has dislodged but cannot be safely returned to its former position.

- Clean the space beneath the jam and grout with a firm mix of 1 cement:1lime:6 sharp sand

- Insert a closely fitting additional timber frame to the inside face of the existing window frame to assist in supporting the lintel. Set base of frame in a mortar bed and secure the new frame to the historic item. Ensure firm engagement with the underside of lintel.
