Shane Rattenbury MLA - Arrangements brief

FUNCTION:	Launch of the 2022 Waterwatch Catchment Health Indicator Program (CHIP) report A copy of the report is at Attachment D .
VENUE:	Dickson Wetland, Dickson. See map at Attachment A .
HOST:	Name: Woo O'Reilly Mobile: Personal Information
DAY:	Wednesday
DATE:	22 March 2023
TIME:	8:30am
TIME COMMITMENT:	30 minutes
CATERING:	Yes – coffee and pastries will be provided
DRESS CODE:	Casual
YOUR ROLE:	A short speech to launch the CHIP report. Speaking notes in Attachment B .
WHERE TO PARK:	Off Hawdon St, Dickson
WHO WILL MEET YOU:	<ul style="list-style-type: none"> Bren Burkevics (Executive Group Manager, Environment, Heritage and Water Division, EPSDD) Woo O'Reilly (Regional Waterwatch Facilitator, EPSDD)
ADVISOR ATTENDING:	Lachlan Roberts/ Anna McGuire (TBC with your office).
AUDIENCE:	Waterwatch volunteers as well as the broader Waterwatch network. This includes members of the three community-based Catchment Groups (Molonglo, Ginninderra and Southern ACT) who partner with the ACT Government to implement the program plus water scientist from UC and members of the UMCN committee. Icon Water representatives are also invited.

Launch of the W

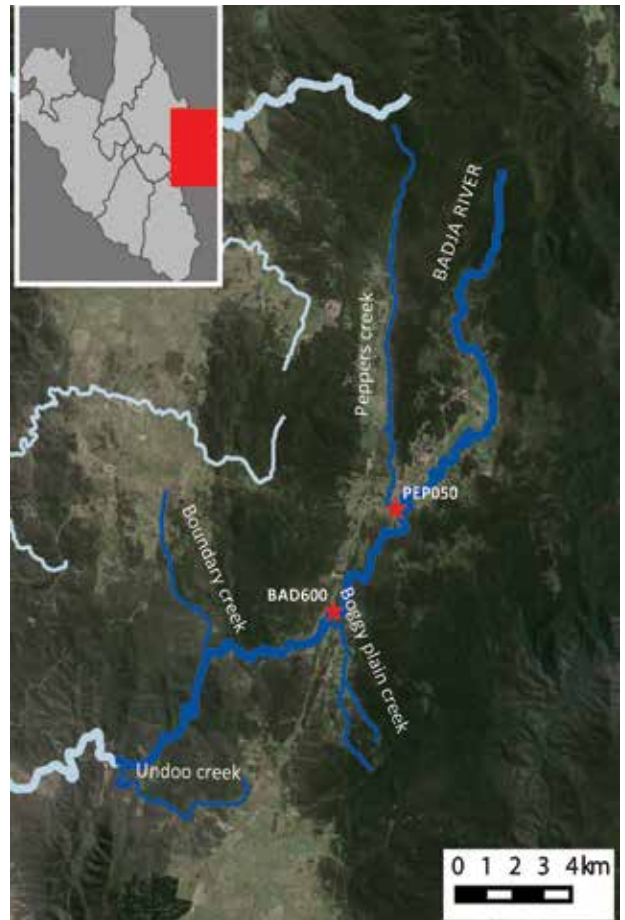
The 2019/20 bushfires greatly impacted this reach with fire burning out most of the catchment. Three years on, much of the riparian shrub and canopy layer vegetation has yet to recover properly. The higher than average rainfall over the last three years has been very favourable, resulting in replenished groundwater and good groundcover being established in this part of the catchment. Several larger flow events have flushed the heavy ash and sediment from in-stream habitats, which was washed into the river after the bushfires. This has contributed to improved waterbug survey results, which have been *excellent* for the last couple of years.

The canopy and shrub layers at BAD600 are still recovering three years on from the 2019/20 bushfires

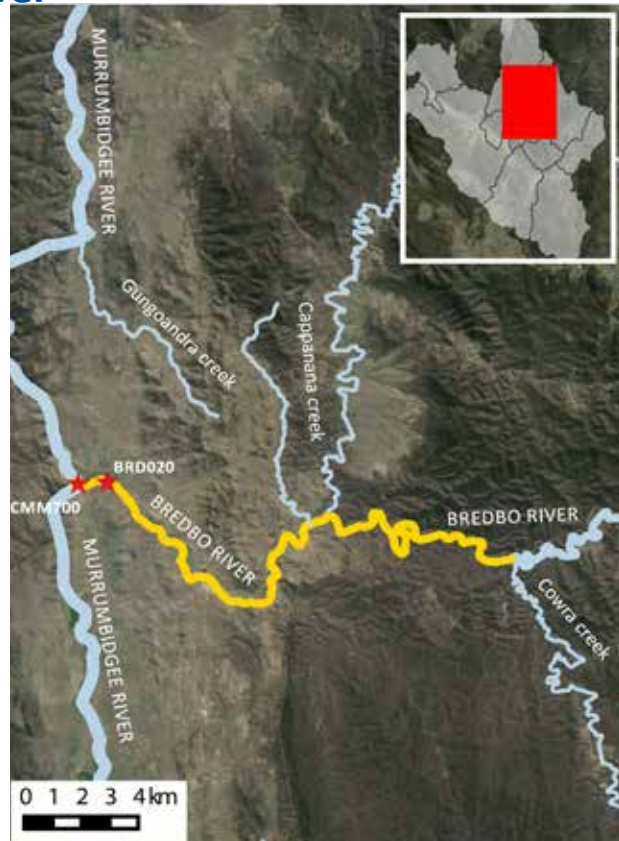
High flows continued throughout 2022 which saw ongoing streambank erosion along this reach, especially in areas where deep rooted native vegetation is limited. Successive flood events saw new deposits of sand and ash at the confluence, indicating the ongoing mobility of both fine and gross sediment in the system. This year's waterbug survey results reflected this with the majority of bugs found belonging to the Orders of Hemiptera (true bugs) and Diptera (fly larvae) which are tolerant of both poor habitat and water quality.

Streambank erosion is evident on the lower Bredbo River (BRD100) after several years of higher flows

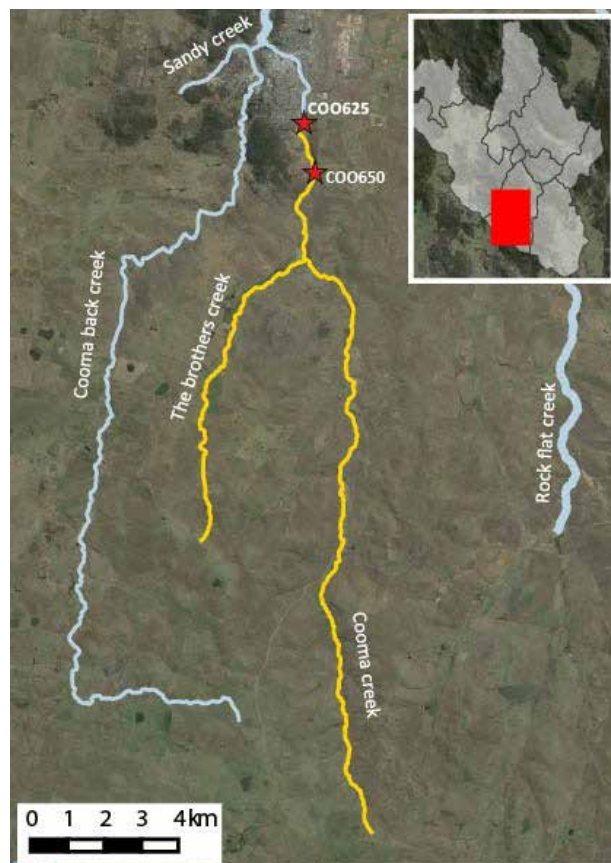
Cooma Creek at COO650 had flood debris high up in the trees indicating the height of the October flood

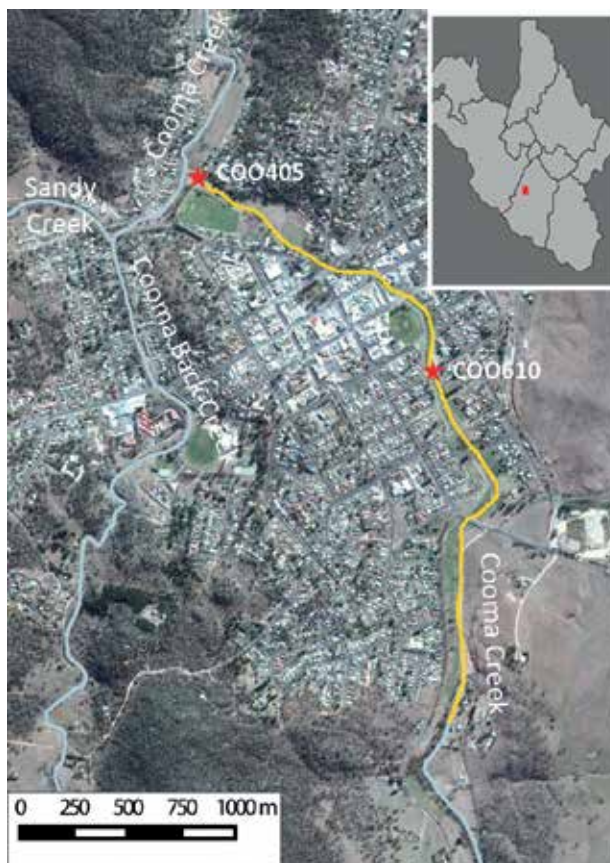
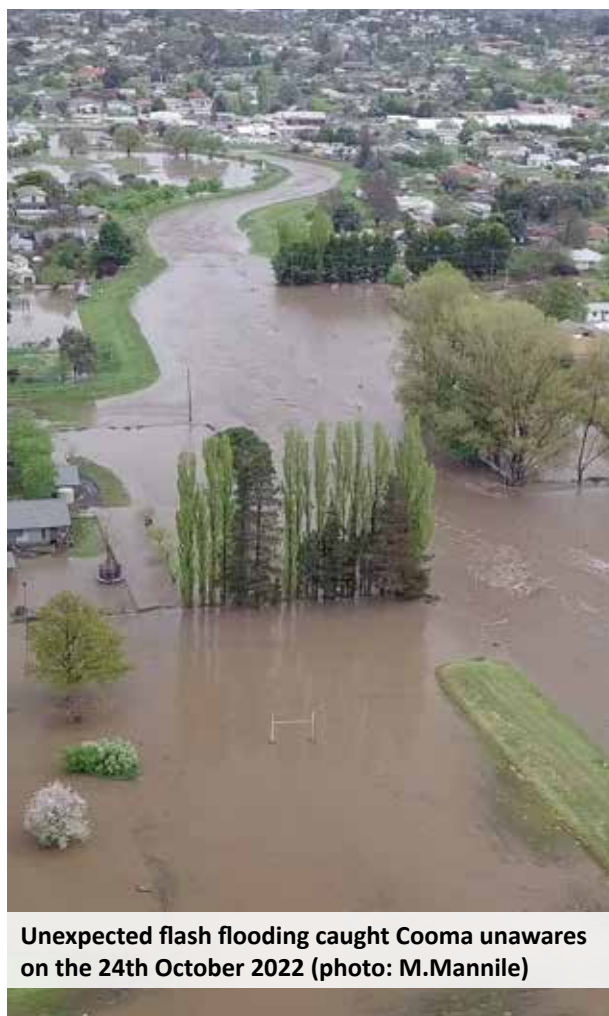
Medium to high flows have continued throughout 2022 including a flash flooding event in late October which outflanked the levee banks, flooding adjoining buildings. The flows have mobilised nutrients and dissolved salts and minerals, as well as increased turbidity. Such results were also seen upstream but it is exacerbated in this reach by pollution present in the urban stormwater inflows. Waterbug surveys reflect this trend and were dominated by waterbug types that are tolerant of increased nutrients and organic matter. These include freshwater snails, segmented worms and fly larvae.

Unexpected flash flooding caught Cooma unawares on the 24th October 2022 (photo: M.Mannile)

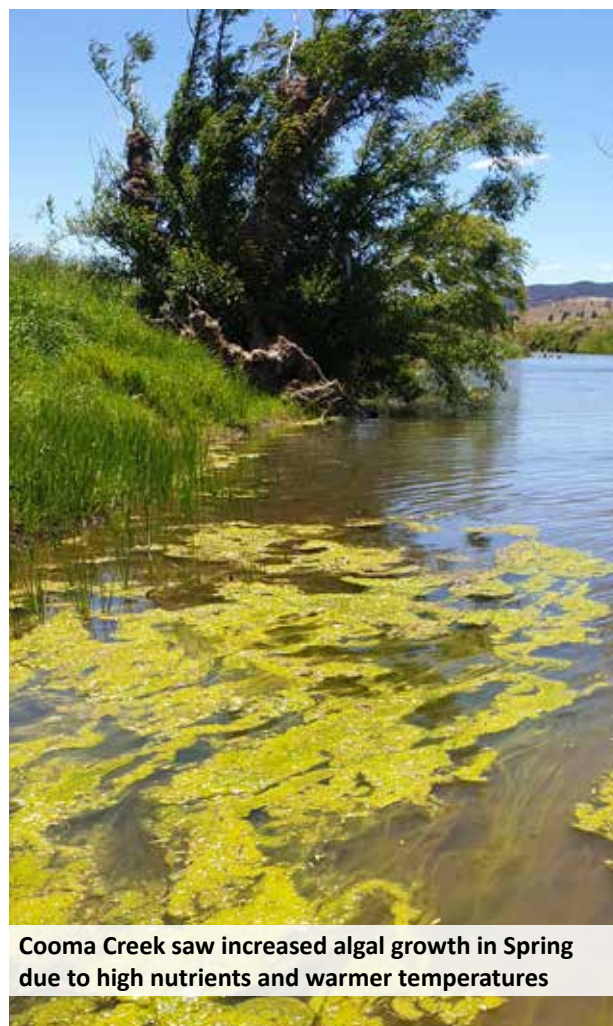
Cooma Creek saw increased algal growth in Spring due to high nutrients and warmer temperatures

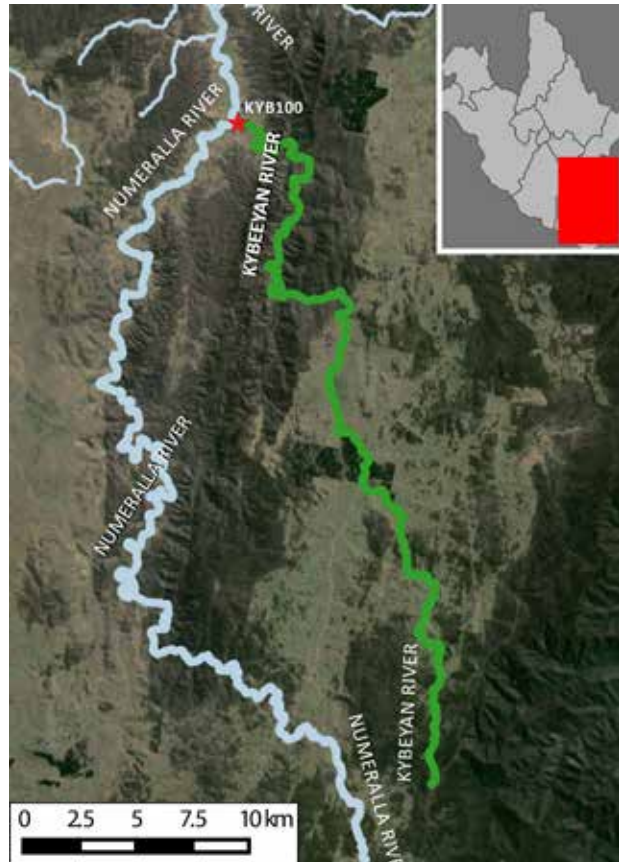
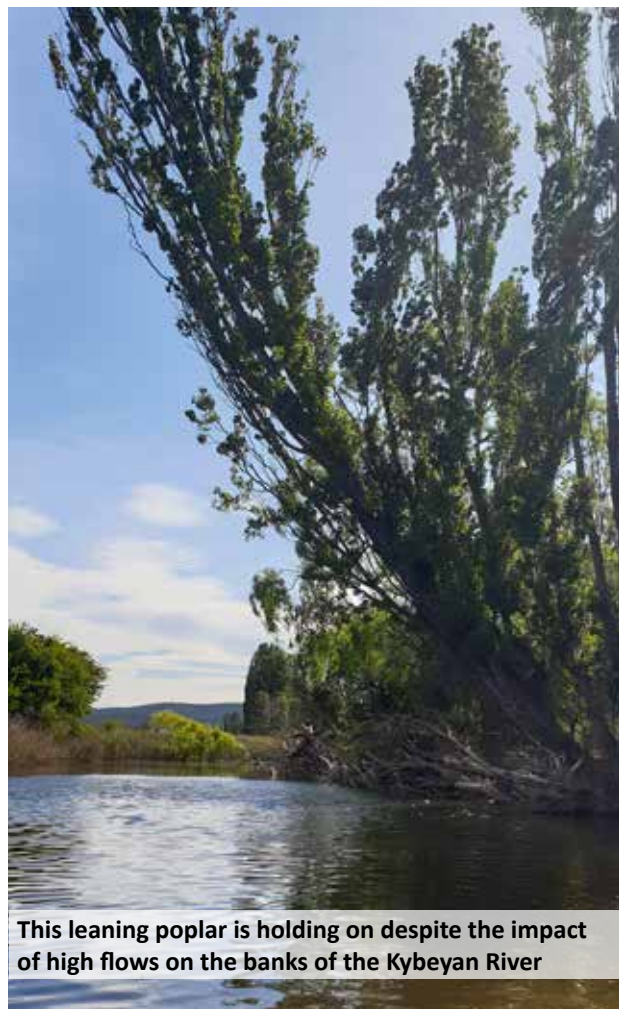
This leaning poplar is holding on despite the impact of high flows on the banks of the Kybeyan River

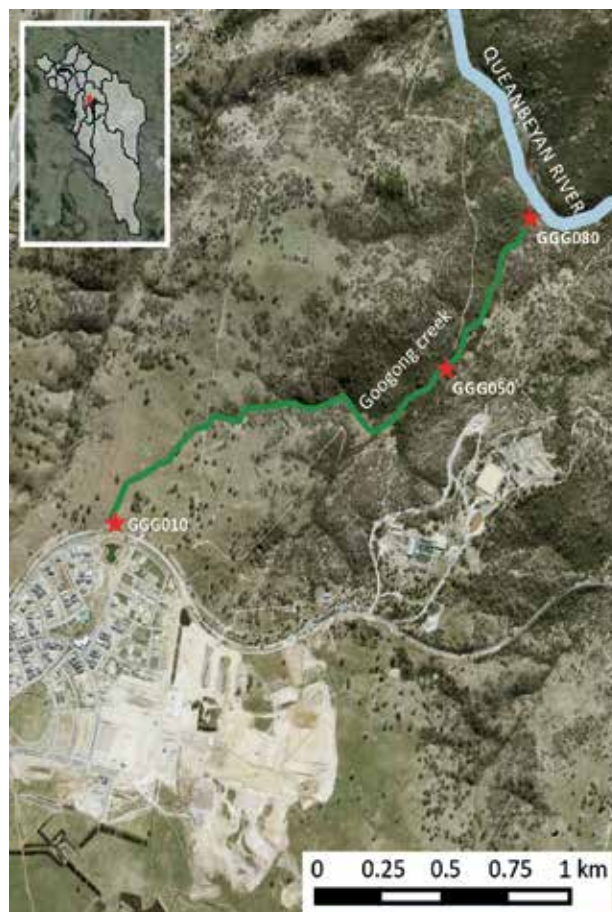
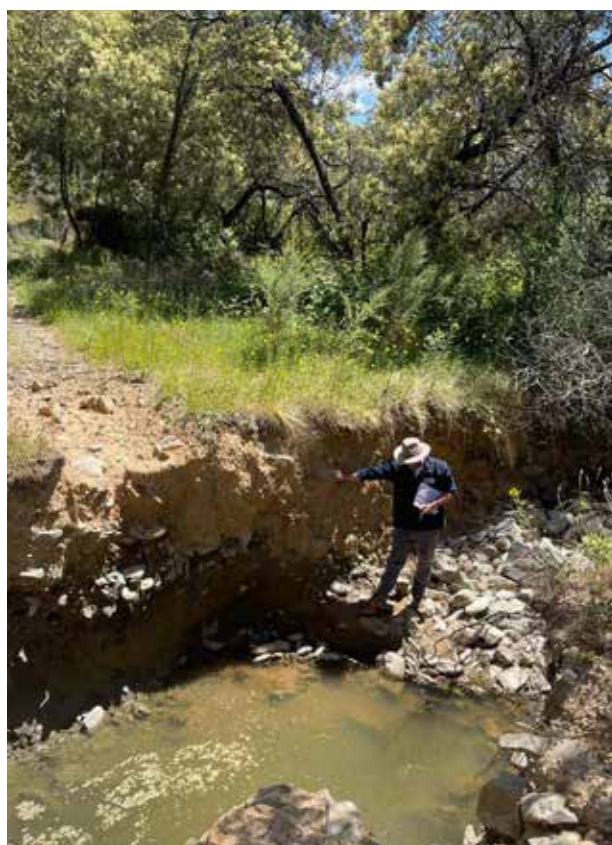
Even with healthy riparian vegetation and a high representation of native mid-story riparian species, extreme erosion was found on the dam at GGG050, which has cut the pipeline access track. Higher flows brought on by this year's increased rainfall have proven too much for the small overflow dam, spilling and eroding a deep gully down the dam wall and depositing sand back into the creek, smothering aquatic habitat.

Extreme gully erosion on Googong Creek at GGG050 has cut the access trail

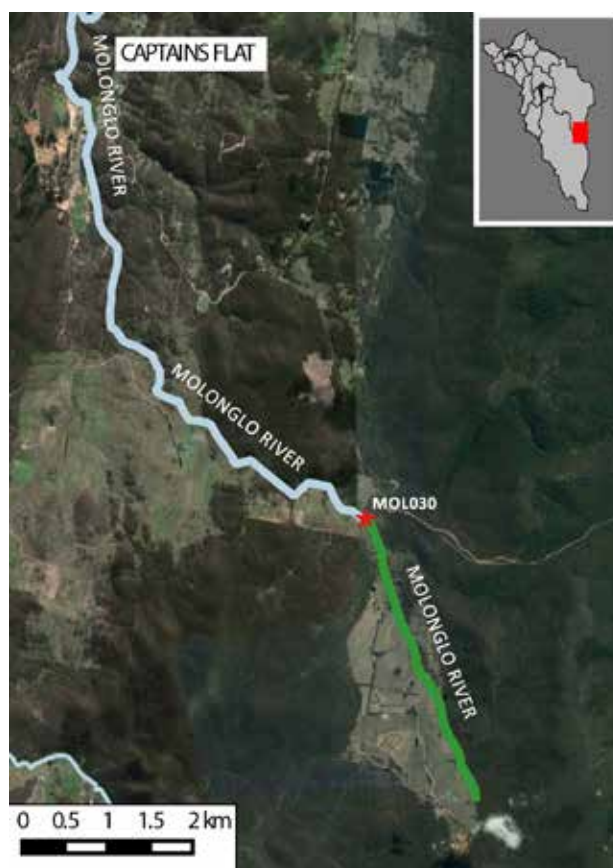
Grader works on Wild Cattle Flat Road in April pushed soil into the Molonglo at MOL030 and left much of the riverbank exposed. A grass fire in September has further reduced riparian coverage, burning Carex and large native tussock grasses growing in the riparian zone. Access to the river by nearby stock may result in a slower recovery of riparian vegetation and risk further erosion issues.

Evidence of a grass fire at MOL030 in September.

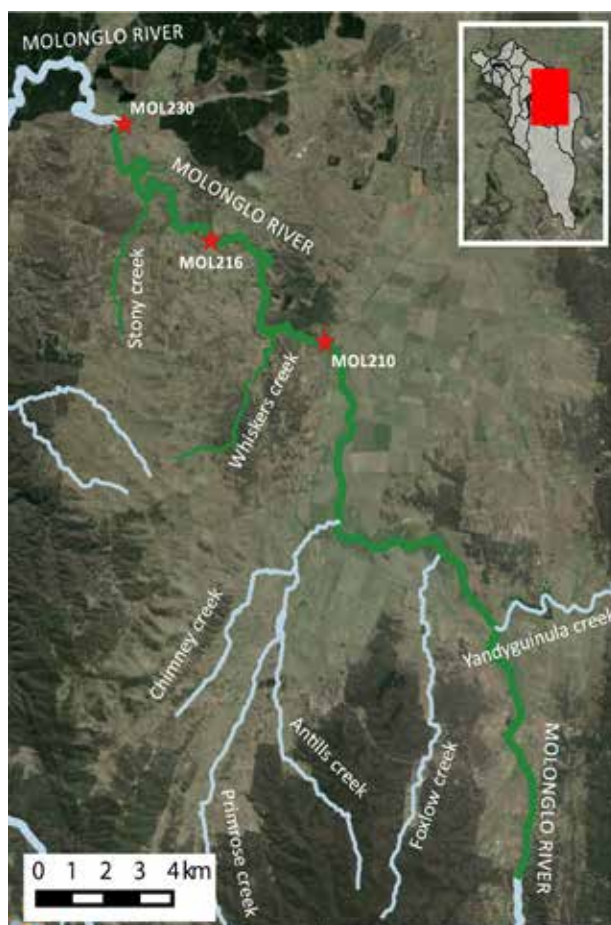
Riparian vegetation in this reach is largely exotic: willows dominate the canopy, and hawthorn and *Pyrocantha* have replaced most of the native mid-storey species. MOL216, located at the Molonglo River Park near Carwoola, has vast infestations of Chilean needle grass and African love grass, which has now taken over the native *Poa* tussock grasses that once dominated.

Debris marks the high flows at MOL210 where Willows are the dominate canopy species

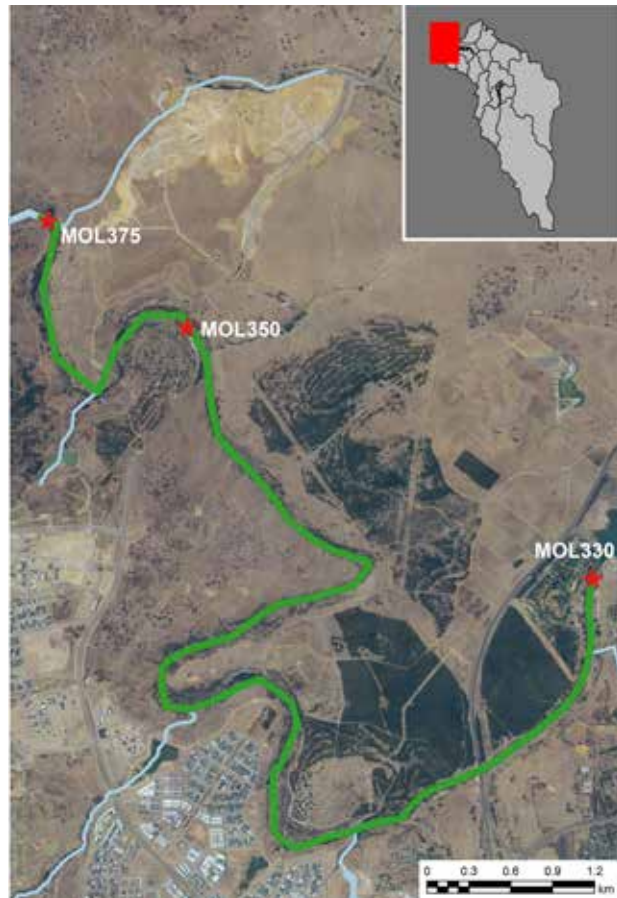
Ongoing development appears to be changing upstream conditions in this reach and contributing to erosion issues, exacerbated by periods of high rainfall. The small creeks that drain into this section of the Molonglo River such as Yarralumla, Weston and Deep Creek, and the unnamed ephemeral creek downstream of Denman Prospect sediment ponds, all experienced significant bank erosion. Gully erosion upstream of MOL375 continues to be an issue but vegetative cover is returning after three years of construction works at Namarag-Molonglo River Reserve.

Erosion on Deep Creek near MOL375 has been worsening in recent years

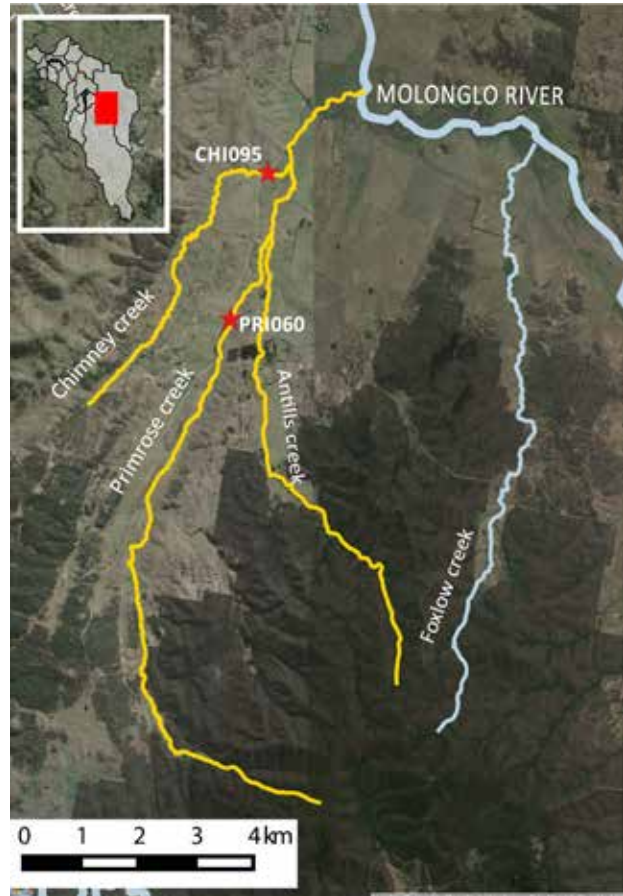
A lack of canopy and mid-storey vegetation layers along Chimney Creek gives this reach one of the worst riparian condition scores in the Molonglo catchment. Access to the creek by stock further exacerbates this issue, as native plants struggle to regenerate amongst trampling hooves, hungry sheep, and fast-growing invasive weeds. Bank erosion on the lower sections of Primrose Creek continues to be an issue with poor riparian coverage resulting in unstable riverbanks and soil being washed into the creek during periods of high flow. Young stands of *Acacia dealbata* are maturing in stock-free sections upstream of PRI060, which we hope will help stabilise banks into the future.

A lack of canopy and mid-storey vegetation is evident on Chimney Creek (CHI095)
