## MINISTERIAL BRIEF

**Subject:** Findings of the 2019 Catchment Health Indicator Report

# Catchment Health Indicator Program

2019

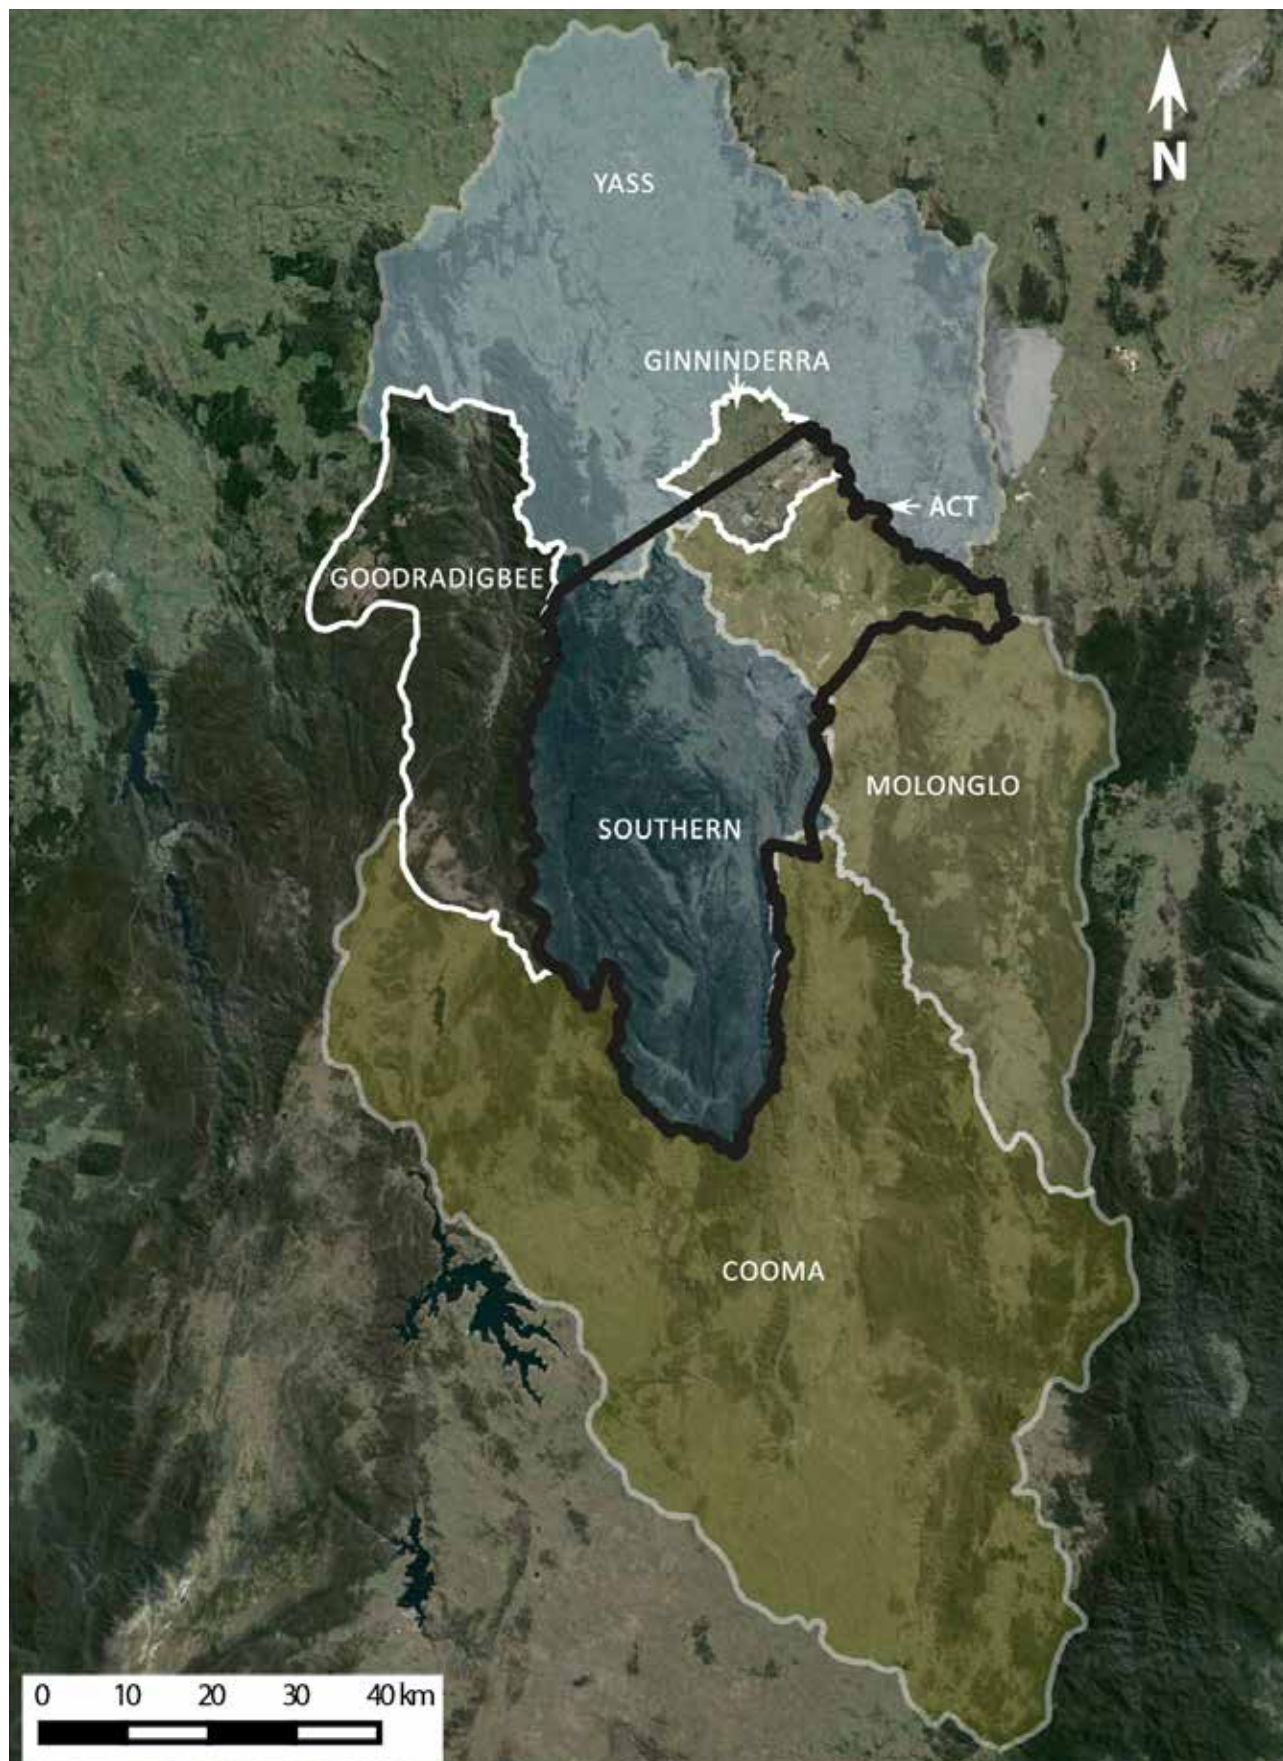
Figure 1. Overview of the upper Murrumbidgee River catchment, outlining the five major sub-catchment areas represented in this report as well as the border of the ACT. The Goodradigbee catchment is not included in this report.

Four Waterwatch coordinators support volunteers in the major sub-catchments of Cooma, Molonglo, Southern ACT, Ginninderra and Yass (see Figure 1). Each of these sub-catchments make up sections I – V of this report.

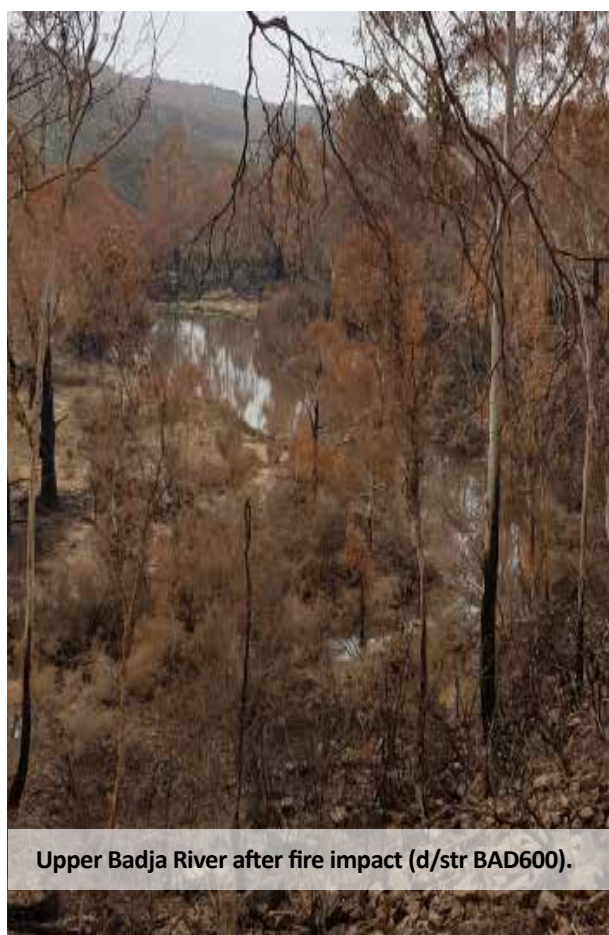
Upper Badja River after fire impact (d/str BAD600).

Nearly the entire Badja River catchment was burnt due to the Badja Forest and Good Good fires which started in December 2019. The impacts of this are not captured in the data for this year.

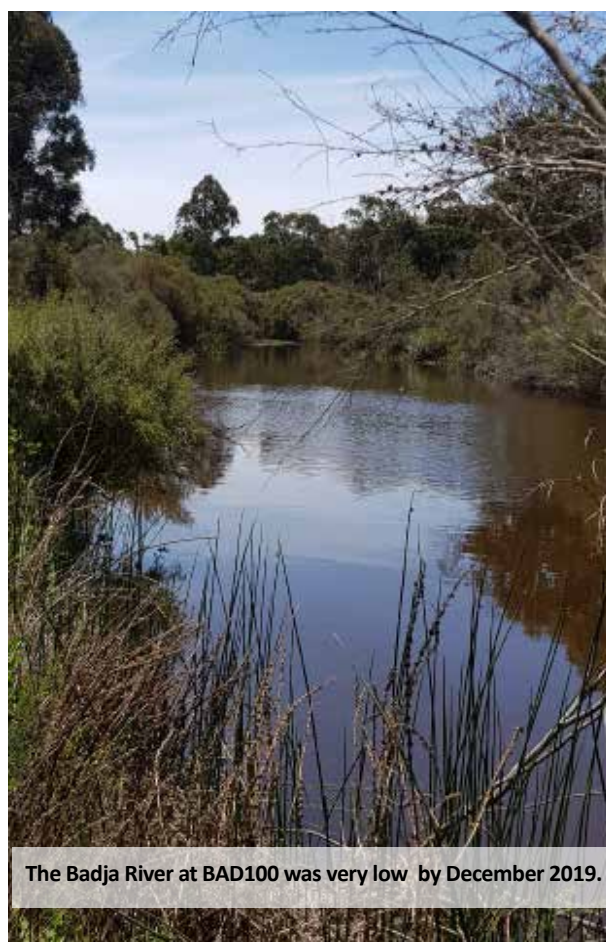
The Badja River at BAD100 was very low by December 2019.

In 2019 the extremely dry conditions saw the river reduced to isolated pools. The Ti-trees in the river corridor started to 'brown-off' (die back) due to the heat and dry. Despite this, water quality and waterbug scores remained high and this reflects the high level of native vegetation in the catchment.

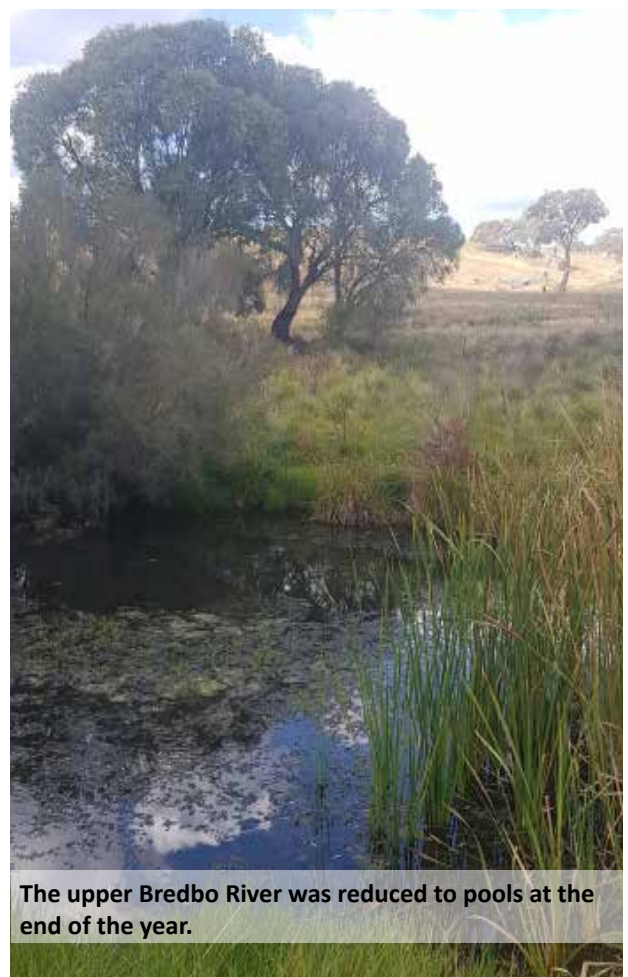
The upper Bredbo River was reduced to pools at the end of the year.

Sampling shows consistently *excellent* water quality - even after heavy runoff events. The extremely dry conditions saw much of this reach reduced to isolated pools towards the end of 2019. Waterbug surveys show a good diversity and abundance of sensitive bug types. This demonstrates the positive effects of a well vegetated catchment and the presence of good instream habitat.

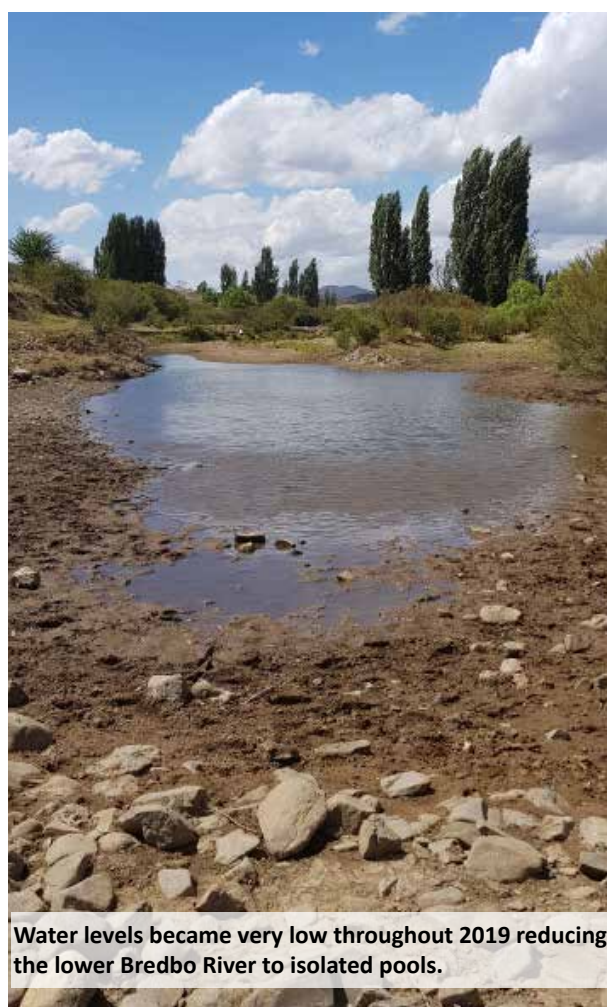
Water levels became very low throughout 2019 reducing the lower Bredbo River to isolated pools.

The extremely dry conditions saw the lower Bredbo River dry to shallow pools at the end of the year. As the water warmed there was an increase in algae and electrical conductivity was elevated due to evaporation. Where Carp were present in pools the water became increasingly turbid.

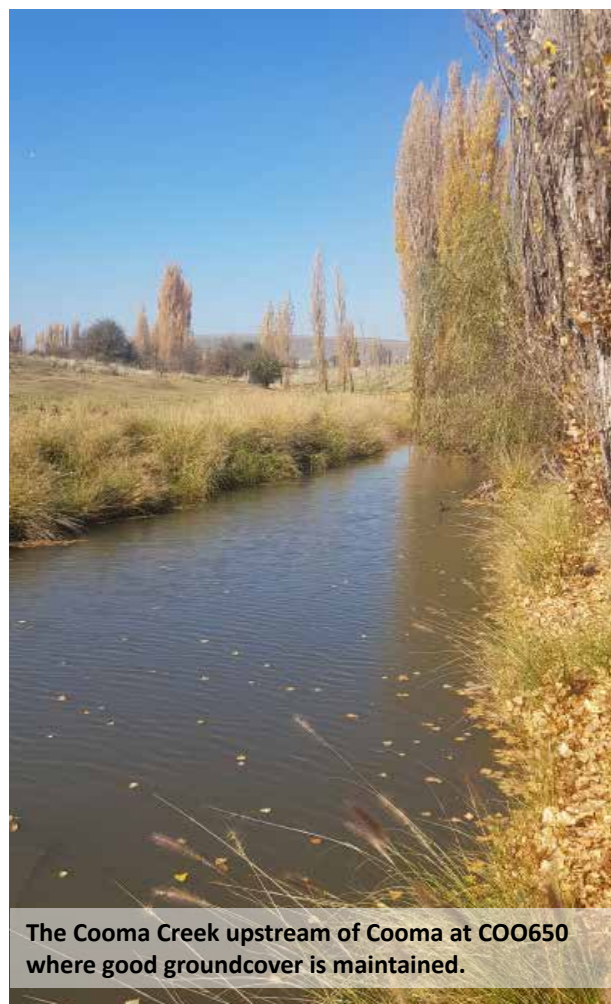
The Cooma Creek upstream of Cooma at COO650 where good groundcover is maintained.

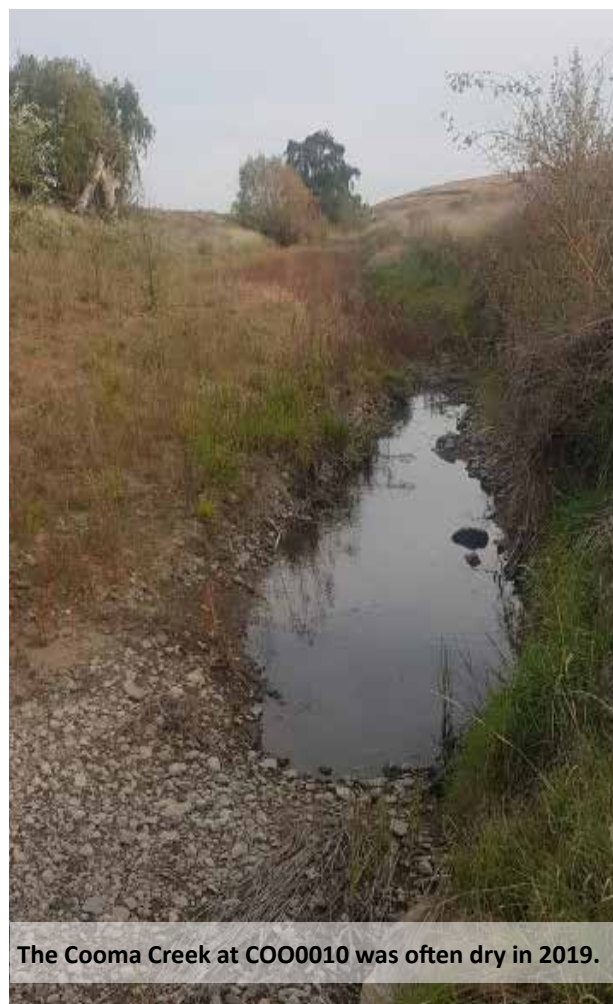
The Cooma Creek at COO0010 was often dry in 2019.

The dry conditions of 2019 saw the lower end of the Cooma Creek dry up completely, especially towards the end of the year.

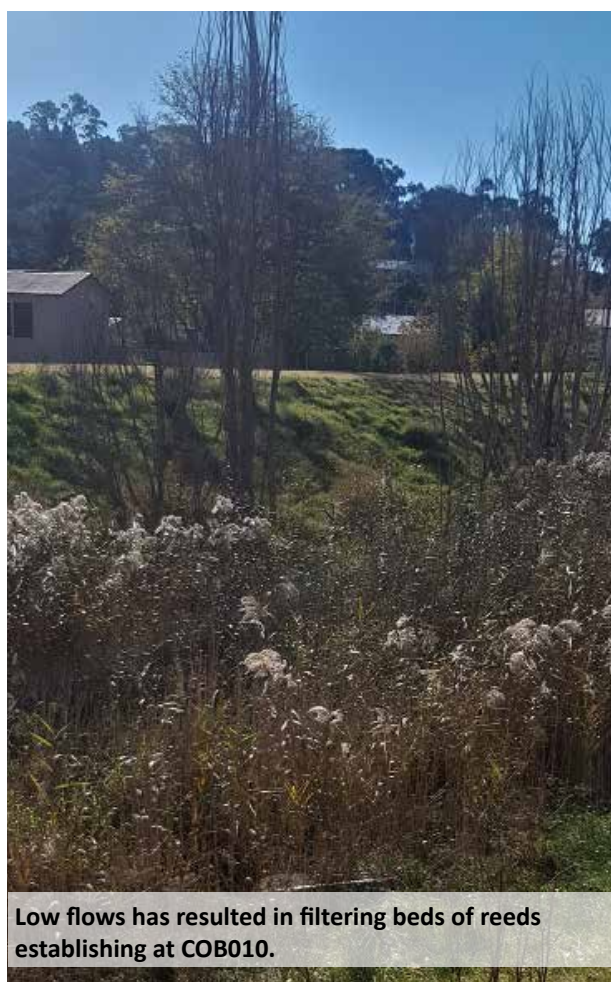
Low flows has resulted in filtering beds of reeds establishing at COB010.

Electrical conductivity is always high in this reach due to catchment geology and urban in-flows. Our monitoring shows that electrical conductivity goes up in dry periods as the salts and minerals become more concentrated in the water column due to evaporation. This reach has had consistently low flows throughout the last few years which have been drier than normal. Observations from our volunteers noted heavy algal growth, in-stream weeds and Azolla (a native floating fern) increasing as flows have reduced. Native reed beds have expanded in recent years taking advantage of the dry conditions. These reeds are beneficial for the creek, providing filtering and stabilising effects as well as improving habitat.

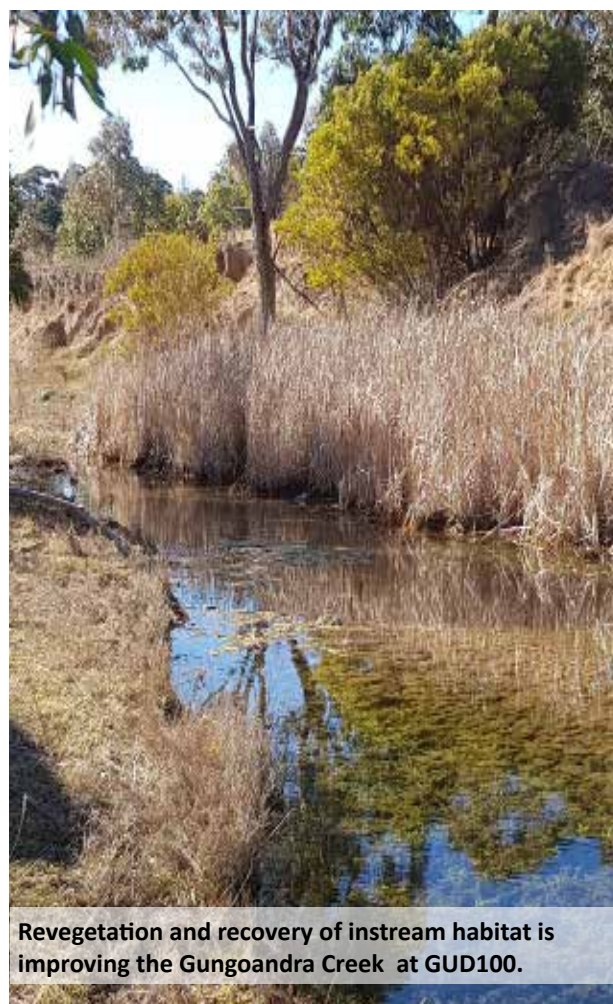
Revegetation and recovery of instream habitat is improving the Gungoandra Creek at GUD100.

Bush Heritage Australia has been working to improve the health of the creek by planting native vegetation in the riparian corridor as well as within the catchment. They have carried out in-stream erosion works as well as feral animal control, targeting pigs which dig up the creek. Removal of stock has seen stands of native reeds establishing along the length of Gungoandra Creek which provide positive benefits such as filtering the water, settling sediment, in-stream habitat and stabilising the stream channel. Recovery works have been supported by funding from Local Land Services and the Rivers of Carbon program as part of the Upper Murrumbidgee Demonstration Reach partnership.

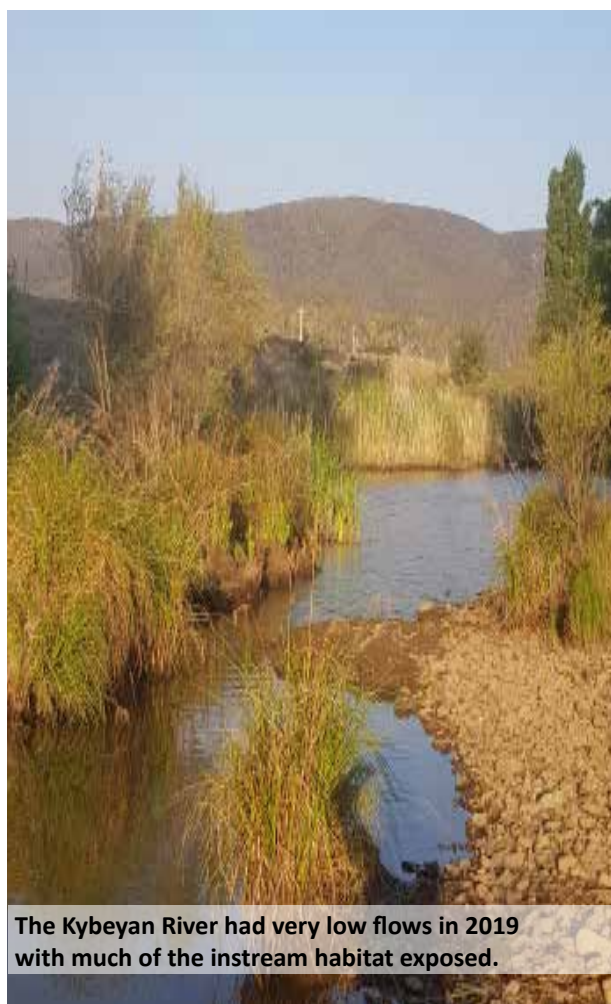
The Kybeyan River had very low flows in 2019 with much of the instream habitat exposed.

The adjoining landholder has noted how much the river has changed over the last 20 years, with Trout once being plentiful and Platypus sightings common every time you visited the river. Now Carp are more often sighted, Eastern gambusia (a small pest fish) are also present in large numbers and Platypus are sighted only very occasionally. The river experienced very low flows during the year due to the extended dry conditions.
