## **SUBMISSION TO THE INQUIRY INTO ACT GOVERNMENT PROCUREMENT**

## **Attachment**

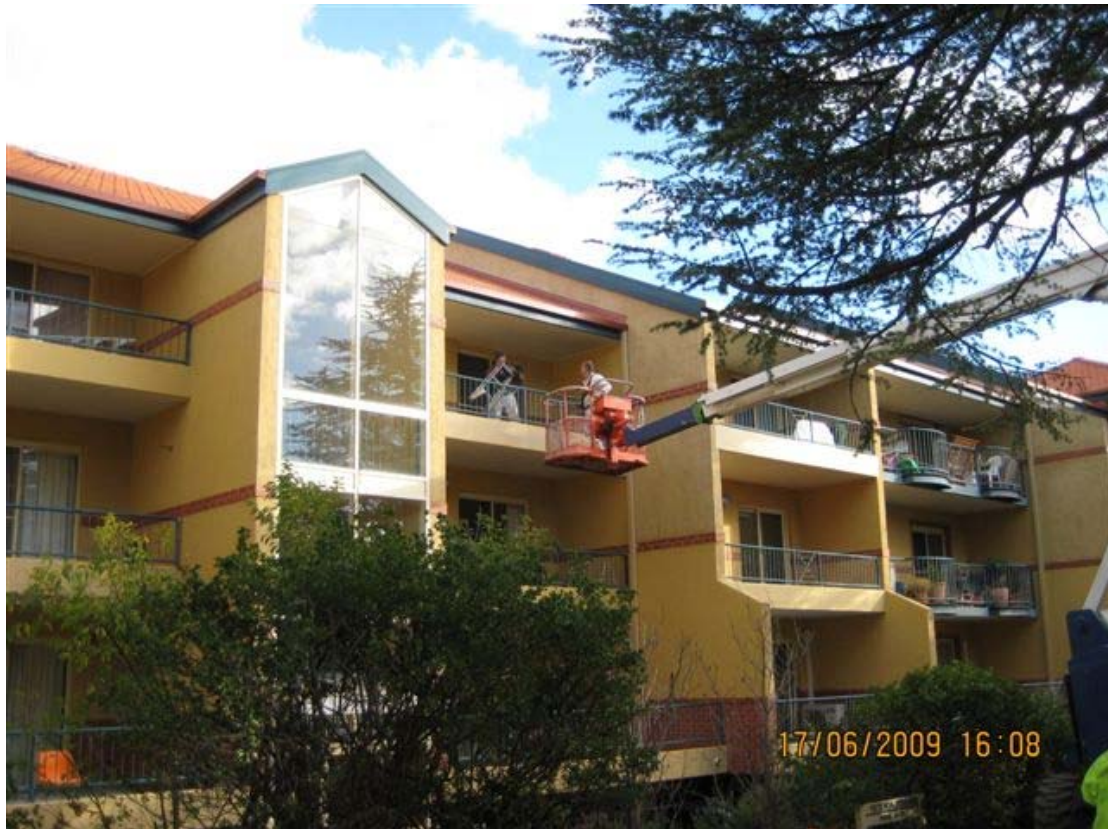
To paint the interior walls on the balconies, the workers were exiting the bucket of the EWP when it was adjacent to the balconies and then stepping over the handrail from the bucket onto a ladder.

1. The risk of a falling a number of floors to the ground.
2. The risk of the bucket controls being activated while climbing from the bucket to the ladder.
3. The ladder was not stabilized, i.e. once the painter is on the ladder, the ladder can become unstable. Further I understand that the Federal Safety Commission has banned the use of ladders on commercial building sites.

A photo of the unsafe work practice in process

The relevant Standard is 2550 'Cranes, Hoists and Winches', Part 10 'Mobile Elevating Work Platforms', Clause 5.9 'Access to and Egress from the Platform in the Elevated Position.' This section is quite clear on the circumstances under which a worker can leave an EWP of the type in use in Braddon. I will reproduce the relevant sections here, but the full text, and associated diagrams are attached (all emphasis added is mine).

*"Personnel shall not enter or leave the platform when elevated... unless **each** of the following conditions are met:*

*(a) Risk analysis shows that this means of access is **safer** than all other means of access"*

This means of access is certainly not the safest means of accessing a balcony – obtaining a key and walking onto the balcony from within the apartment is unarguably the safest method of access this workspace.

*"(b) The structural adequacy of the landing area has been established and the landing area is clear"*

The workspace in question had not been cleared, nor their adequacy checked as these were private residences. The floors may have been cluttered or slippery. There was nothing to ensure that the ladder did not slip causing the worker to fall while moving between the bucket and the landing. In one case workers were seen using patio chairs to climb into the bucket of an EWP.

*"(e) The work platform floor is capable of being located within 300mm **vertically** of the landing (see Figures 5.9 (A) and (B))"*

Given the type of EWP being used is a "cherry picker" (Figure A) rather than a "scissor lift" (Figure B), you can clearly see that it is a requirement that the platform must be immediately **above** the floor which the worker is attempting to access.

*(f) Where the work platform is located **over the landing**, the landing point is not less than 2m from the edge of the structure, unless a safety harness is properly worn and attached to a suitable anchorage, where any potential fall is in excess of 2 m, see Figure 5.9 (A)"*

Again this type of EWP is only for use when the bucket is over the landing and more than 2m from the edge of the structure, completely contrary to how it was being used in this case.

From the attached diagram, and the clauses outlined above, you can clearly see that the work method approved by WorkCover does not meet the Australian Standards for Mobile Elevated Work Platforms. It is completely incomprehensible that such work practices would have been approved, especially when a completely safe alternative exists.
